BUILDING DECAY ASSOCIATED WITH RAIN SEEPAGE

# BUILDING DECAY

# RAIN SEEPAGE

**Technical Bulletin 1356**

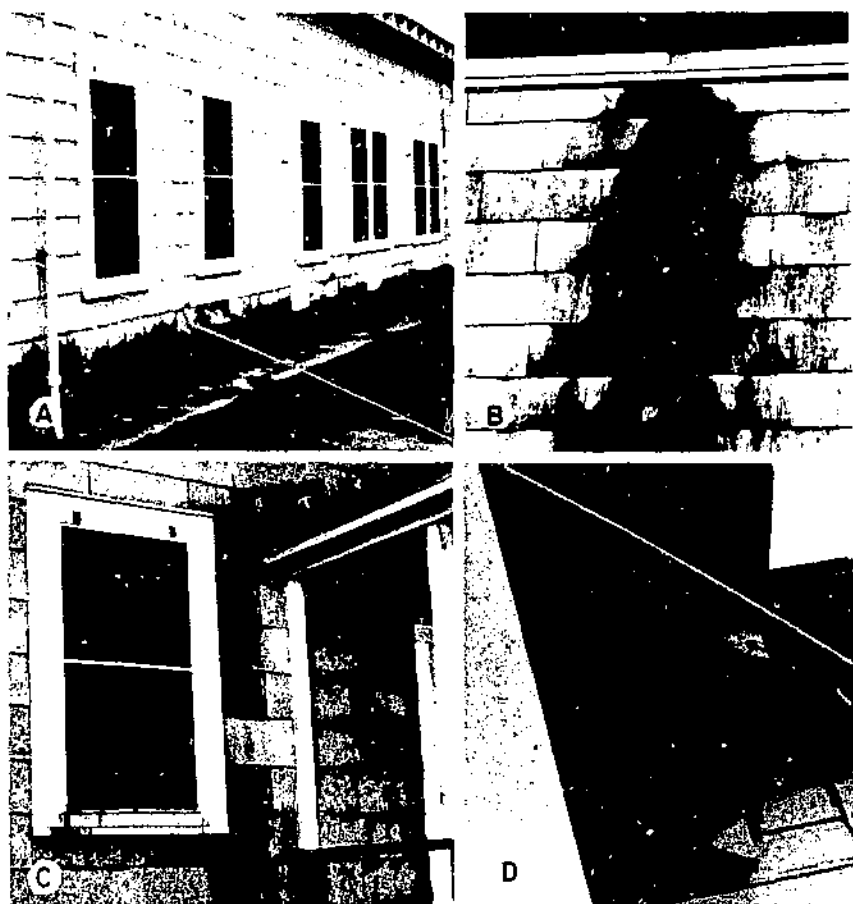
FIGURE 2. Decay associated with roof runoff: *A*, Splash from sidewalk wetted sheathing and plate at the base of the wall (shingles siding broken for inspection of sill); *B*, leaks in the horizontal joints of gravel stops are common; *C*, water from the roof runs down wall and wets window trim; *D*, sheathing decayed at roof edge when unprotected by a metal flashing.

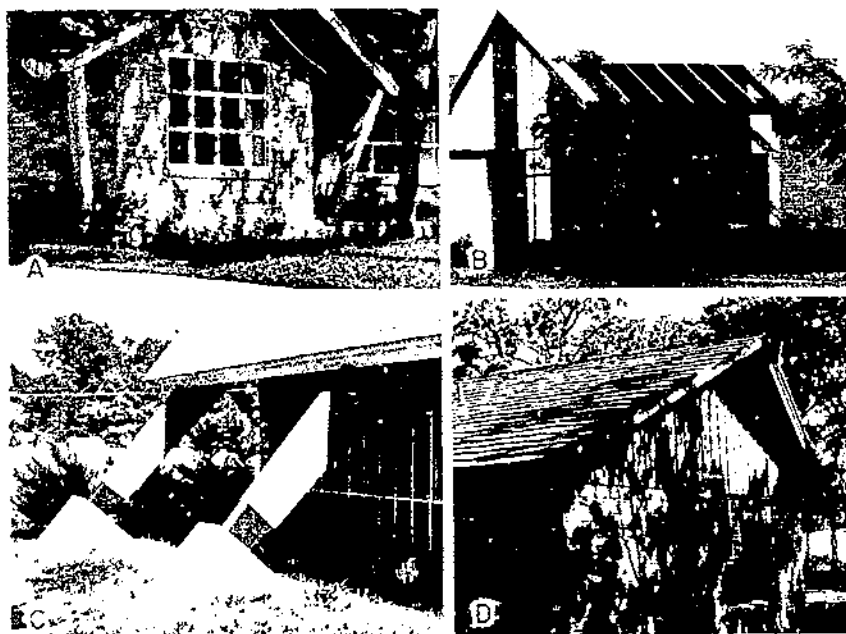
FIGURE 3. Structural members protruding beyond the roof or otherwise exposed to decay-resistant material: *A*, Columns with high seepage hazard above door; *B*, rafters exposed to weath; *C*, church arches exposed to rainwetting; *D*, roof timbers protruding.

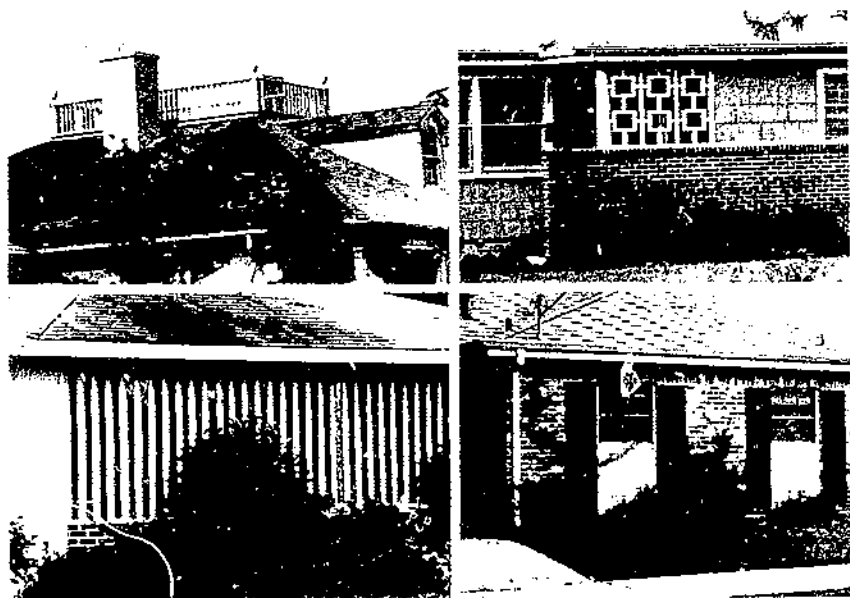
FIGURE 4. When decorative woodwork such as balustrades, grills, and shutters is exposed to excessive rain seepage.

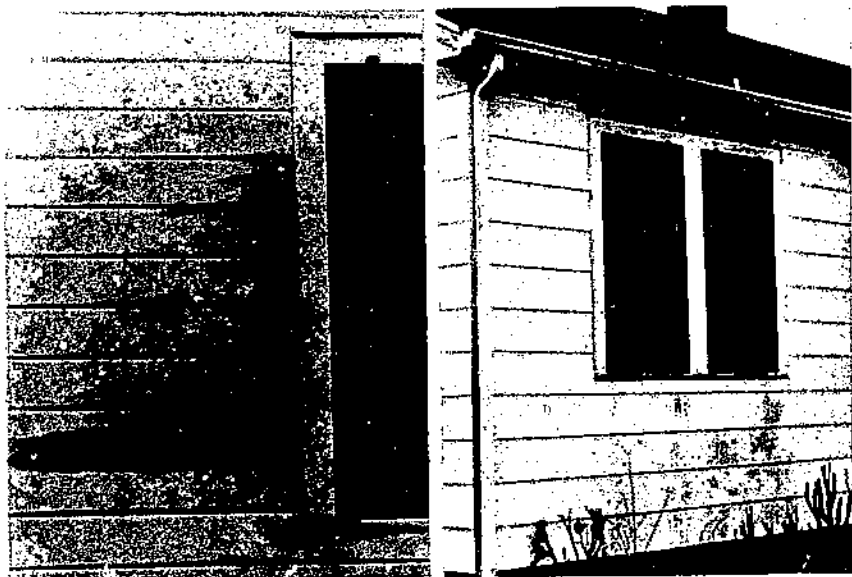
In the Gulf States, several projects with severe siding decay were re-examined after 15 to 20 years. Most of the houses had been covered with asbestos-cement shingles (fig. 5), usually applied over the defective wood siding. No further trouble was reported or could be seen in the covered buildings. Apparently, such covering corrects a severe rain seepage problem. In the few cases seen, steel or aluminum siding has been effective. Probably

FIGURE 5.—Deterioration of siding on a house 3 years after construction in St. Petersburg, Fla. (left). Shortly after this picture was taken the siding was covered with asbestos cement. Fifteen years later the building was still in good condition (right).

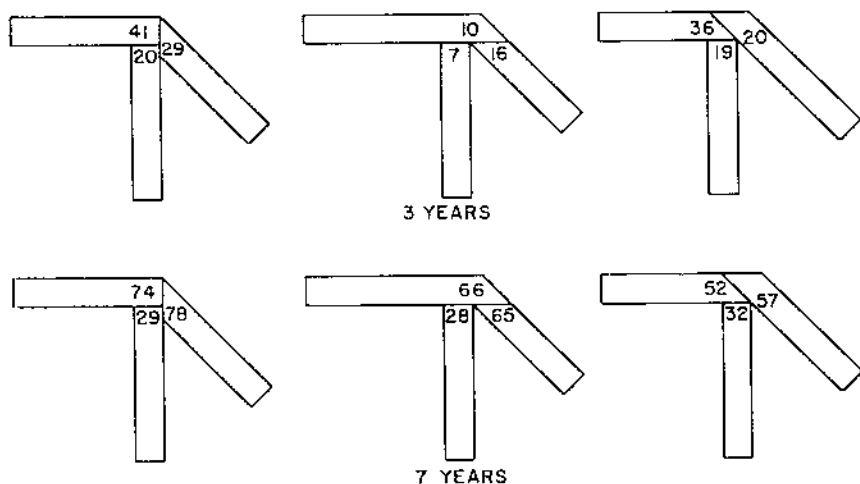
FIGURE 7. Amount of decay (on a scale of 0 to 100) at the joint of porch and step rails to a common post.

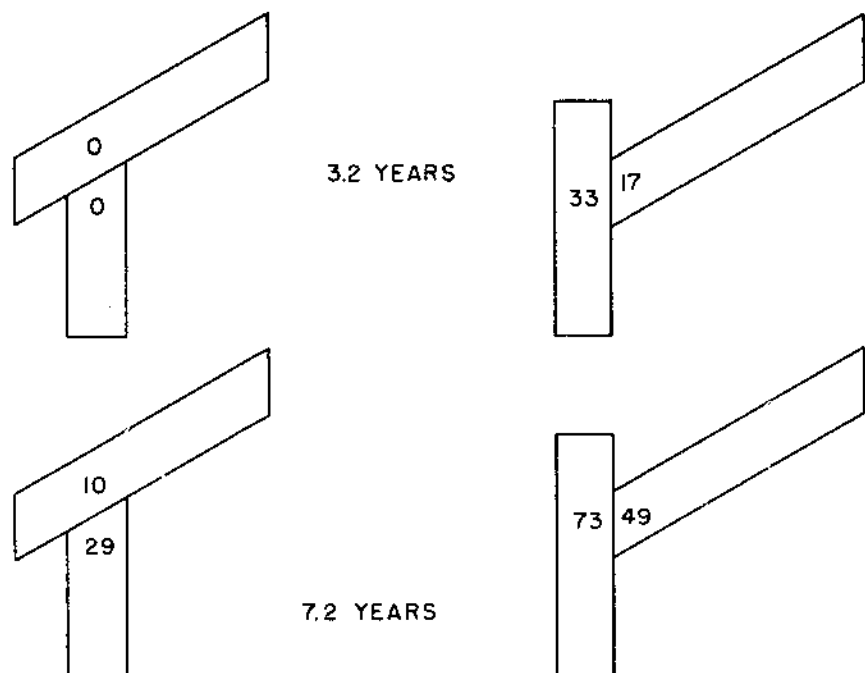
FIGURE 8.—Amount of decay (on a scale of 0 to 100) in painted step rails and newels when the rail abutted or capped the newel.

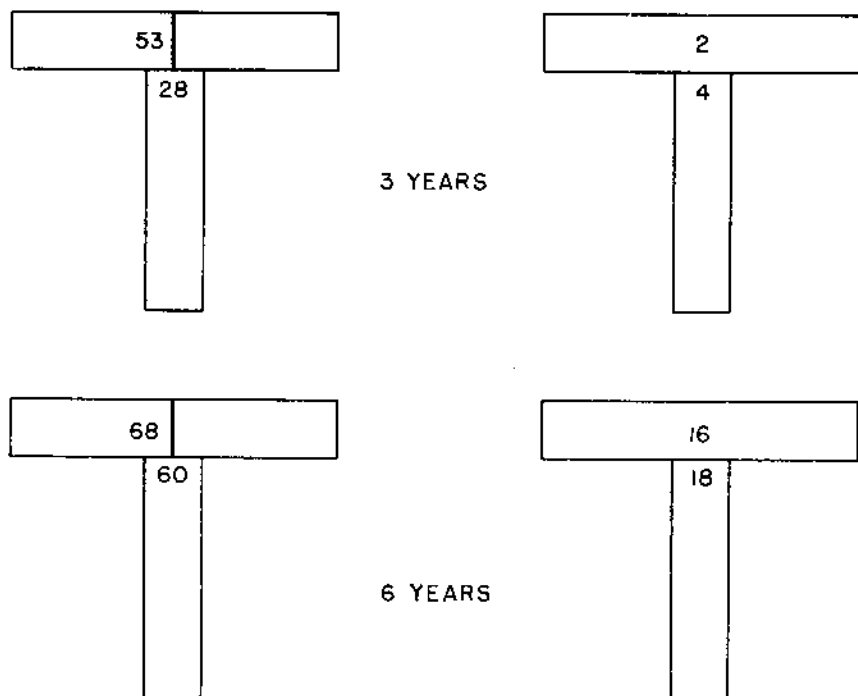
FIGURE 9.—Effect of joining a stoop rail over a post on the amount of decay (on a scale of 0 to 100).

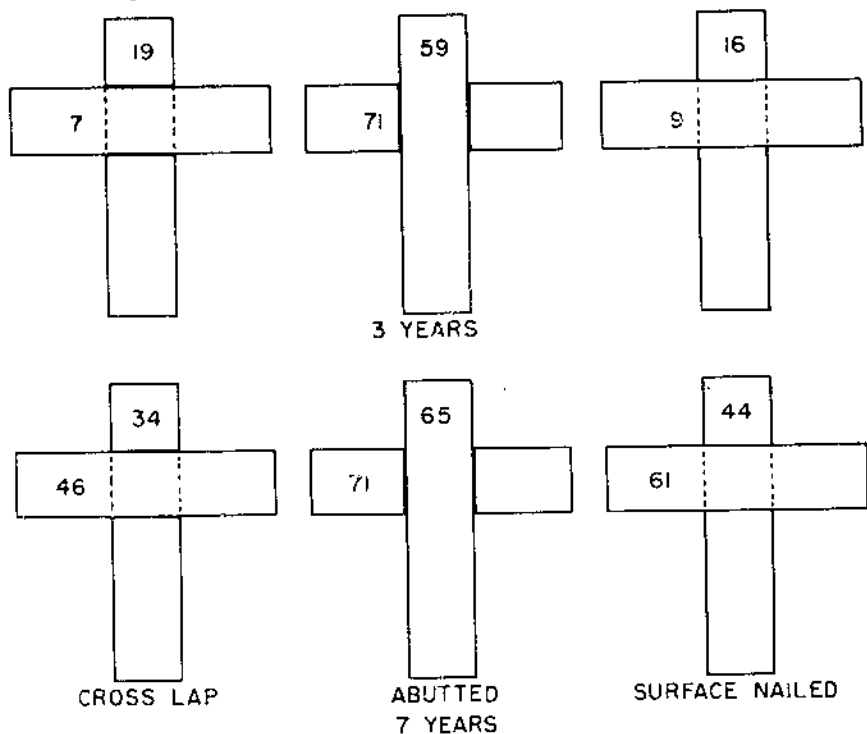
FIGURE 10.—Amount of decay (on a scale of 0 to 100) at joints of secondary rails when notched to form a flush cross-lap joint; sawed through and abutted to the edges of the post; or nailed to the flat surface of the post.

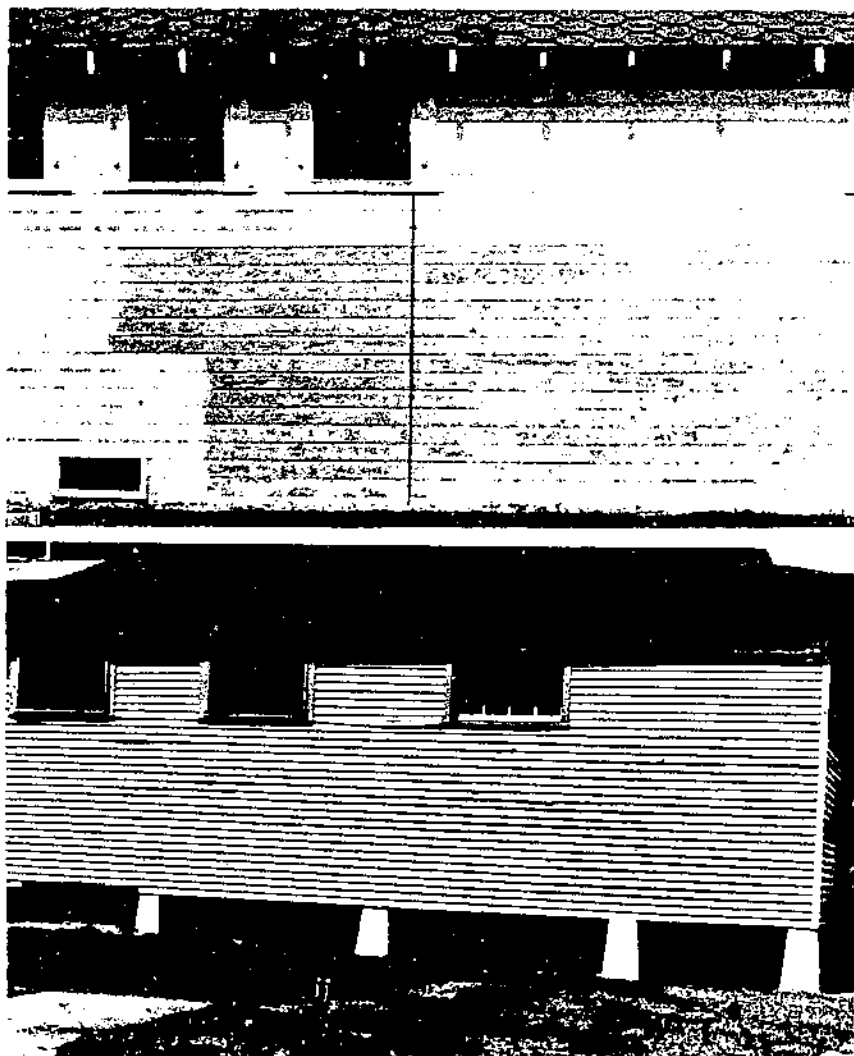
FIGURE 24. Buildings in Orange, Tex., (top) and New Orleans, La., (bottom) with paint peeling associated with rain seepage. They were used for studying spray application of water-repellent preservative.

This study suggests that in-place spraying is beneficial on walls showing rain seepage damage, provided the seepage is only light to moderate, no horizontal splits occur in the siding, and no thick paint films are present.
