# Tsunami Impacts on Shallow Groundwater and Associated Water Supply on the East Coast of Sri Lanka

A post-tsunami well recovery support initiative and  
an assessment of groundwater salinity in  
three areas of Batticaloa and Ampara Districts

# **Tsunami Impacts on Shallow Groundwater and Associated Water Supply on the East Coast of Sri Lanka**

**A post-tsunami well recovery support initiative  
and an assessment of groundwater salinity  
in three areas of Batticaloa and Ampara Districts**

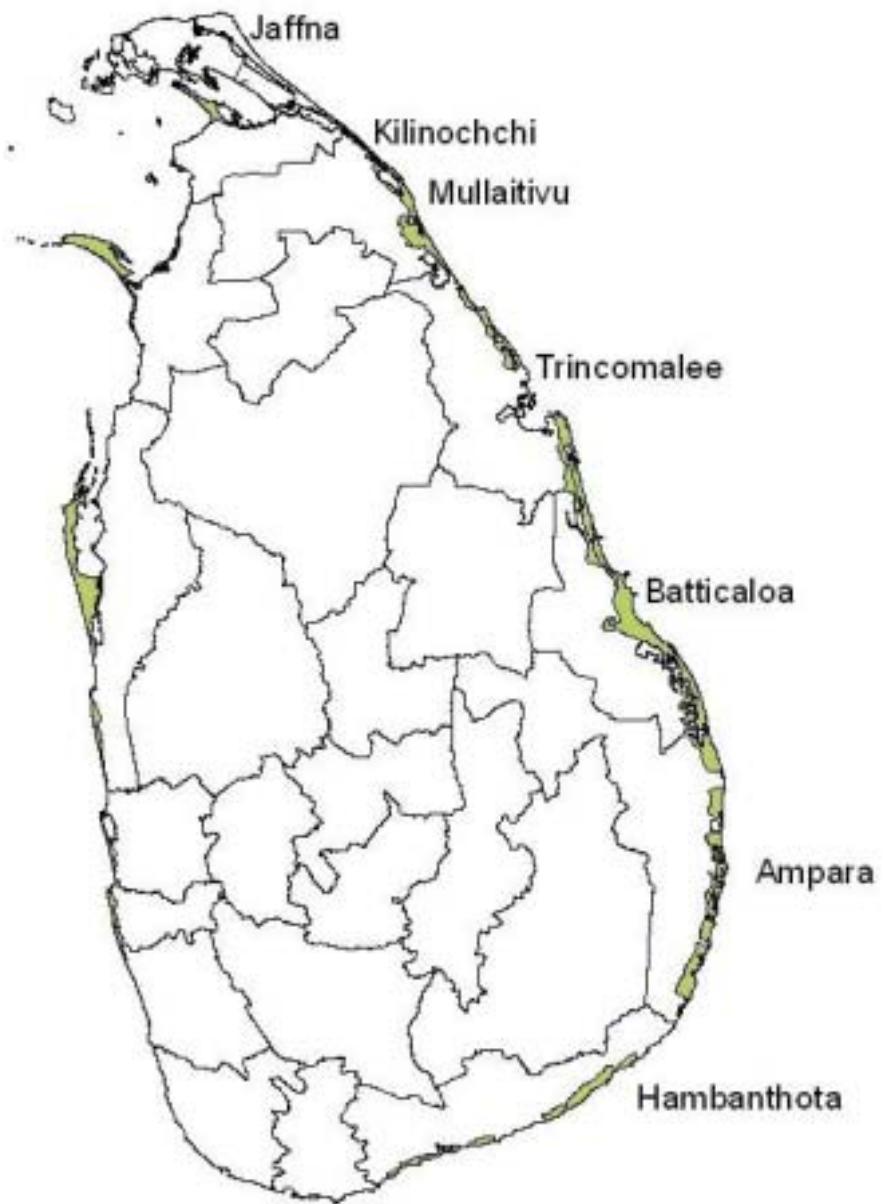
Figure 1. Extent and location of the sandy coastal aquifers in Sri Lanka

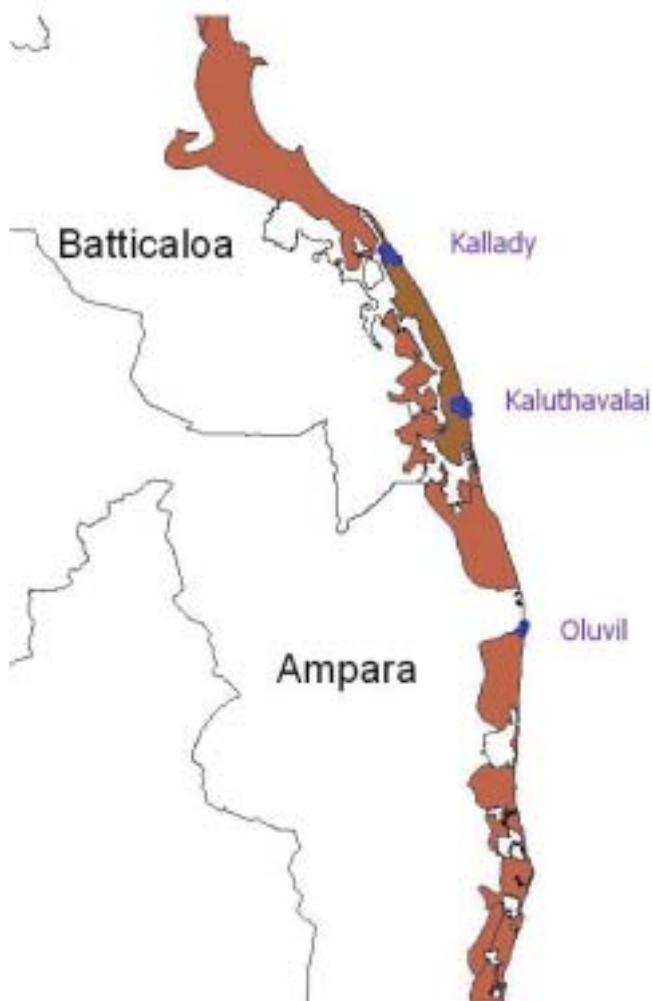
Figure 8. Monitoring sites on the east coast

Three sites on the east coast were selected for the monitoring programme after discussion with the stakeholders and authorities with knowledge of the local conditions: Kallady, Kaluthavalai and Oluvil, which belong to the districts of Batticaloa and Ampara. (Figure 8, Table 2). The sites were chosen to be representative of some of the general characteristics on the east coast with respect to physiography, demography, land and water use. Also, areas that were severely devastated by the tsunami were chosen, as these areas were expected to suffer most from salinization. Some tsunami damage and impact assessment data from the various districts on the east coast are given in Table 3. Finally, security considerations related to civil unrest, hindered the selection of some sites that would have been important from a scientific and humanitarian perspective (like Vakarai further north in Batticaloa District).

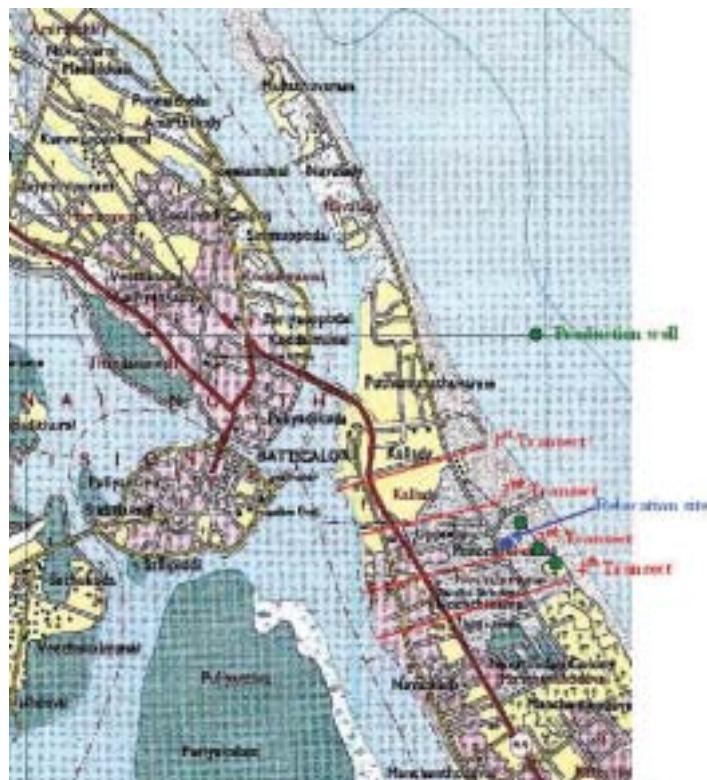
**Figure 9. Sampling transects (red lines 1-4) at the Kallady site**

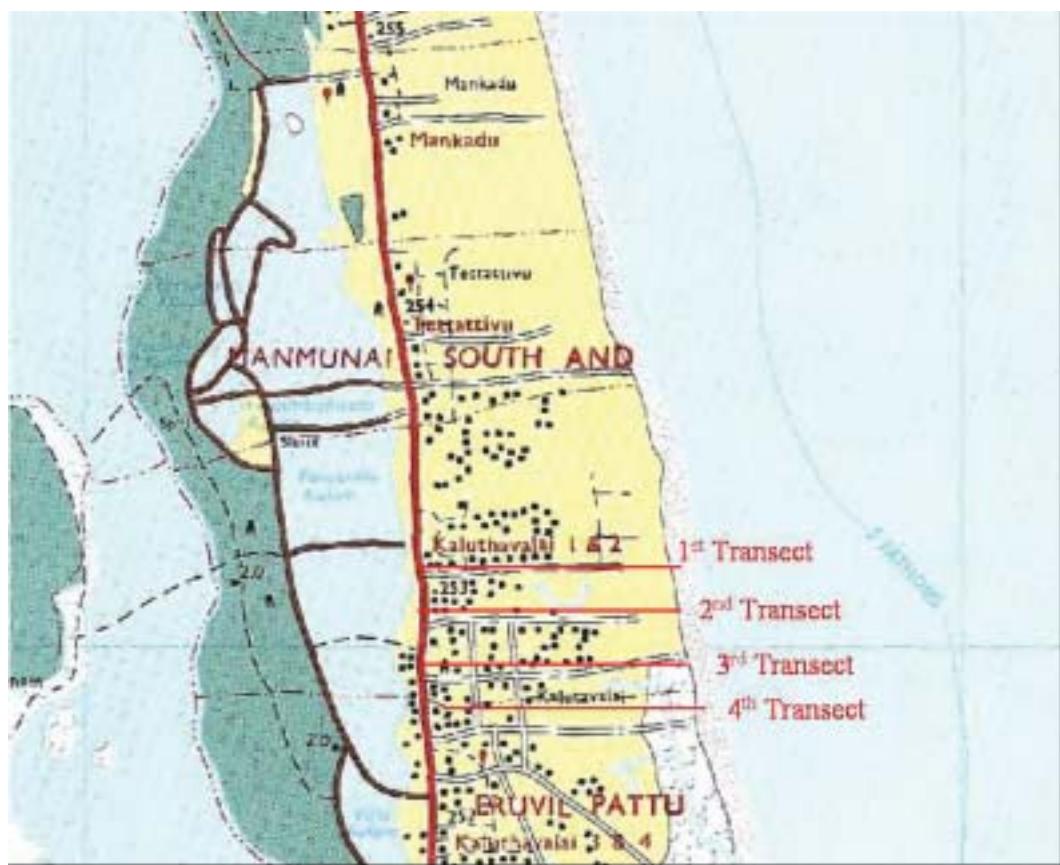
Figure 10. Sampling transects (red lines 1-4) at the Kaluthavalai site

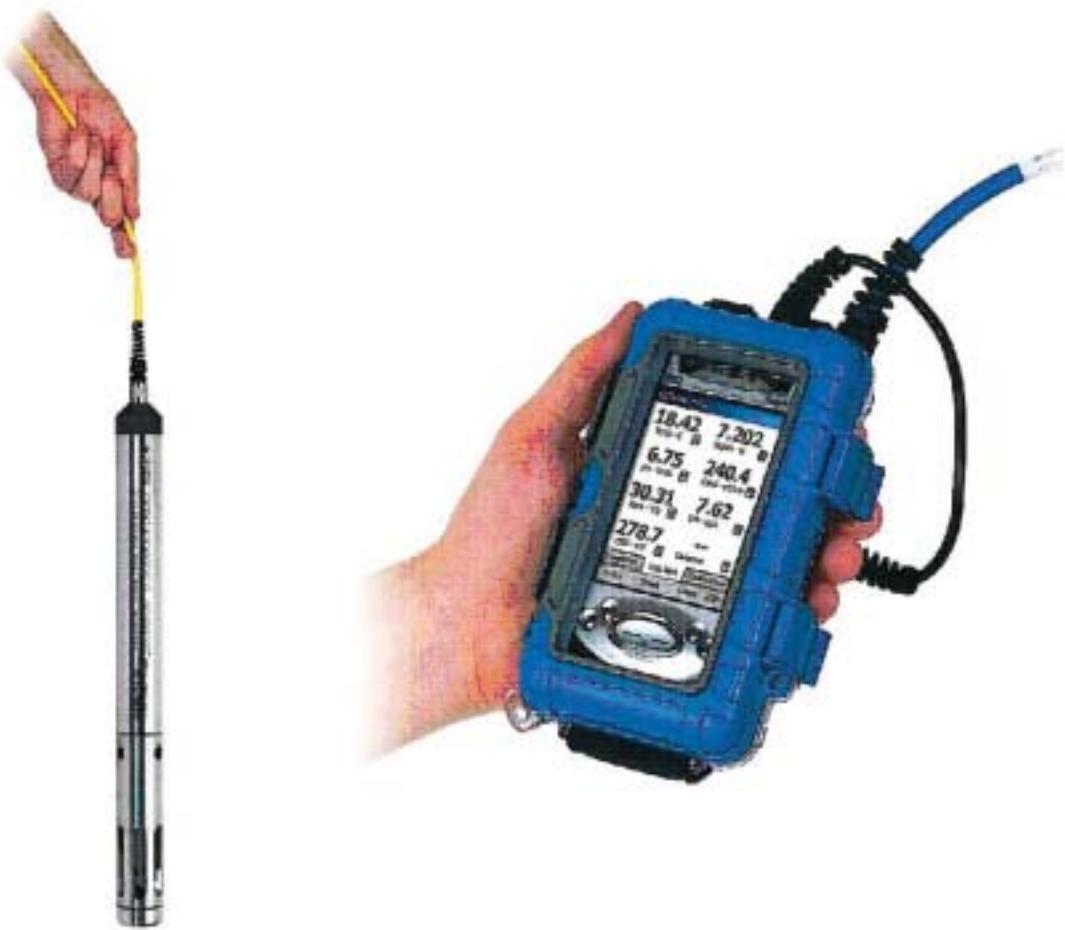
Figure 13. The Troll 9000 monitoring probe and the associated data logger

Groundwater levels in the wells were monitored by a measuring tape. Salinity, temperature, and turbidity were monitored by a 4.5 cm diameter stainless steel Troll 9000 monitoring probe from In-Situ Inc.<sup>6</sup> (Figure 12). Individual sensors registered the salinity (here reported as EC, specific electrical conductivity), turbidity, temperature, and the hydraulic pressure at the water level of the sampling point. The probe automatically compensated the EC measurements for temperature.

Because the probe was measuring the parameters in-situ, i.e. directly inside the well or whatever other water body, and because it was connected directly to a data logger (Figure 13), there was no need to extract samples and either measure them in the field with a portable monitoring probe or devise or to bring them to a laboratory for analysis. Also, the monitoring of salinity at different depths of a well could easily be achieved by sinking in the probe to the various levels and logging the results directly.

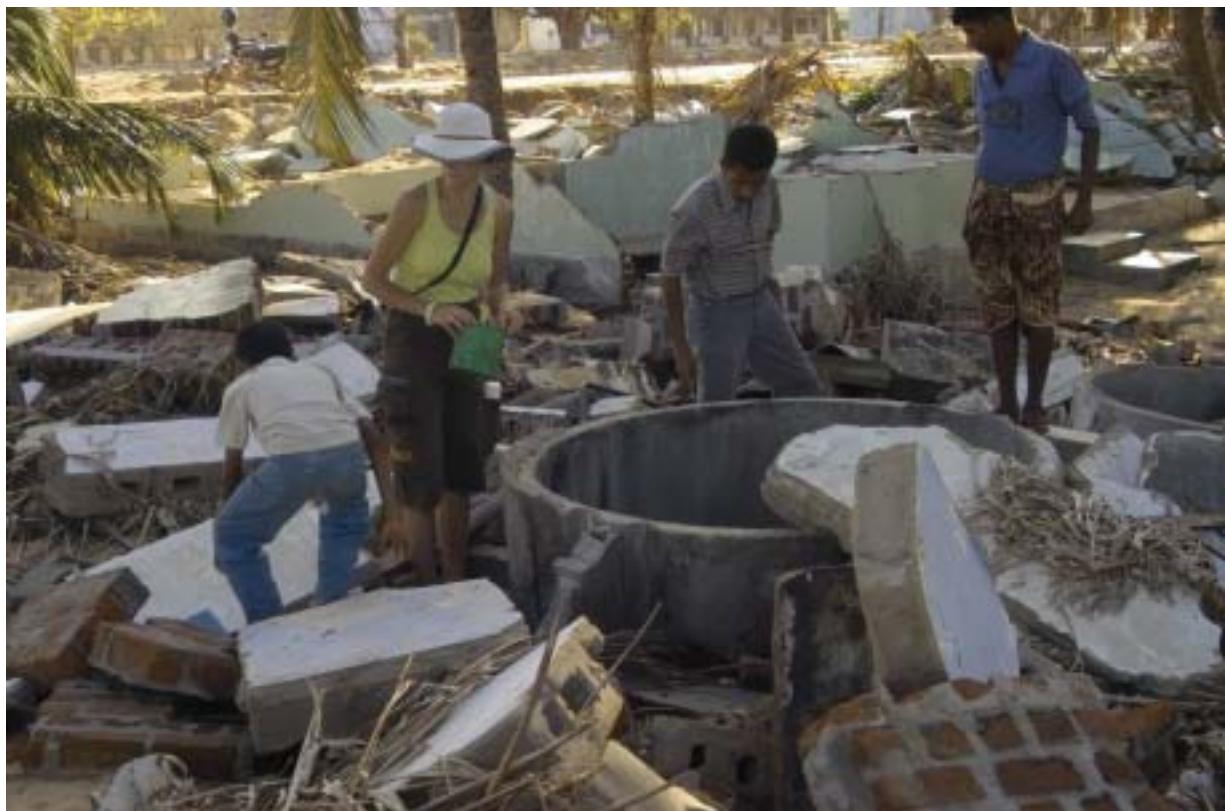
Figure 15. Initial well salinity monitoring in Maruthumunai, end of January, 2005

Table 6 shows the salinity of the wells (not properly geo-referenced) that were located at increasing distance from the coast line (Photos in Figure 15 and Figure 16 were taken during the sampling). The wells were between 3 and 5 m deep and the groundwater level at this point was 1.5 to 2 m below ground level. The data shows that the wells were very saline, but the salinity was (with one exception) significantly higher at the bottom than at the top, up to a factor of almost 10. The salinity levels as well as the stratification decreased with distance from the coast. The explication for this could be that the wells close to the sea were abandoned and had not been in use since the tsunami whereas the wells more inland (last two) had been pumped causing a mixing of the well water. The two most distant wells belonged to houses that withstood the tsunami and hence their owners had tried to revive their water supply. It is however not clear whether these wells were in fact totally inundated by the waves.

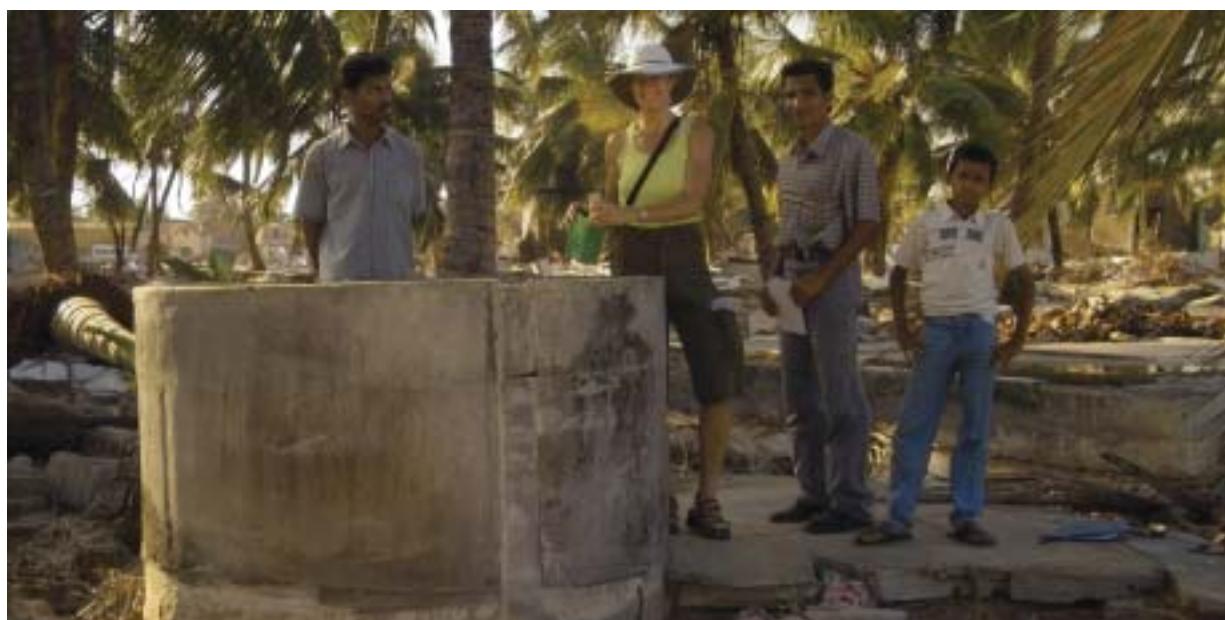
Figure 16. Well sampling very close to the coast where the tsunami eroded large volumes of coastal sand
