TECHNICAL BULLETIN No. 633

JANUARY 1939

PRINCIPLES OF GULLY EROSION IN THE PIEDMONT OF SOUTH CAROLINA

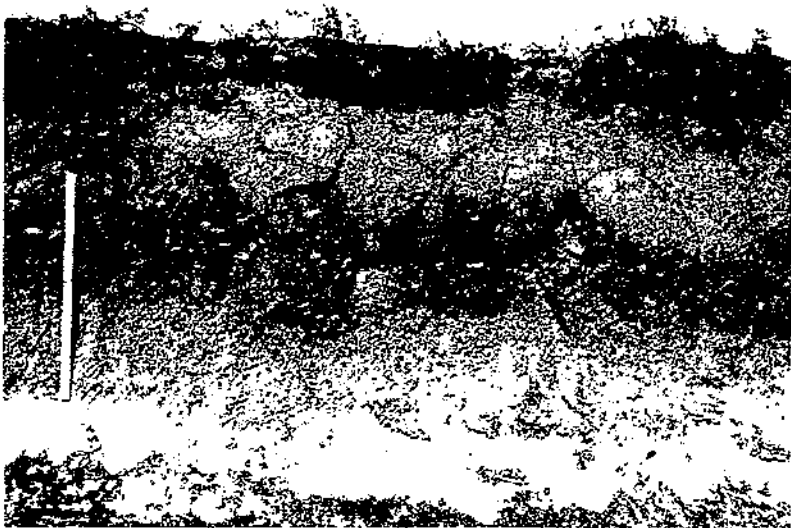
FIGURE 9.—The stone line across the middle of the picture lies at the base of the B horizon of the soil. Beneath the line, traces of the original rock structure are visible. The scale at the left is 6 feet high.

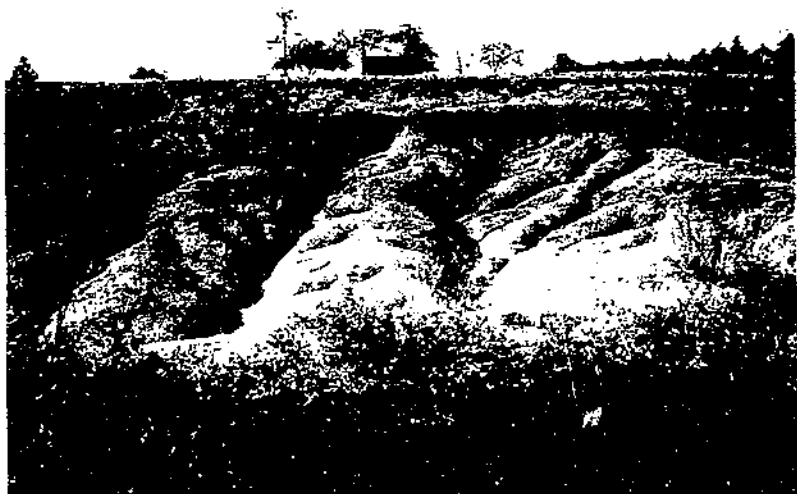
FIGURE 11.—Water flowing over the edge of these old bench terraces has caused severe sheet erosion and shallow gullying on the areas immediately down slope. Six miles south of Spartanburg, S. C.

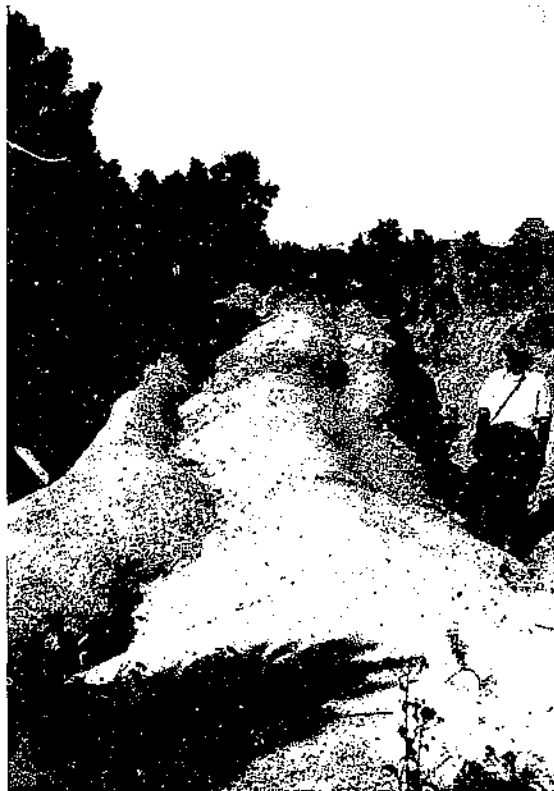
FIGURE 13.—Many gullies have developed from road ditches and wheel ruts. This hillside road has been abandoned and a roundabout route by way of the concrete highway must now be used.

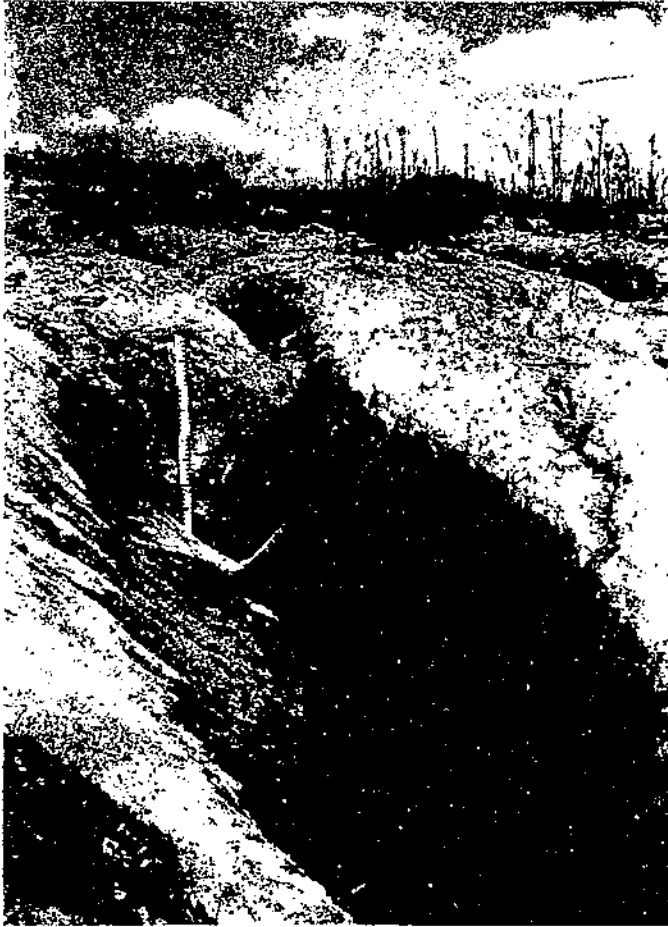
FIGURE 17.—Pot holes 3 feet deep cut in the bottom of a gully channel.

When the gully channel has been cut almost to the bottom of the B horizon, the material becomes somewhat less uniform in resistance. Minor irregularities are revealed by the differential erosion of the flowing water. These tend to enlarge and deepen, and in many places pot holes develop. Some are only a few inches in diameter, but others are 2 to 3 feet across and of even greater depth (fig. 17). These pot holes are enlarged as the water churns with a circular motion and abrades the sides and bottoms with sand and stones carried along by the current. As they cut into the underlying C horizon, the pot holes enlarge more rapidly at their bottoms, and may be of much greater diameter there than at their necks in the tougher B horizon clay. Under rare conditions, enlarging pot holes may intersect the wall of a deeper and larger gully, thereby producing an

underground passageway for the water. As the pot-holing process continues, the lower part of the B horizon is quickly cut away and the gully floor, now cutting entirely in the parent material or saprolite, deepens even more rapidly.

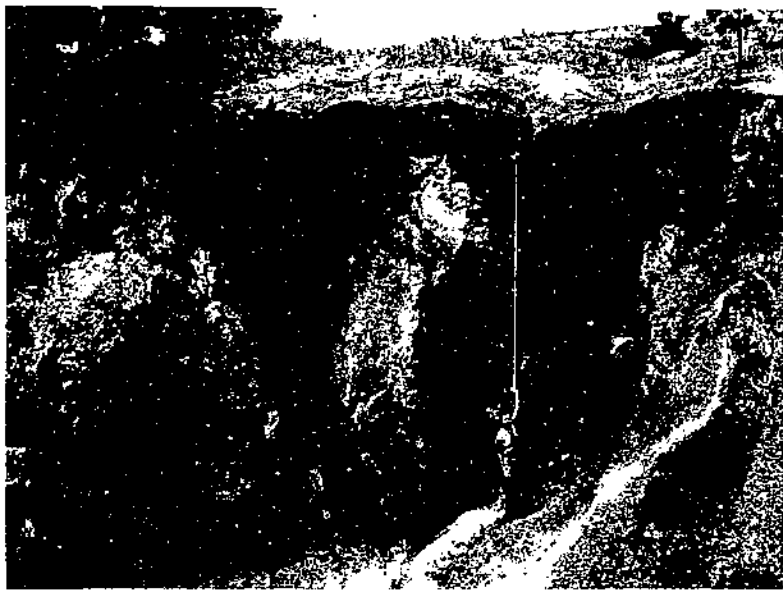
FIGURE 19.—Two plunge pools formed beneath lips of resistant subsoil. They are cutting headward into an abandoned field.

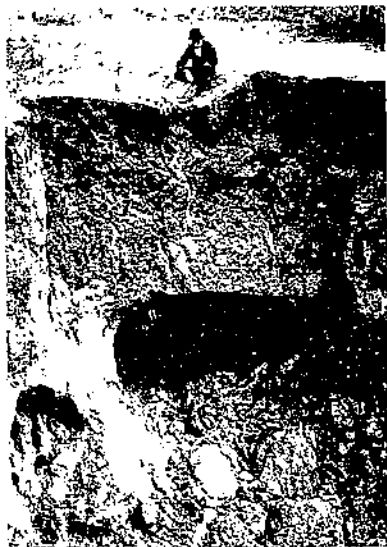
FIGURE 23.—The cave in gully head B, Foster's Tavern area, on January 14, 1937, after the arch had collapsed as a result of prolonged rains.

Prolonged winter rains early in January (figs. 43 and 46) brought about the caving of the arch in the gully head. The channels along

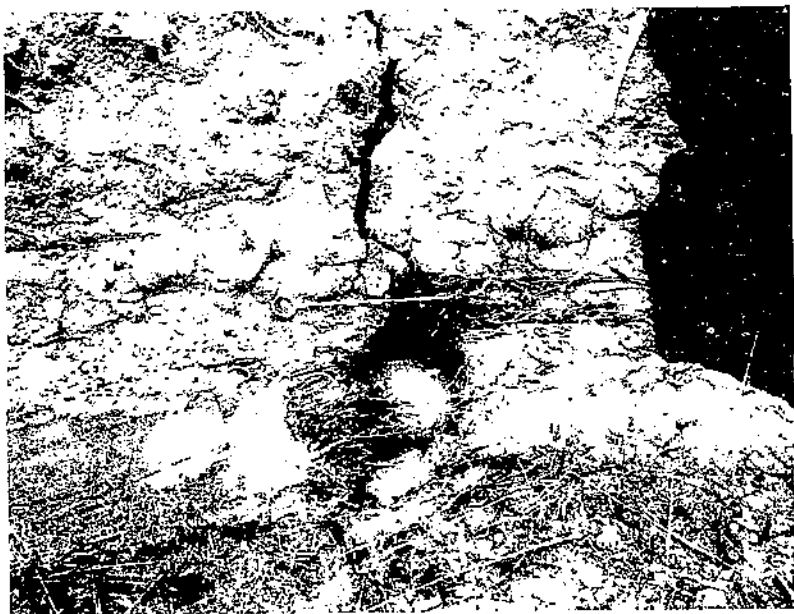
FIGURE 24.—Water flowing from left to right in the terrace channel passes downward through the tension crack to a seep cave in the wall of the gully shown at the right. The striped rod is marked in inches.

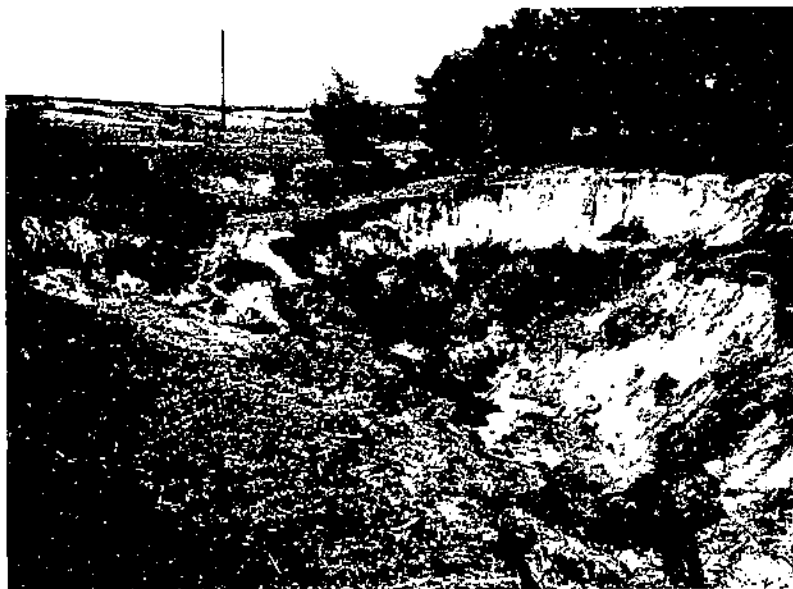
FIGURE 30.—Slumping in the light-gray Worsham soil along this small stream was the major cause of the large crescent-shaped depression at the right and of the smaller one on the left bank.

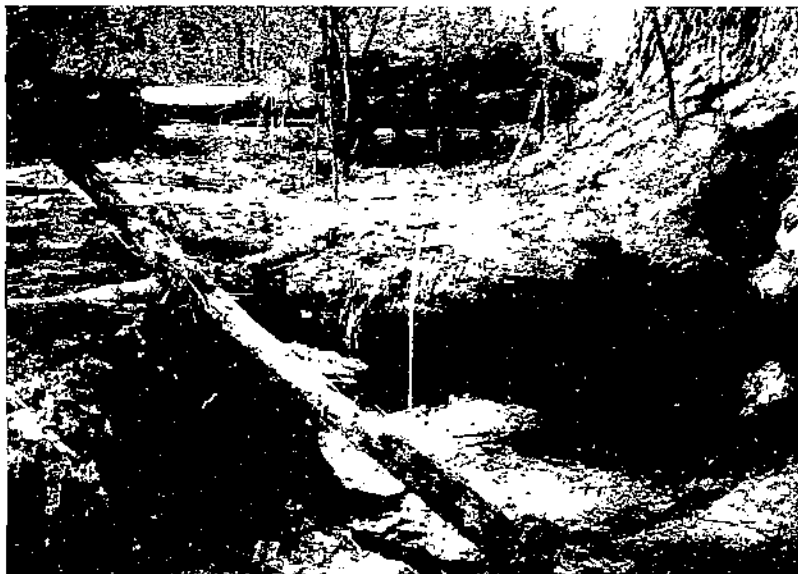
FIGURE 41. Unless precautionary measures are taken, the knife-point shown in the foreground will continue to migrate upstream and soon will undermine the log check dam.

As long as any water flows through the gully there is always the possibility of the cutting out of both the gully floor and its stabilizing vegetation by the upstream migration of a knickpoint or overfall. This must be considered in the construction of check dams, and ample precautions must be taken to protect the dam farthest down the channel against undermining by a headward-migrating knickpoint (p. 74 and fig. 41).

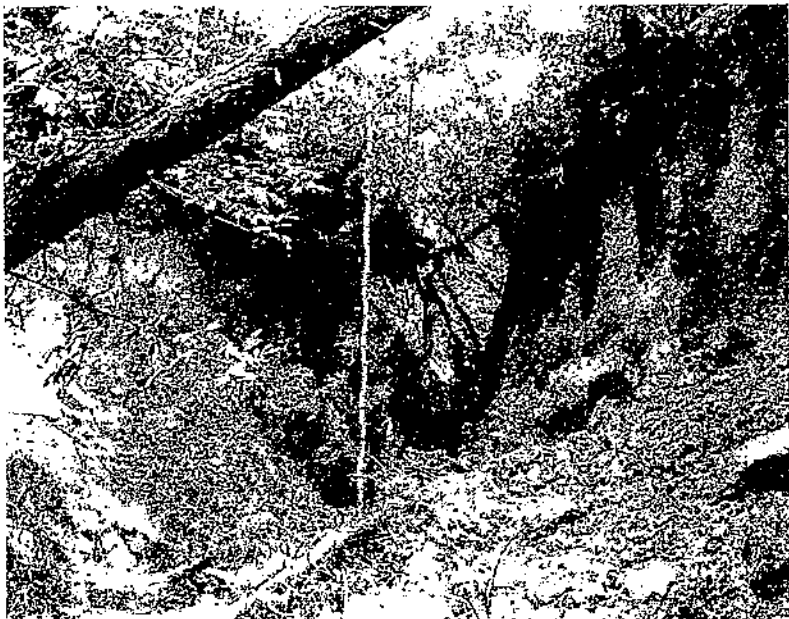
FIGURE 47.—View upstream toward the narrows, 10 feet deep and 4 feet wide, in the lower segment of Clayton's gully, July 11, 1936. The channel is cutting in the floor of an old wooded valley, the slopes of which have been little changed since the Revolution.

west tributary enters, was cut back slightly during that rain, and a small amount of caving took place. The changes were relatively slight, however, and conditions remained much as they were during the summer (figs. 47, 49, and 51). On October 15-16 the area received a rain of unusual intensity. The gage at the Layton gully had not been set in operation at that date, but at Nesbitt's gage, 3 miles to the southeast (fig. 6), 4.39 inches of rain were recorded in 20 hours (fig. 43); 2 inches of the rain fell in 2 hours. The intensity at the Layton gully area may have been somewhat higher. A standard gage 1.5 miles northeast of the gully received 5.53 inches, another standard gage 4 miles west received 6.25 inches, and a recording gage $5\frac{1}{2}$ miles northwest of the gully caught 5.87 inches, 3.63 inches of which fell between 8 and 10 a. m. on the 16th. As a result of this rain, the narrows in the lower channel of the Layton gully were entirely cut away (fig. 48), and the active head (J), where the west fork enters the main gully, receded some 15 feet (fig. 50). Caving of the walls increased the 19-foot width of that part of the gully to 31 feet (fig. 52). The tough soil of the B horizon along the western rim caved in blocks several tons in weight, which plunged forward and landed on the gully floor in an almost inverted position. Approximately 1,500 square feet of wooded land along the gully rim caved during and immediately after this heavy October storm (fig. 53). Such large volumes of caved material can be worn down and washed away only by powerful rains. Most of the fallen blocks in the Layton gully remained for many months, their buttressing effect giving the walls partial protection against further caving.

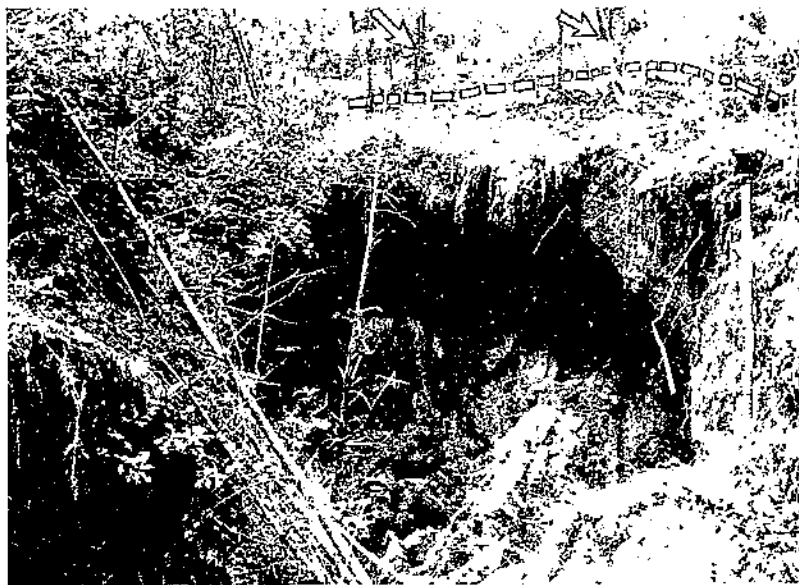
FIGURE 49.—Cave and plunge pool where water from the west fork enters the main channel of Layton's gully. August 4, 1935. The red B horizon 6 feet thick overlies weak gray rotten rock.

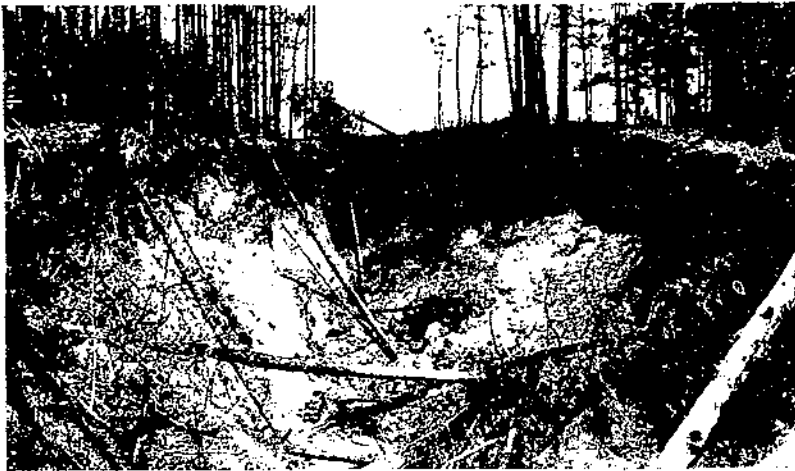
FIGURE 55.—Head B of Cox's gully, March 26, 1937. This branch of the gully grew headward 20 feet between October 27, 1936, and April 6, 1937.

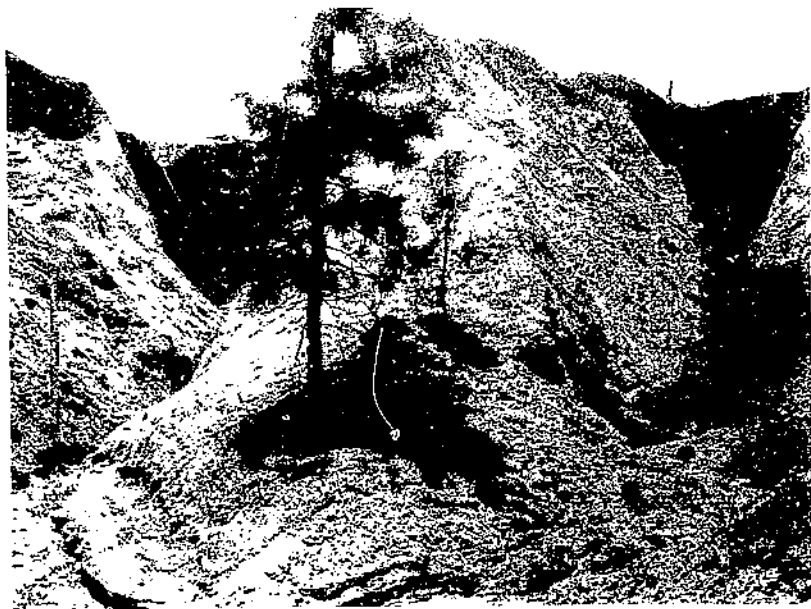
FIGURE 61.—View headward from cross section 3 in the upper segment of Layton's gully showing the barrier walls characteristic of active erosion. Head A-1 is at the left, head B-2 at the right.

more recently cut headward portion (figs. 60-63). Pine, tuliptree, sourwood, dogwood, maple, oak, ash, and hickory are common, and some of the pines and tuliptrees have been shown by boring to be 30 to 35 years old.

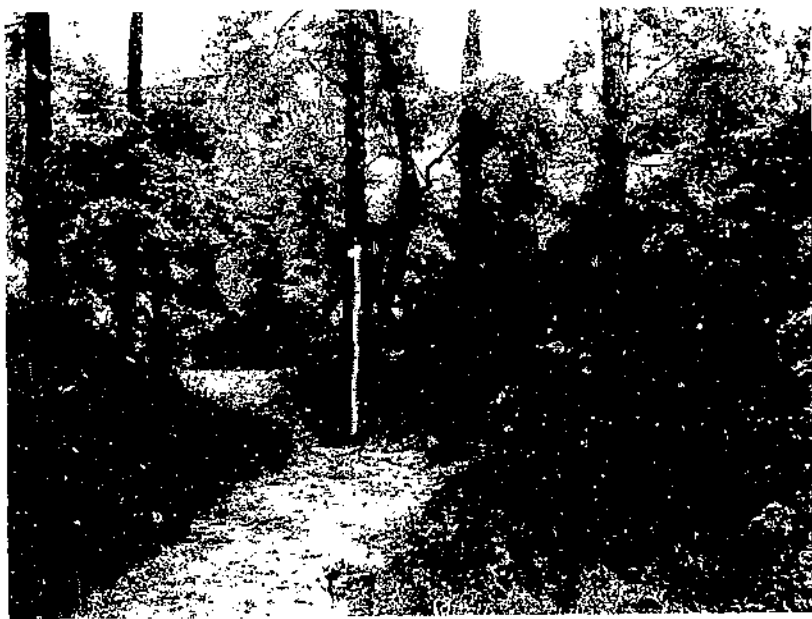
FIGURE 62.—View down the channel in the middle or stabilized segment of Layton's gully between cross sections 6 and 7. The larger trees are 32 to 35 years old.

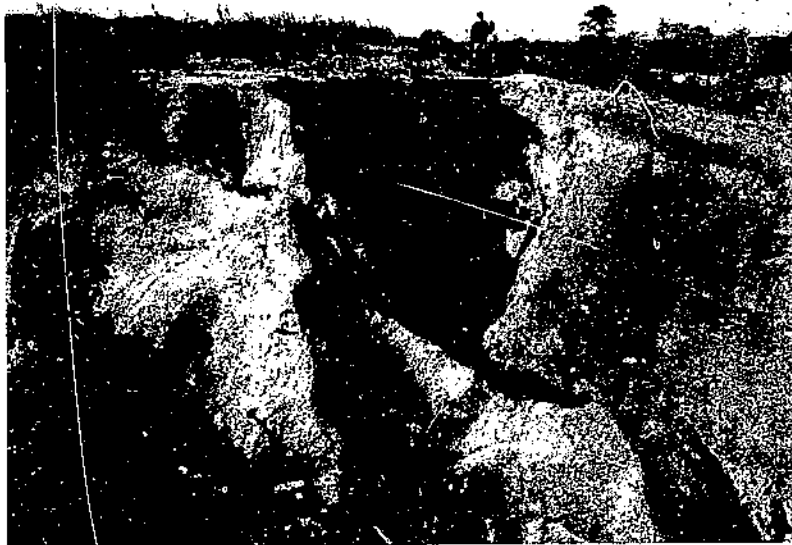
FIGURE 64.—Head B-4 on the west side of Layton's gully. Although this head drains less than 100 feet of terrace it has cut about 6 feet in a year.

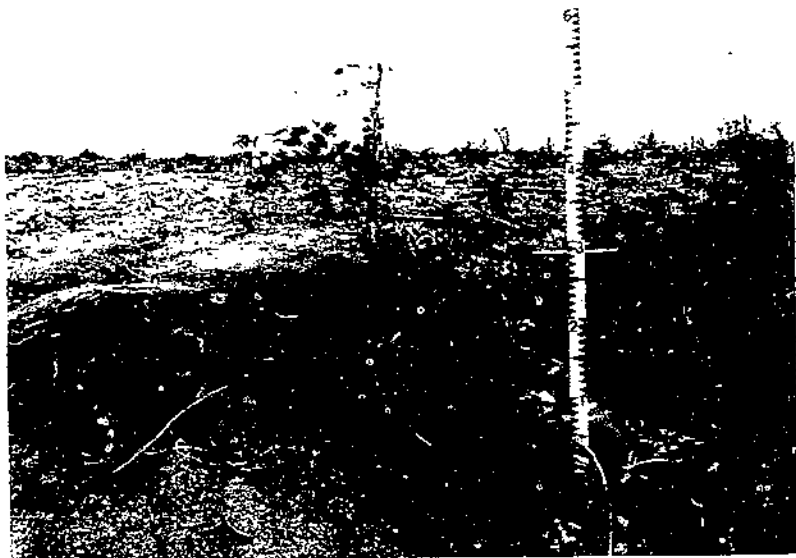
FIGURE 66.—Almost 3 feet of soil has been stripped from around this ash sapling in the area drained by the west fork of Layton's gully.

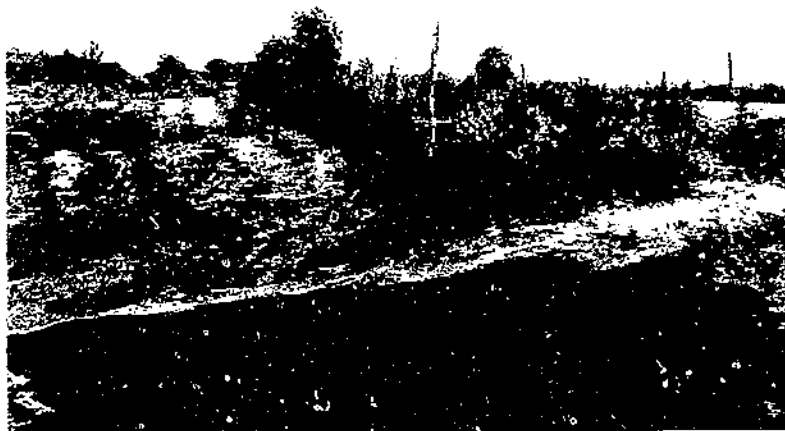
FIGURE 67.—View eastward across basin A of Layton's gully. Several inches of topsoil still remain in the grassy strip along the roadside. The cottonfield at the left has eroded far down into the subsoil.

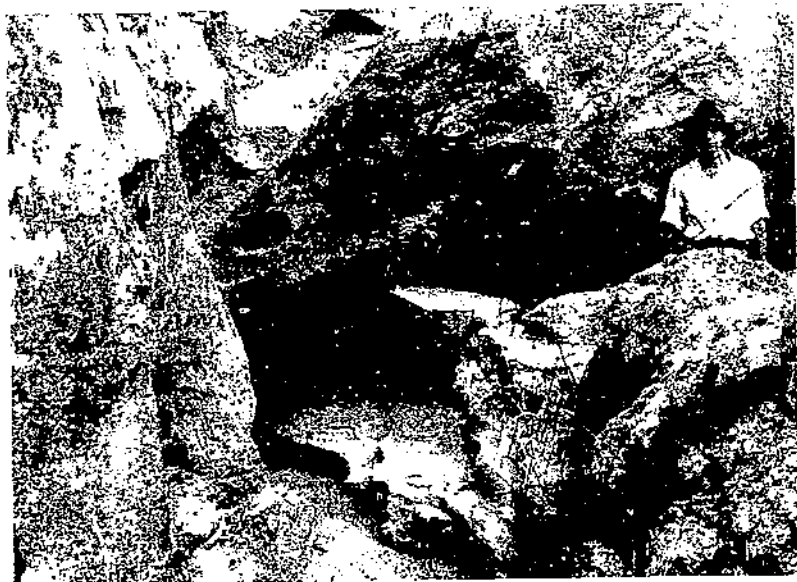
FIGURE 73.—Deep undercut in weak saprolite on the west wall of the main channel of Walden's gully, along the line of section 4-P. Although the rock structures are preserved, the wall material is soft and porous.

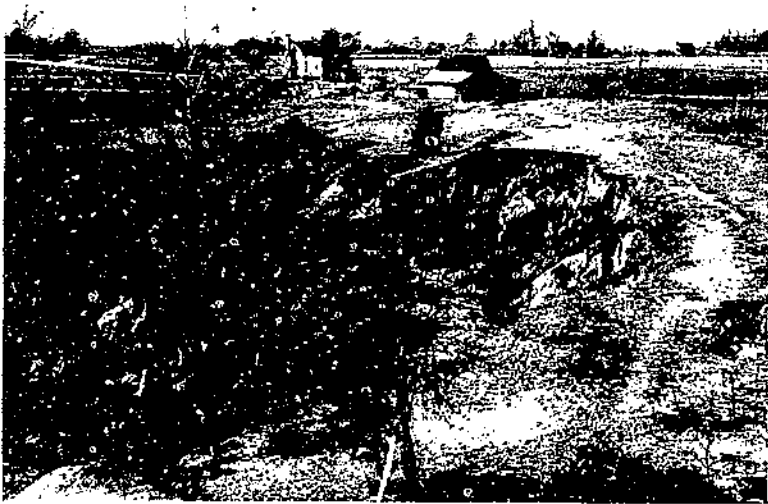
FIGURE 86.—Headward portion of Barry's gully. The Bermuda grass pasture extends to the fence. The field across the road is planted in small grain.
