Asphalt Linings For Seepage Control:
Evaluation of Effectiveness
and Durability of
Three Types of Linings

Technical Bulletin No. 1440

Agricultural Research Service
U.S. DEPARTMENT OF AGRICULTURE
in Cooperation With
Utah Agricultural Experiment Station
and
Bureau of Reclamation
U.S. DEPARTMENT OF THE INTERIOR

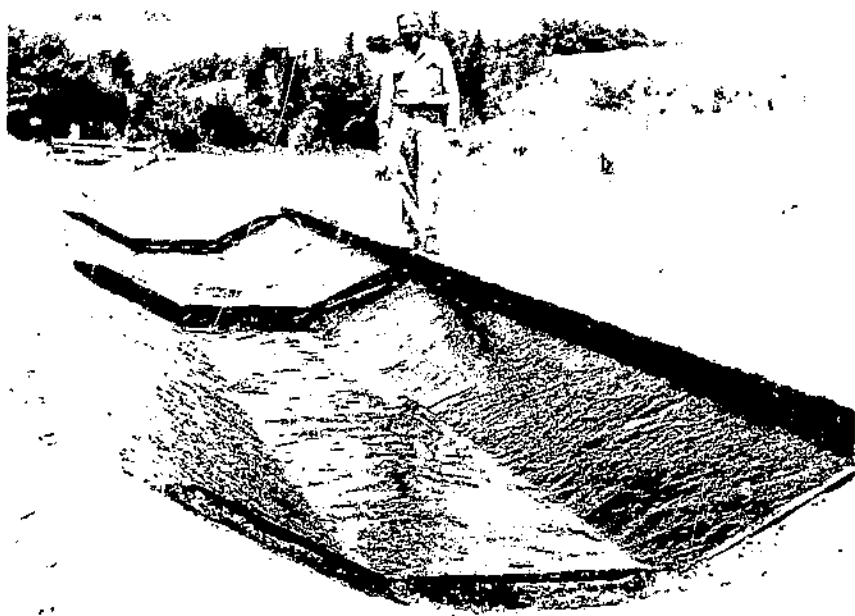
FIGURE 4.—Buried asphaltic-membrane linings in two sections of experimental seepage-control channel before application of sand and gravel topping. PN-2315

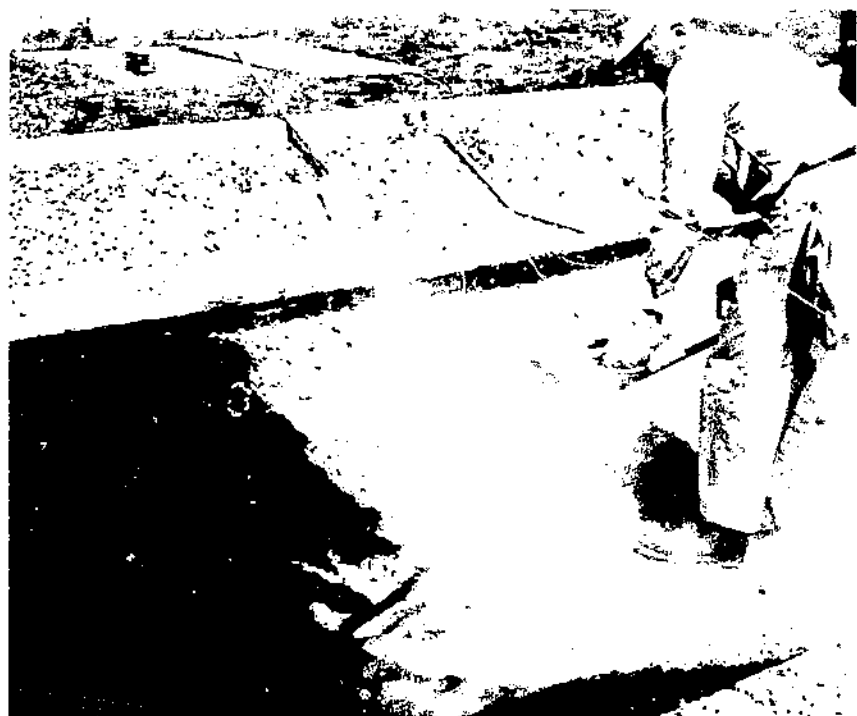
PN-2316

FIGURE 5.—Catalytically blown asphalt is being applied to gravel topping in experimental seepage-control channel to form asphalt-membrane macadam lining.

The macadam linings consisted of an asphaltic membrane applied at the rate of 1.35 g.s.y. on a sand-filled pea gravel subgrade (fig. 5). The thickness of the membrane ranged from $\frac{1}{4}$ to $\frac{3}{8}$ inch on the sideslopes and from 3.16 to 5.16 inch in the bottom. The sprayed membrane was covered with a thin layer of pea gravel, and another asphalt spraying was applied. The gradation of the gravel used was as follows:

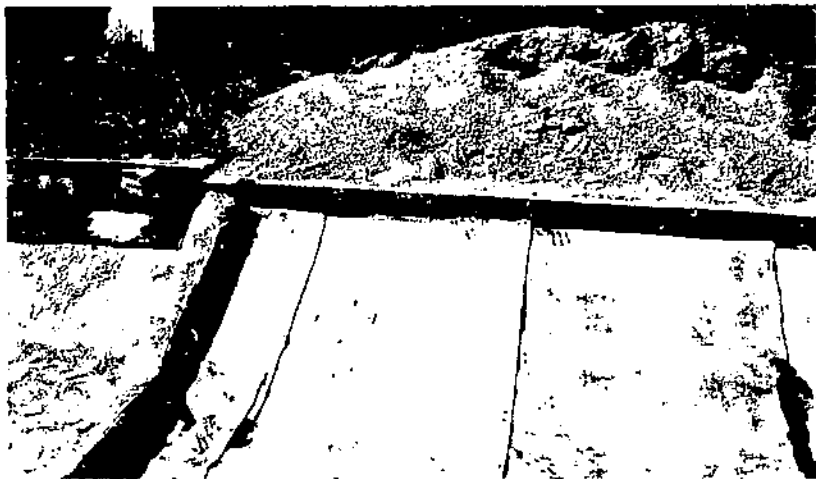
FN-2318

FIGURE 7.—Prefabricated asphaltic membrane in place and ready to be covered.

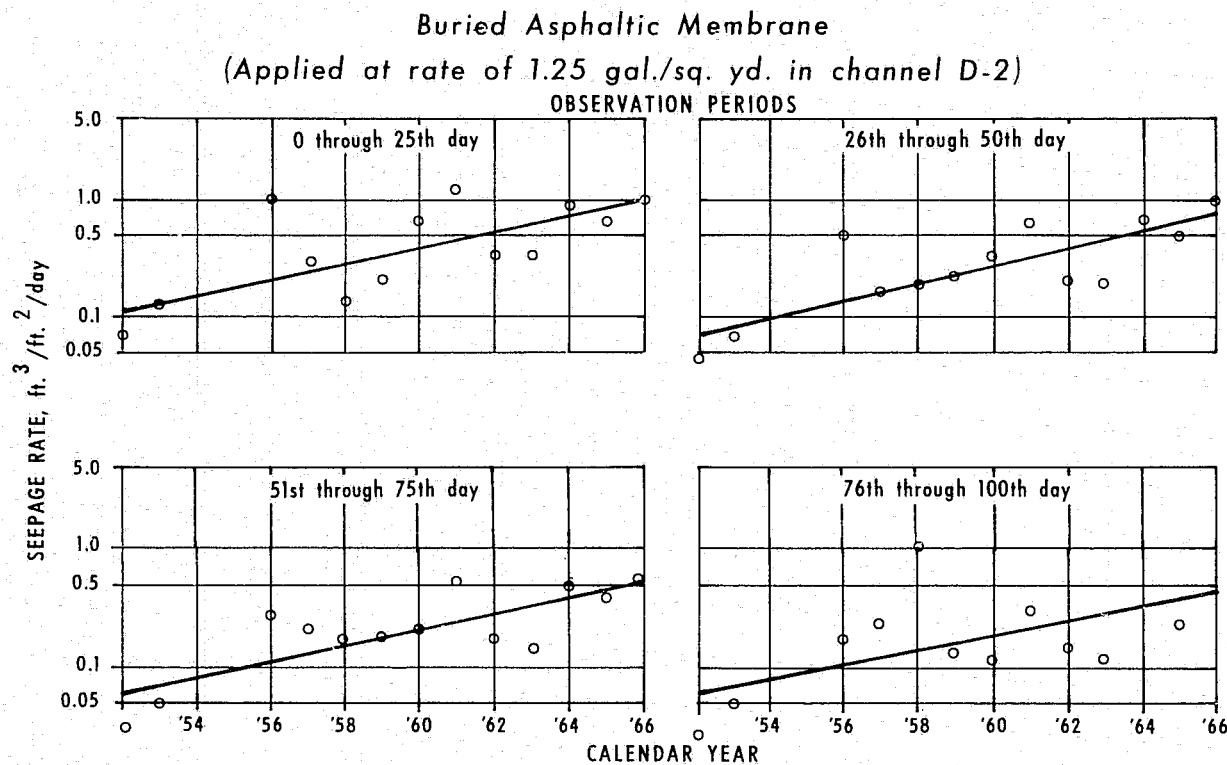
FIGURE 19.—Relation between seepage rate of a buried asphaltic-membrane macadam experimental liner and years of study. Charts show average seepage rates for each quarter of the first 100 days that the liner was in operation during the years included on the charts.

The relationship between seepage and years in operation was studied and the rate of deterioration estimated (figs. 12 through 25). The seepage rate, representing each successive 25-day period for each lining material, was plotted against years of service. A semilog regression of seepage on years fit the measured data quite closely. To determine whether or not the seepage increased or decreased significantly over the years, a *t*-test was used to evaluate the hypothesis that the regression coefficient was equal to zero. If the slope of the regression line, as shown by the *t*-test, was significantly different from zero, the seepage changed significantly over the years.

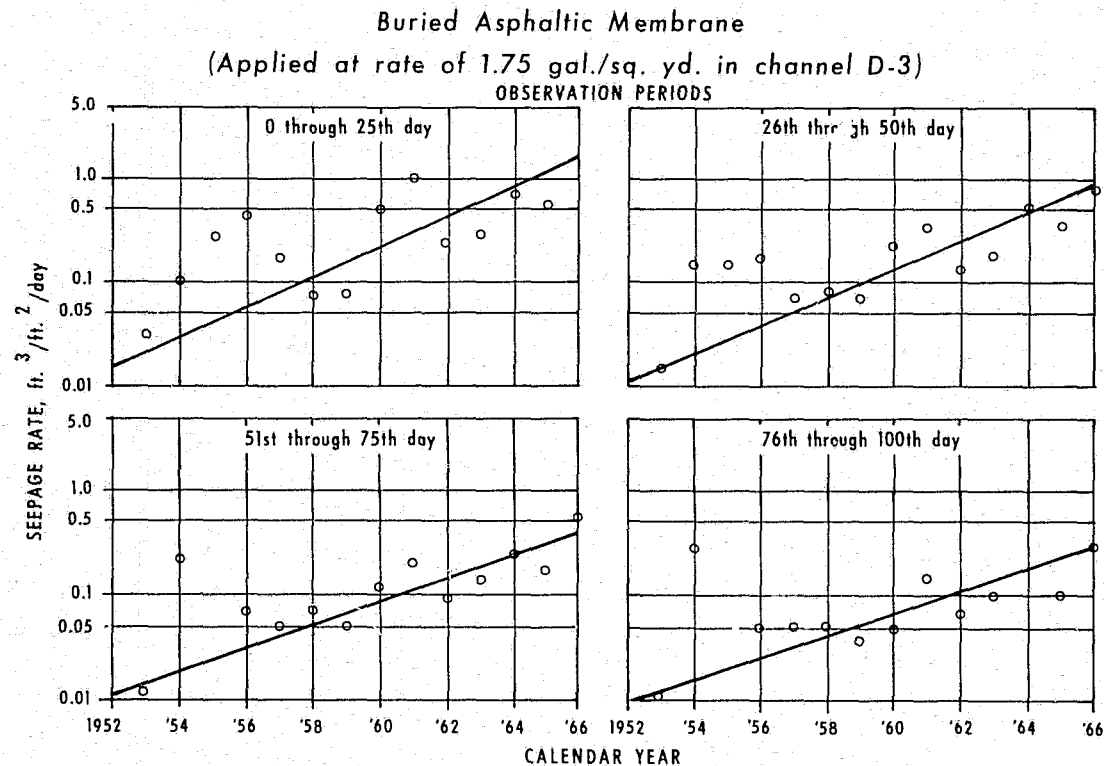
FIGURE 20.—Relation between seepage rate of a buried asphaltic-membrane experimental liner and years of study. Charts show average seepage rates for each quarter for the first 100 days that the liner was in operation during the years included on the charts.

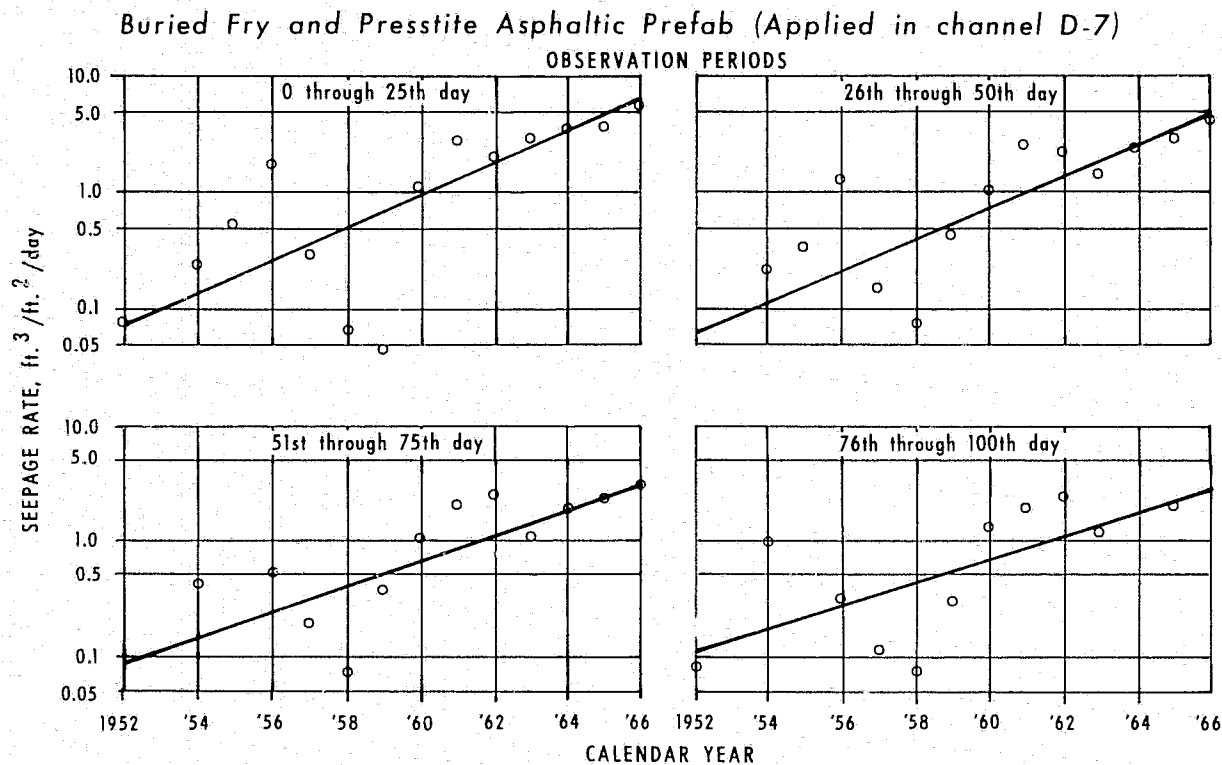
FIGURE 23.—Relation between seepage rate of a buried prefabricated experimental liner and years of study. Charts show average seepage rates for each quarter of the first 100 days that the liner was in operation during the years included on the charts.

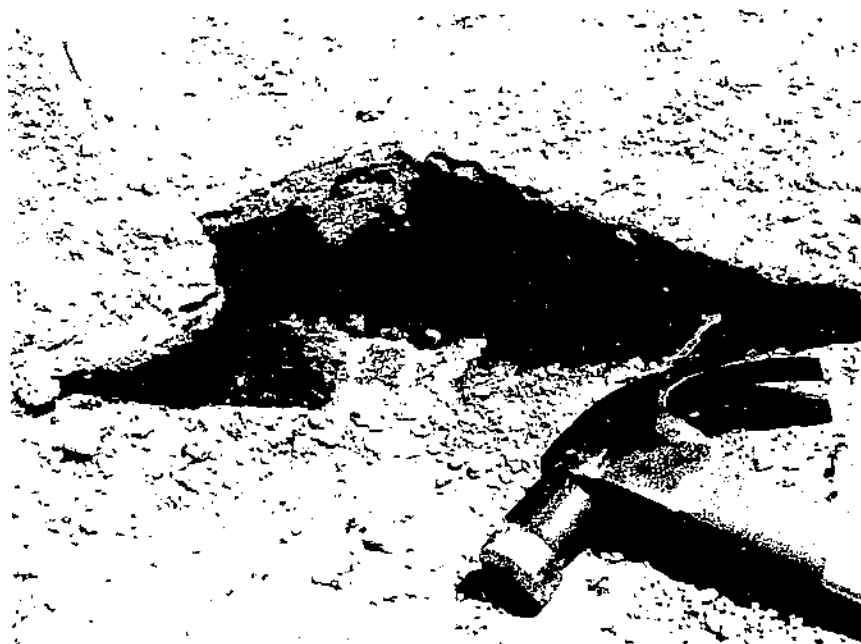
PS 2323

FIGURE 29.—Burned asphaltic membrane with cover removed to show "fish-mouth" that occurred at the lap joint.
