# **FRACTURE TRACE MAPPING AND WATER WELL YIELD IN THE PIEDMONT REGION OF SOUTH CAROLINA**

by D. B. Stafford, J. T. Ligon, and D. S. Snipes

**Final Technical Completion Report**

Technical Completion Report

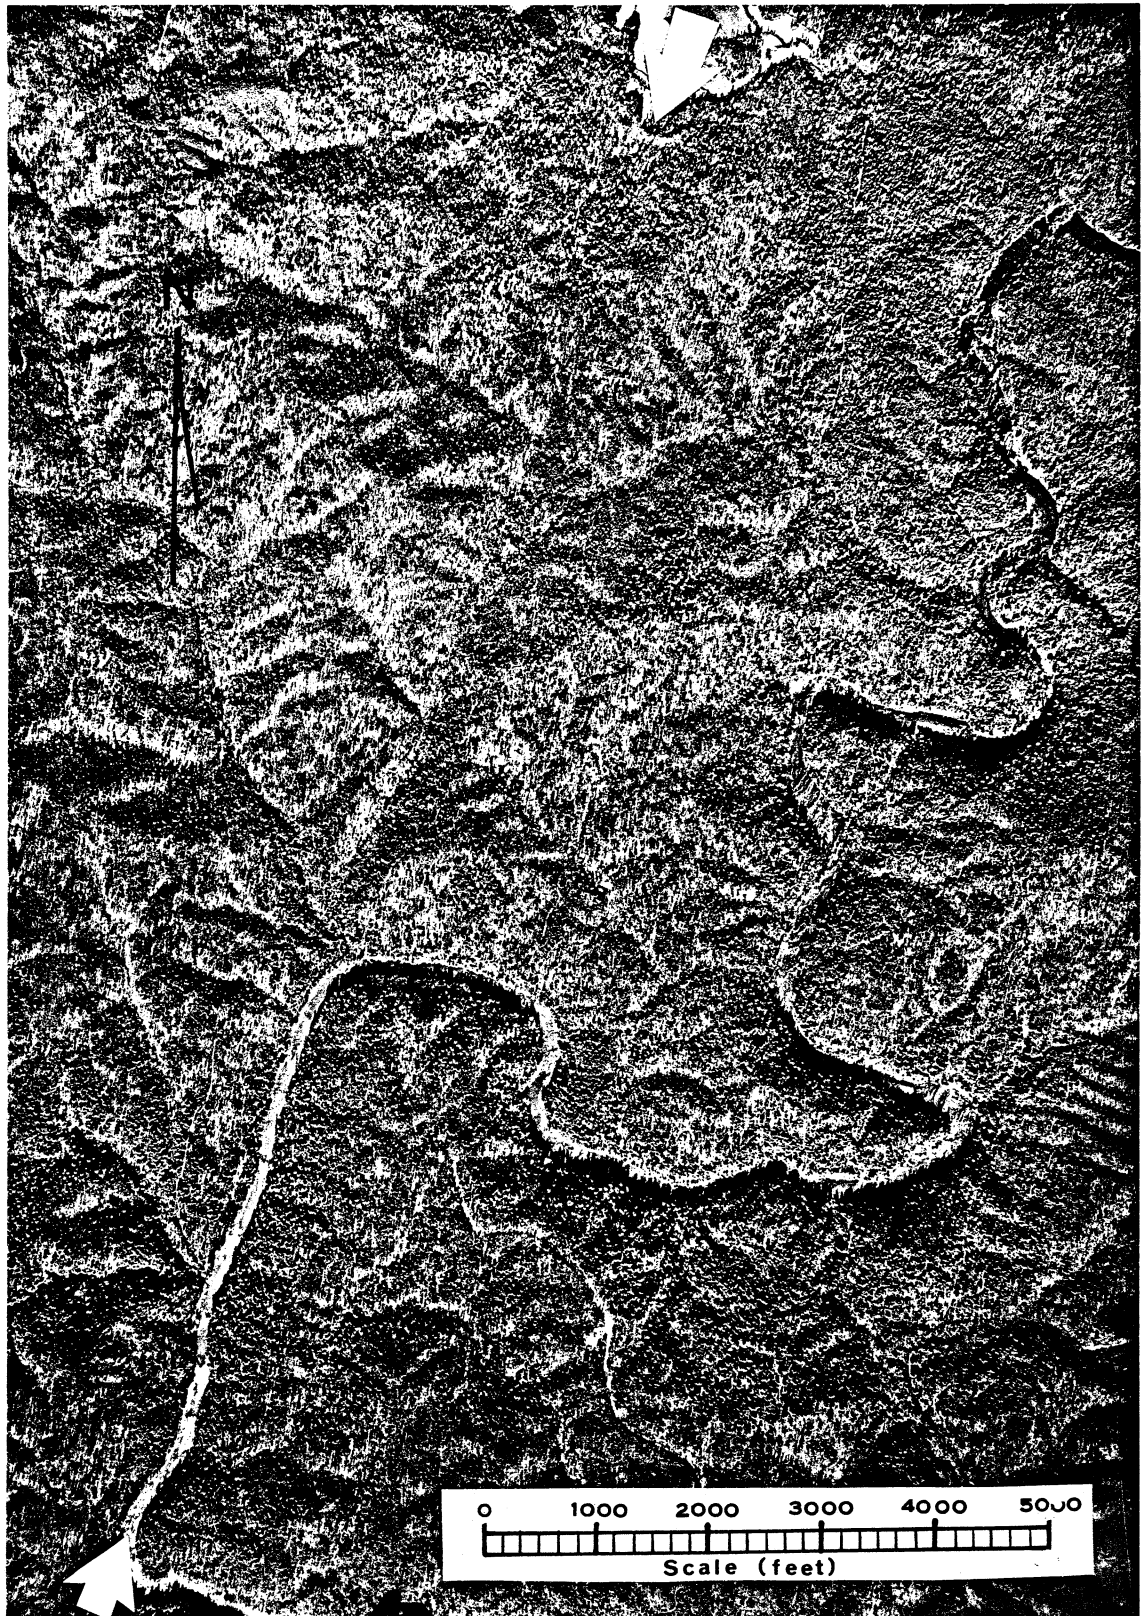
Figure 4. Coincident Alignment of Linear Drainage and Topographic Anomalies to Form a Prominent Lineament in Oconee County, South Carolina.

An example of a prominent lineament detected on both photo index sheets and contact prints is illustrated in Figure 4 as it is displayed on the contact print. This feature consists of a linear drainage anomaly and a linear topographic anomaly that are aligned. The lineament is approximately three miles long and is located in Oconee County. Although this feature is unusually prominent, it indicates the extent to which drainage and topography can be influenced by a fracture zone. The feature is even more obvious when the aerial photograph is viewed stereoscopically.
