FRESH LAMB transported by REFRIGERATED RAIL CARS and PIGGYBACK TRAILERS

Marketing Research Report No. 553

UNITED STATES DEPARTMENT OF AGRICULTURE
Agricultural Marketing Service
Transportation and Facilities Research Division
Market Quality Research Division

FRESH LAMB TRANSPORTED BY REFRIGERATED RAIL CARS
AND PIGGYBACK TRAILERS

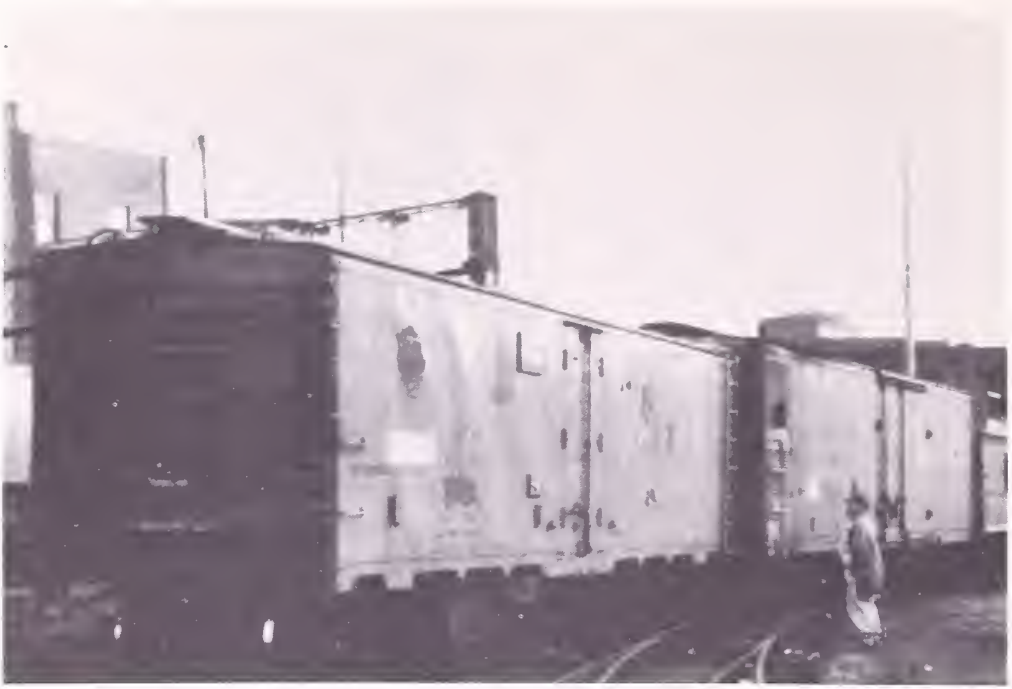
Figure 4.--Cars used in this test.

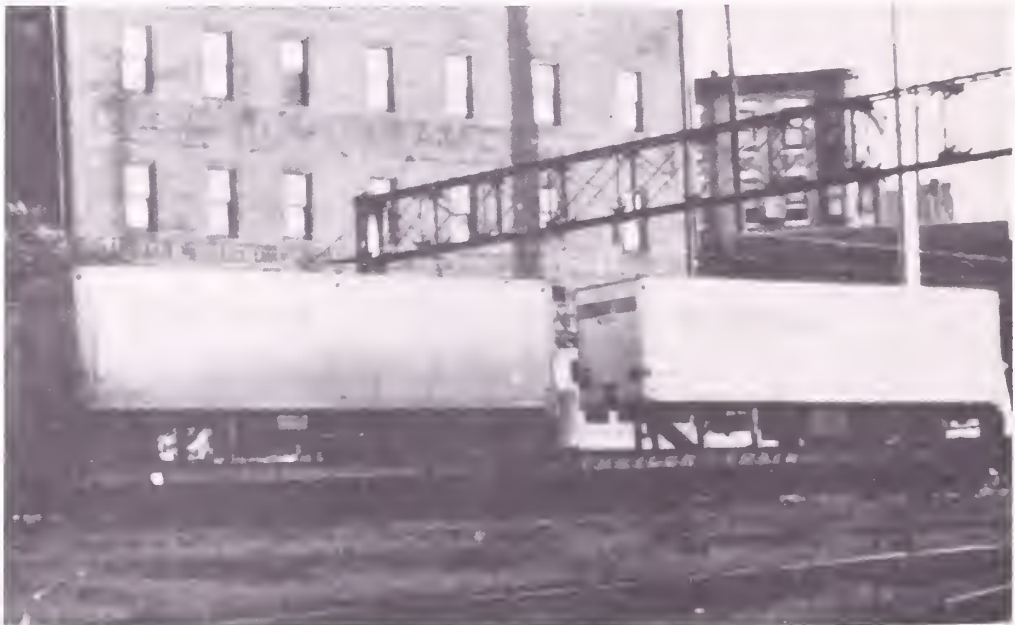
Figure 5.--Trailers used in this test.

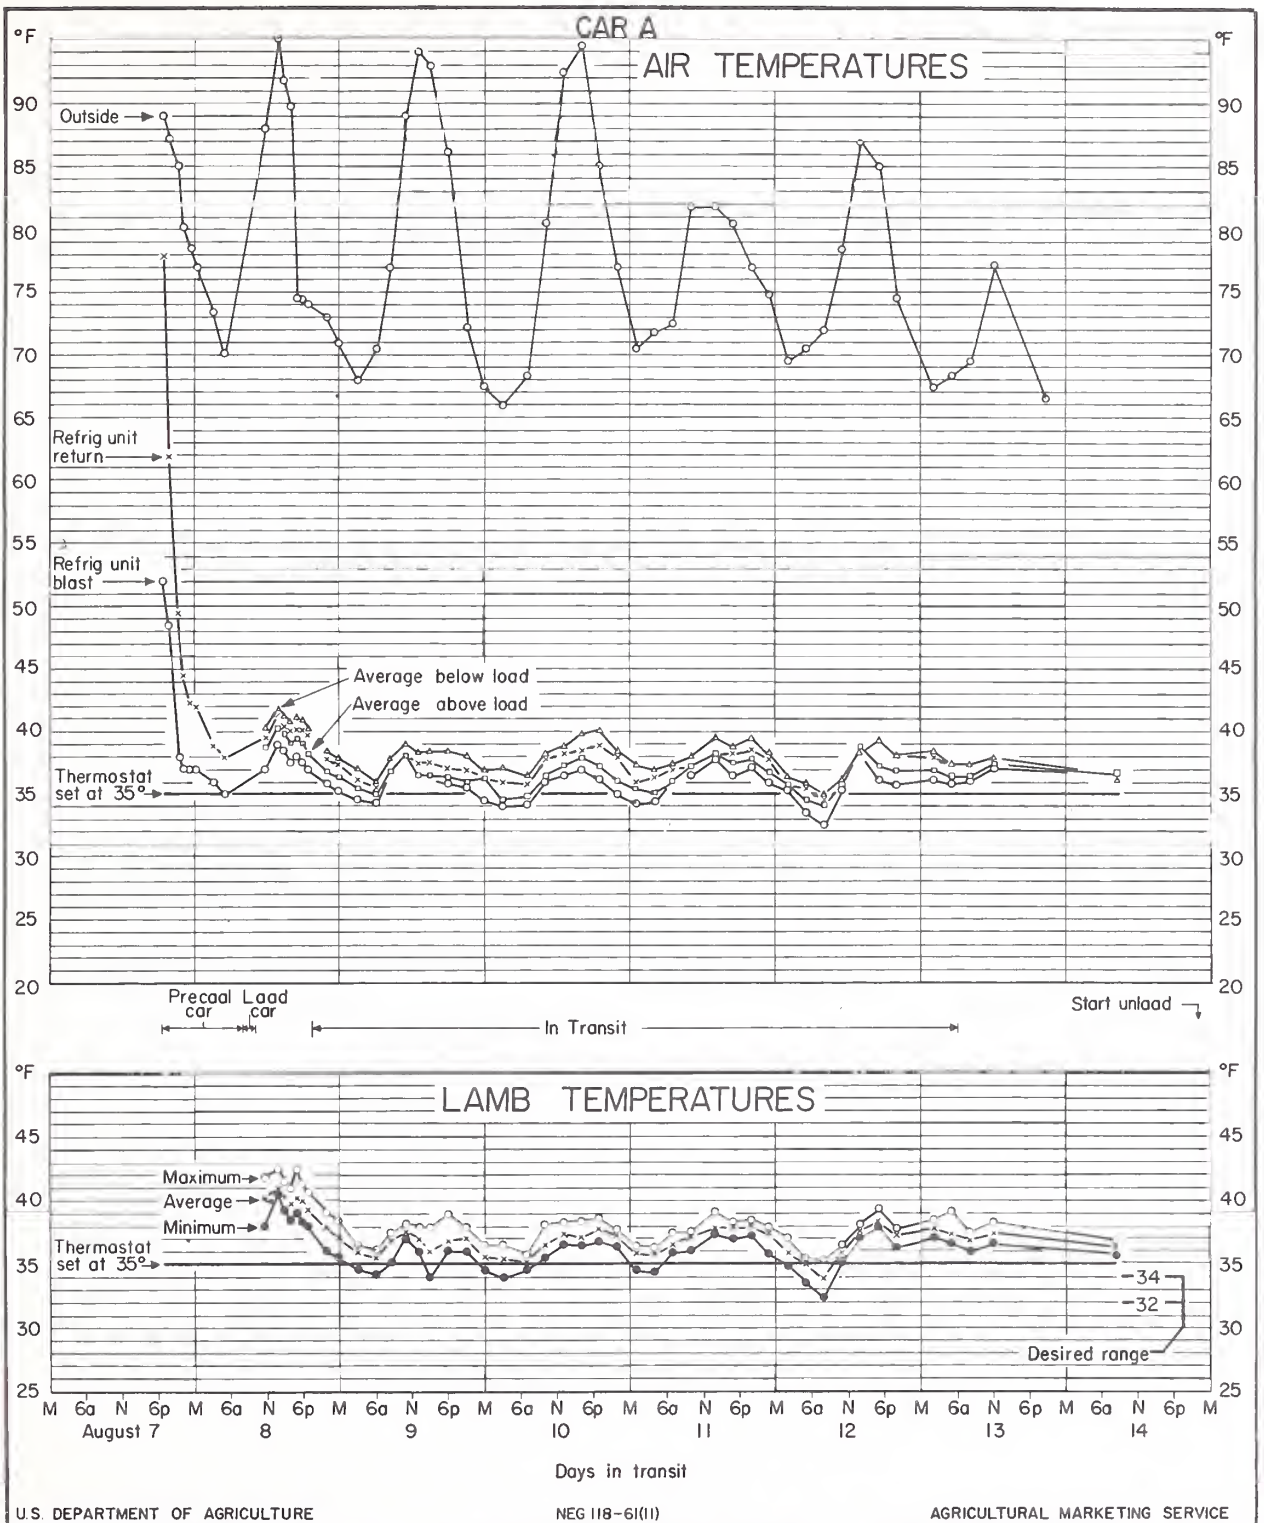
Figure 7.--Temperatures in car A with ice bunker and continuous air circulation through the load.

Figures 7 through 10 show temperatures during the trip. The initial readings on these curves were taken immediately after the vehicles were loaded and the doors sealed. These initial temperature readings seem inconsistent with the 24-hour chilling period of the lamb. But the loading dock was not refrigerated, and during the loading both the lamb and the precooled cars and trailers were exposed to the warm ambient air. Although the harm caused to fresh meat by such warming up is not immediately discernible, it is entirely possible that this change in temperature would affect the keeping quality of the meat. The most harmful effect of moving fresh meat at a temperature of about 35° F. from the chilling room to a warm loading dock would probably be the condensation of moisture on the fresh meat, a condition favorable for the slime-forming microorganisms.

Car A.--The thermostat was initially set at 35° F. On the second day, the temperature readings being too high, the thermostat was reset at 34° F. The maximum temperature at any point in the cargo during the trip was 39°, and the minimum temperature was 32.4°. The temperature spread on arrival in Philadelphia was 1.5°. Most of the time the warmest spot was at the bunker end of the car (thermocouple position No. 3, fig. 6) and the coldest spot in the cargo was at the opposite end of the car. However, with a temperature spread as small as this, the location of the hot and cold spots is probably of little, if any, significance. At any rate, one operational test such as this would not be very indicative.

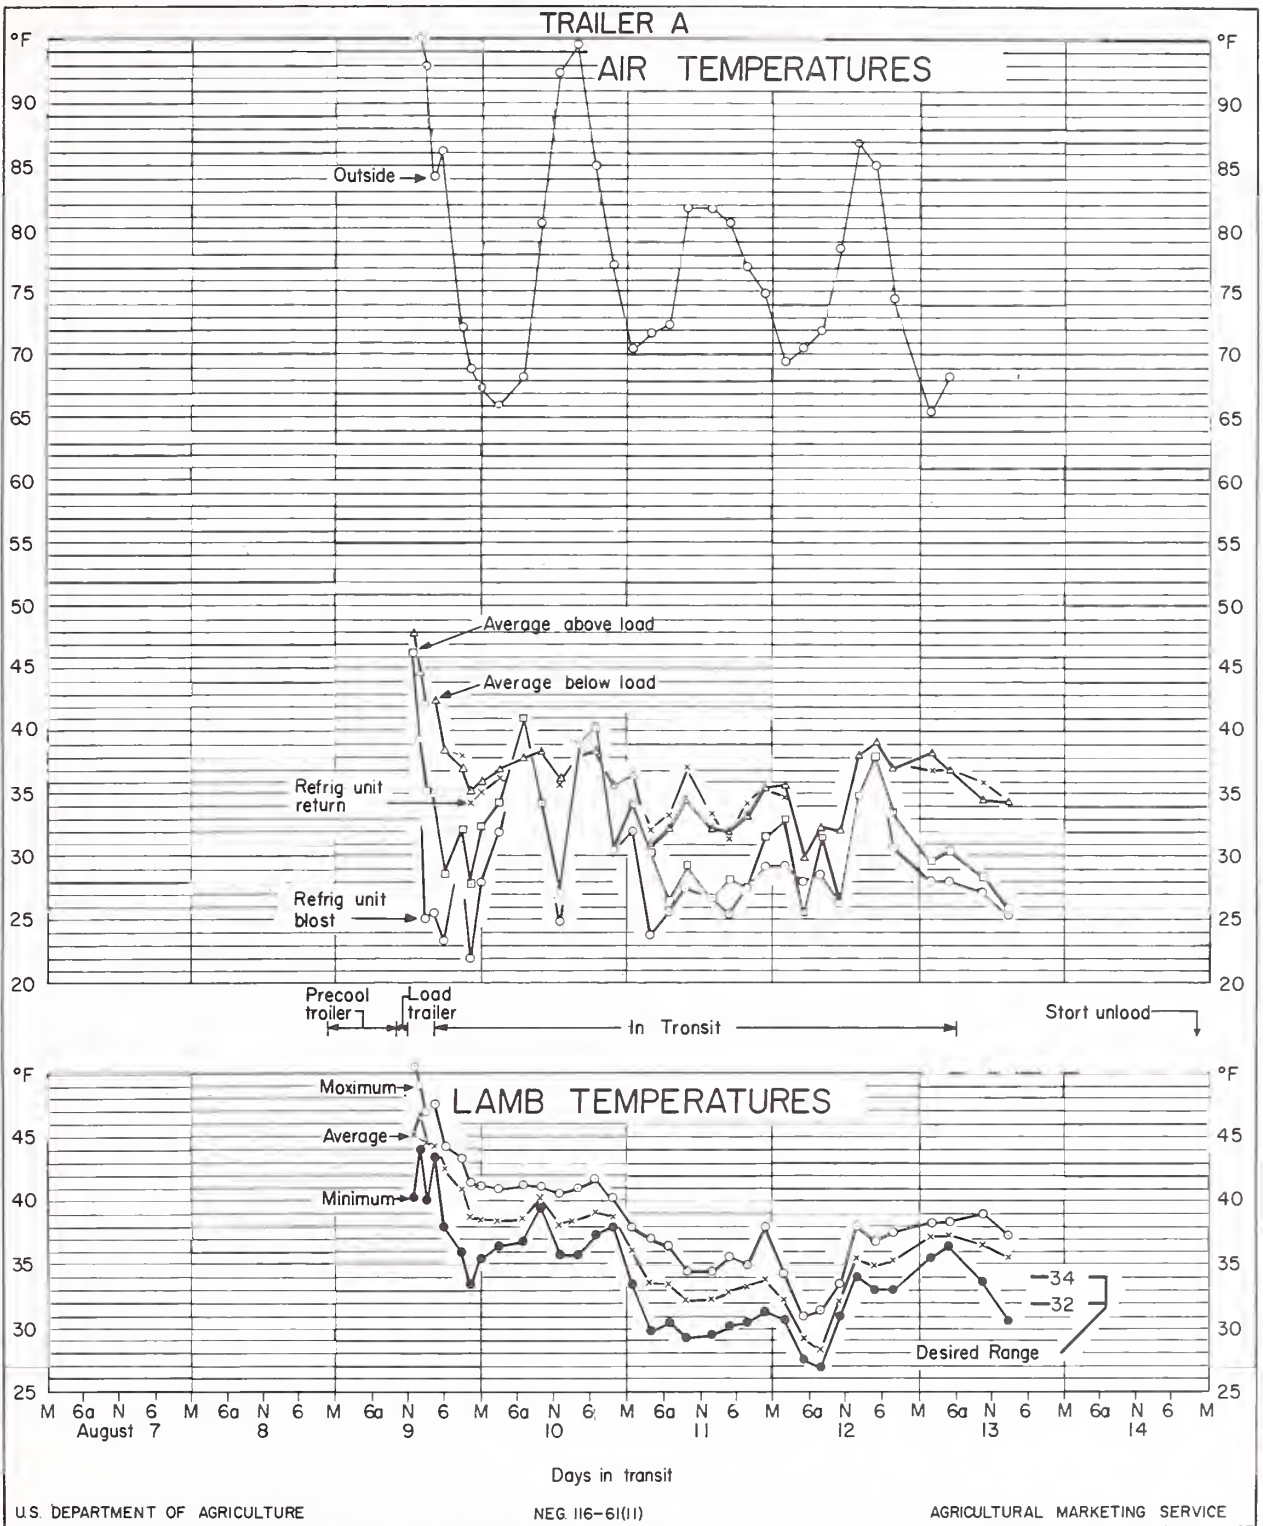
Figure 9.--Temperatures in trailer A with mechanical refrigeration system and four ceiling ducts for air distribution.

Trailer A.--The thermostat was initially set at 35° F. On the third day of the trip the lamb temperature went unduly low; consequently, the thermostat was raised at 7:30 a.m. on August 12. Temperature readings at one point during the trip indicated that the defrost mechanism was not operating properly. After the controls had been manually operated to defrost the coil, the mechanism seemed to operate properly for the rest of the trip. The maximum temperature at any one point during the trip was 41.8°; the minimum was 27°. The average temperature spread was 4.4°. Most of the time the warmest spot was near the ceiling, at the front of the trailer, and the coolest spot was near the rear of the trailer.
