Impact of Coal Mining Subsidence on Sandy Geomorphology and Vegetation Habitat in Sandy Area

Guoping ZHAO^{1*}, Puxia WU¹, Weibo SHEN^{2,3}

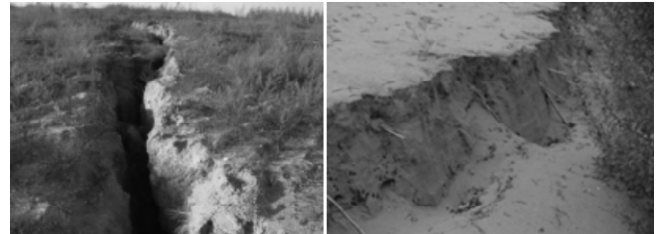
Fig. 1 The subsidence area studied

At present, after years of coal mining, the surface subsidence is obvious in this area (Fig. 1). The maximum subsidence is more than 200 cm. The collapse fissures are staggered and widely distributed, with maximum width of 120 cm and minimum width of 1 cm. The height of the collapse staggers is 5–150 cm. The maximum displacement of vegetation is more than 100 cm, leading to the death of a large number of artificial vegetation and the decrease of bulk density of the sandy soil to 1.5–1.6 g/cm³. The surface damage rate is 40%–60%. The wind erosion area is more than 50%. The vegetation coverage has dropped to less than 20%. The blown sand activities are frequent. Nearly half of the sand dunes have been activated, and the phenomenon of "secondary desertification" in the sandy areas has become increasingly apparent.

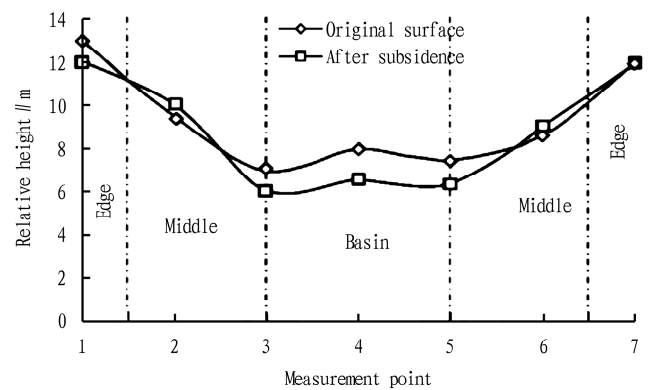
Fig. 2 Location of measurement points in the subsidence area

was selected. In typical areas such as edge, middle, and basin (Fig. 2), five plots (10 m × 10 m) were arranged randomly for investigation on collapse fissure width (W), fissure stagger height (H), fissure density (P_{ss}) and surface damage rate (I_{ss}). Fissure density is expressed by the number of fissures per unit area, and the unit is strips/m; and surface damage rate is expressed by the percentage of surface damage area to unit area.
