PATAPSCO RIVER BASIN STUDY

Prepared By:
Regional Planning Council
U.S.D.A. Soil Conservation Service
March 1980

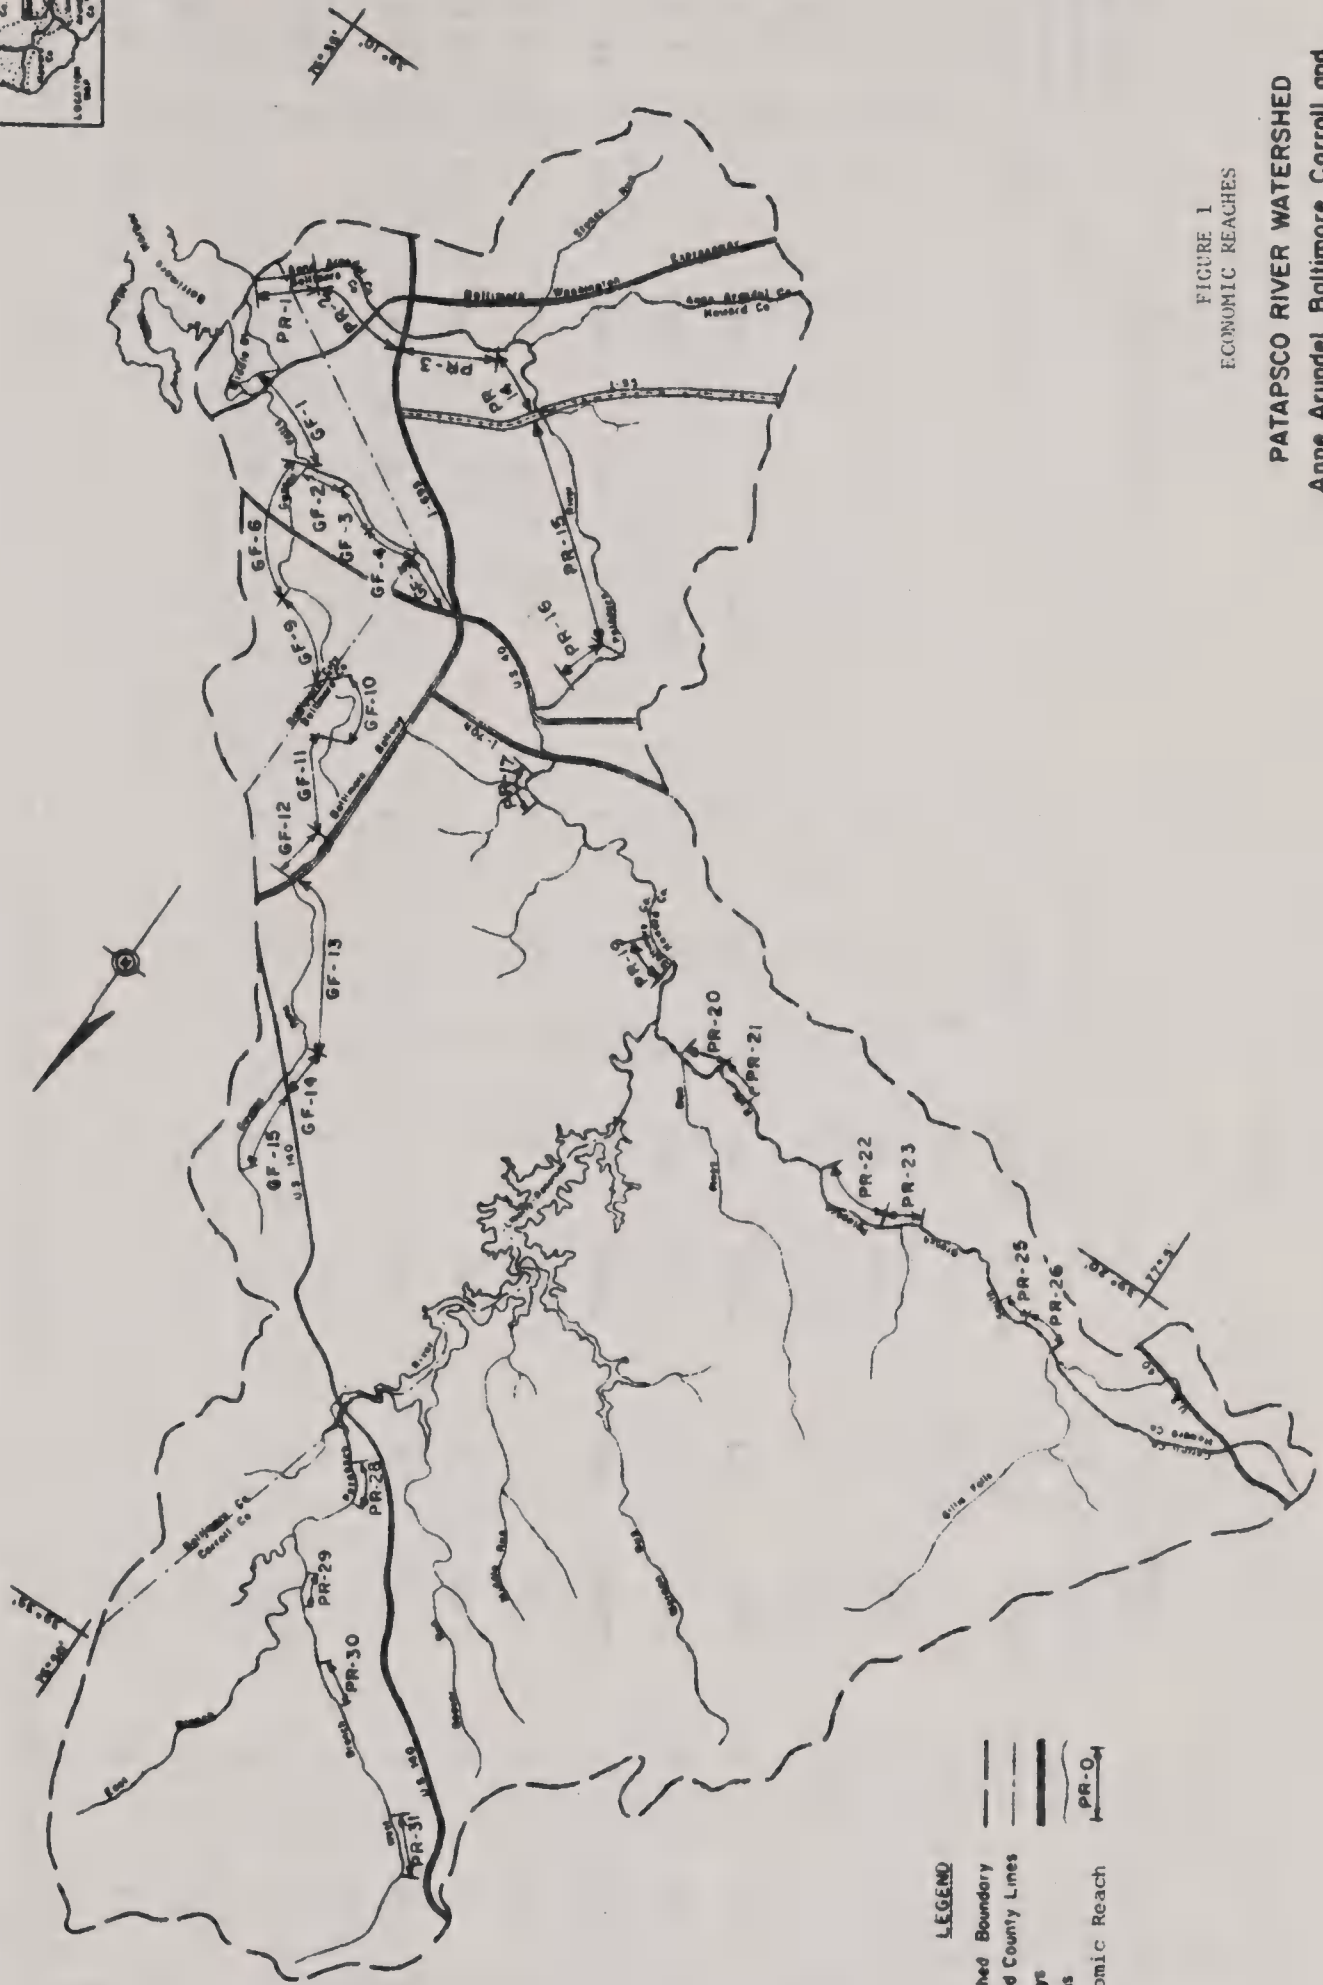
- Watershed Boundary
- - - City and County Lines
- == Highway
- ~ Stream
- PR-01 Economic Reach

13.	Land Treatment Needs	5-4
14.	Reach Identification and Summary of Damage by Reach	6-10
15.	Estimated Flood Damages, Patapsco River	6-12
16.	Estimated Flood Damages, Gwynn's Falls	6-13

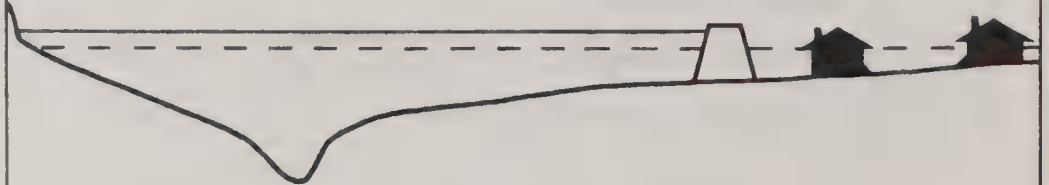
Figure 3

IMPACTS OF DIKING ON A FLOOD PRONE AREA

- 2) Constriction of the natural floodplain by man-made obstructions: Roads and bridges which serve the area must necessarily follow or cross over the floodplain. In many cases they cause constrictions which back water upstream (See Figure 3). Recently man has learned to design such facilities properly so that they have a minimal impact on the ability of the floodplain to convey floodwater. However, in many cases, older or abandoned constrictions still have a great impact on flood levels.

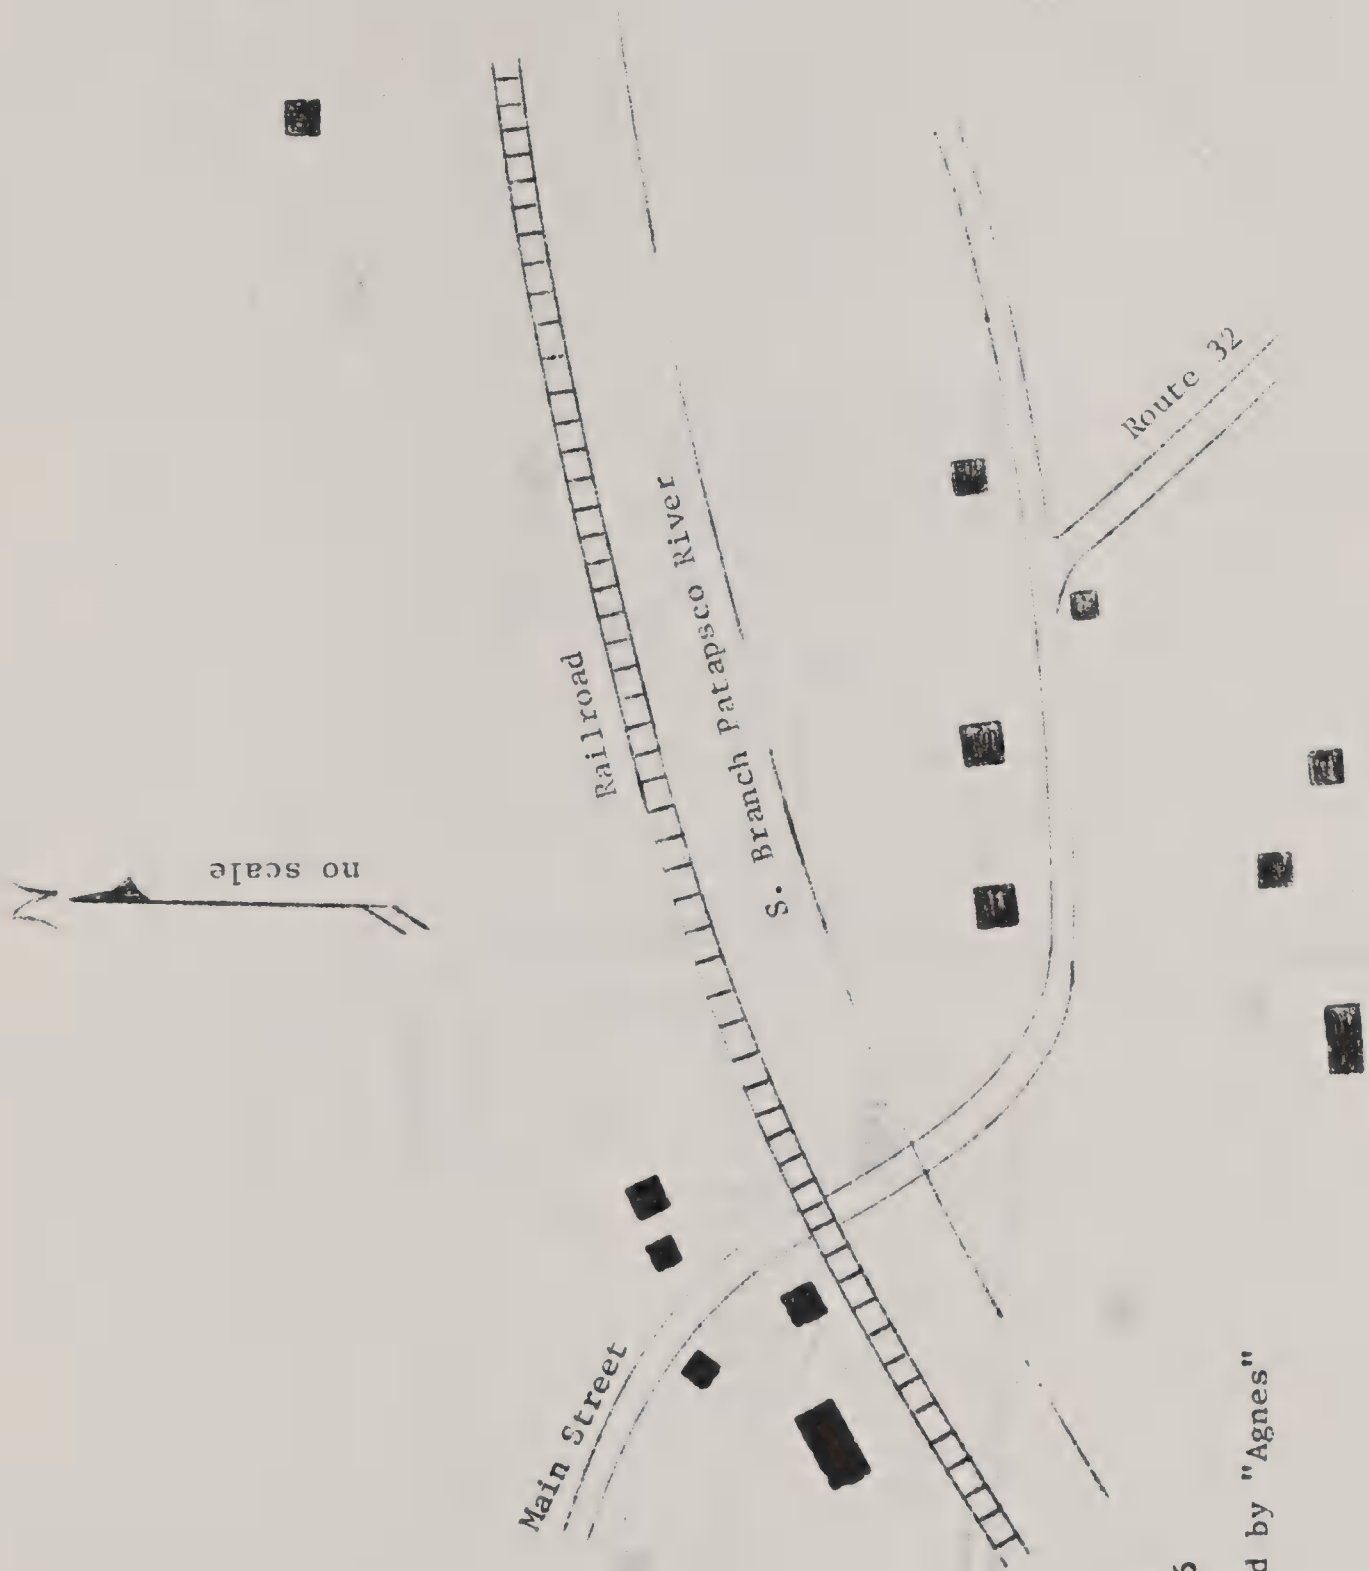
FIGURE 6

Structures Flooded by "Agnes"

PR-22 Sykesville

Sykesville (PR-22), had more commercial structures damaged than any other area along the South Branch. (See Figure 6.) Six businesses and two homes were flooded. Two taverns on the Howard County side of the river had from five to eight feet of water around them. The other businesses and homes had less of a problem with damage confined to basements and low levels on the first floor. In Gaither (PR-23), five houses were flooded with first floor depths rising to nearly six feet in three of them.

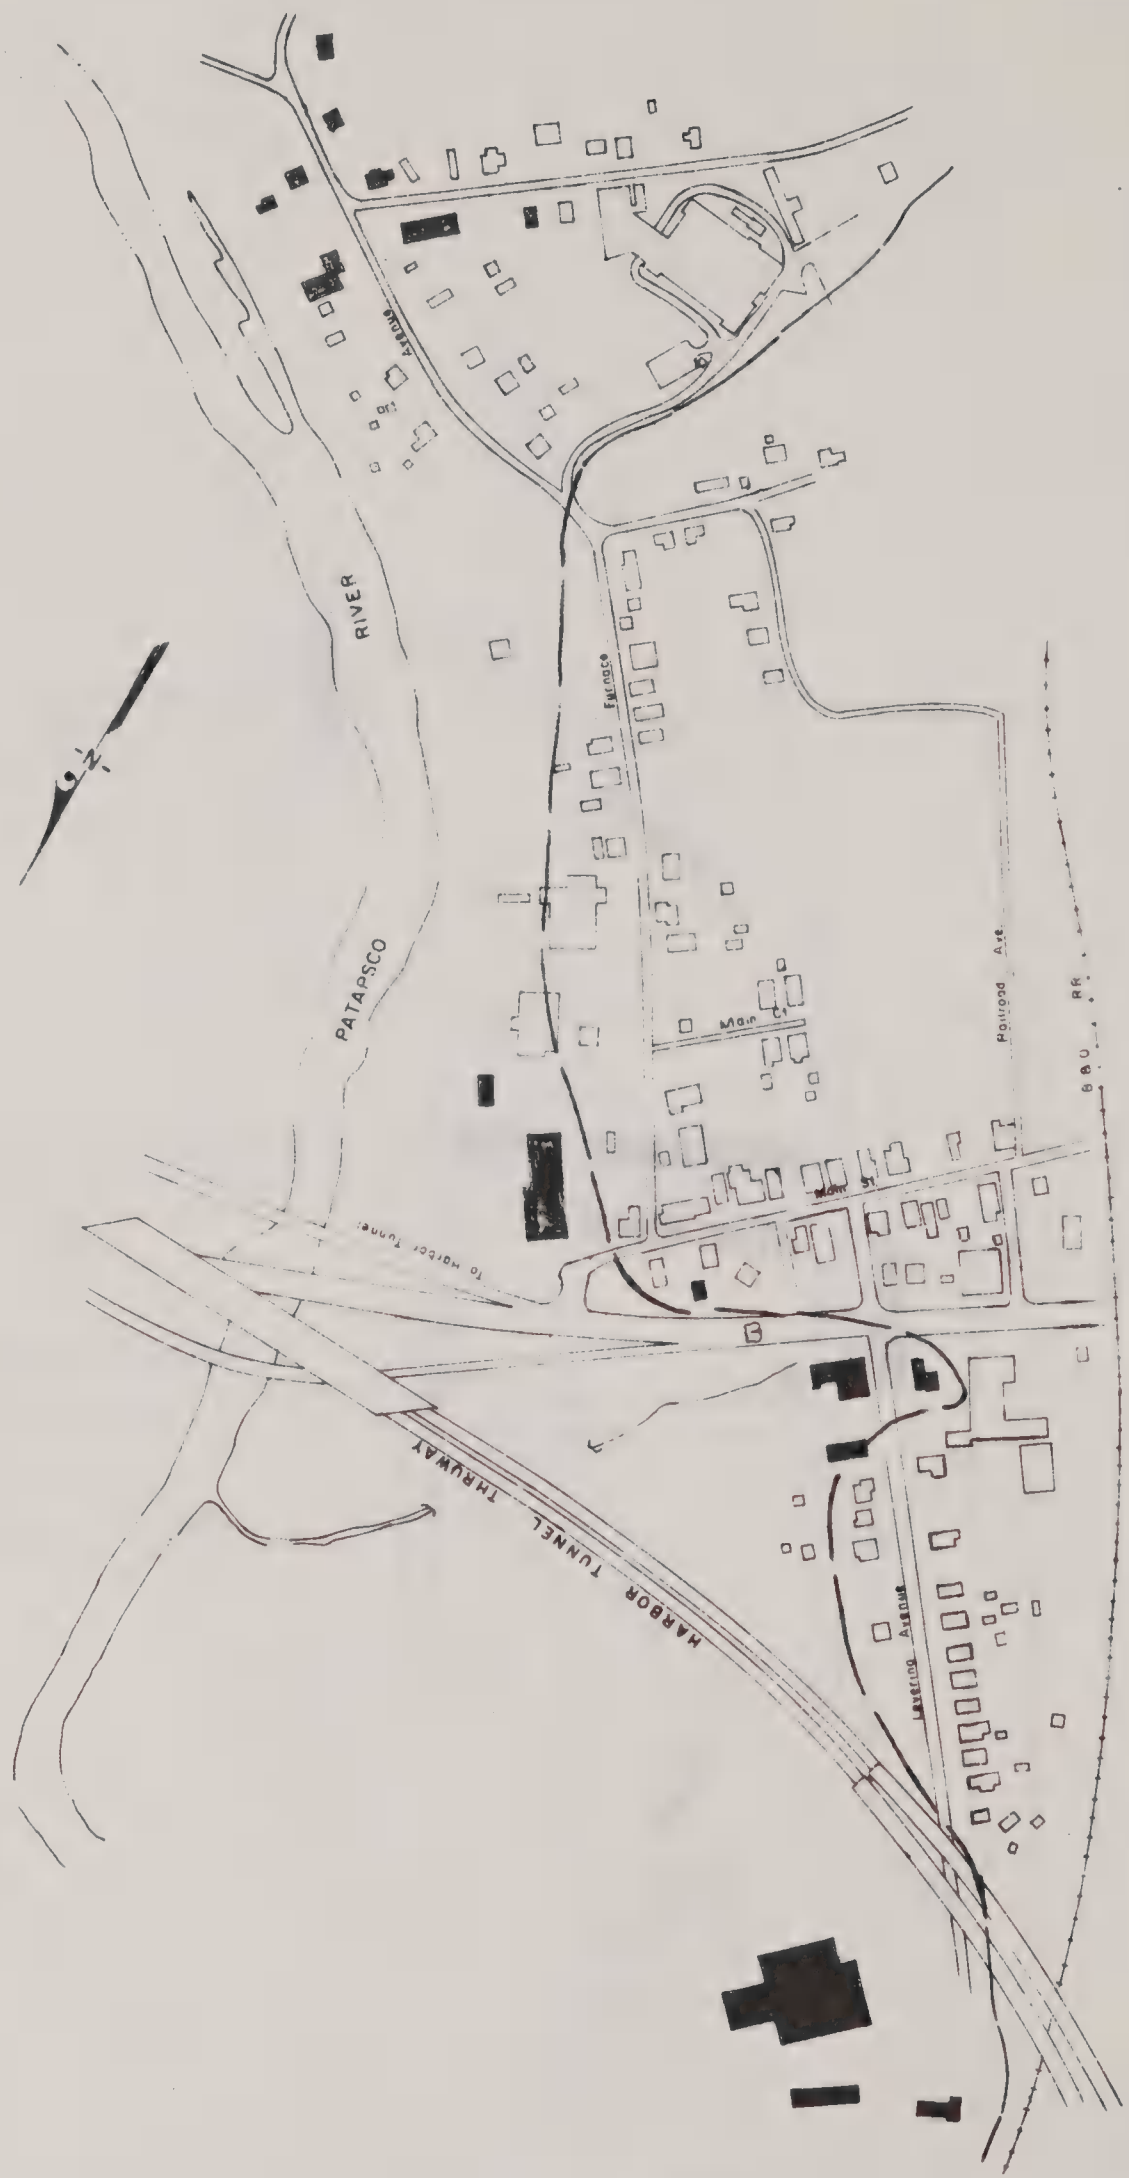
FIGURE 9
 Structures Flooded by "Agnes"
 Patapsco River
 PR-14 Elkridge

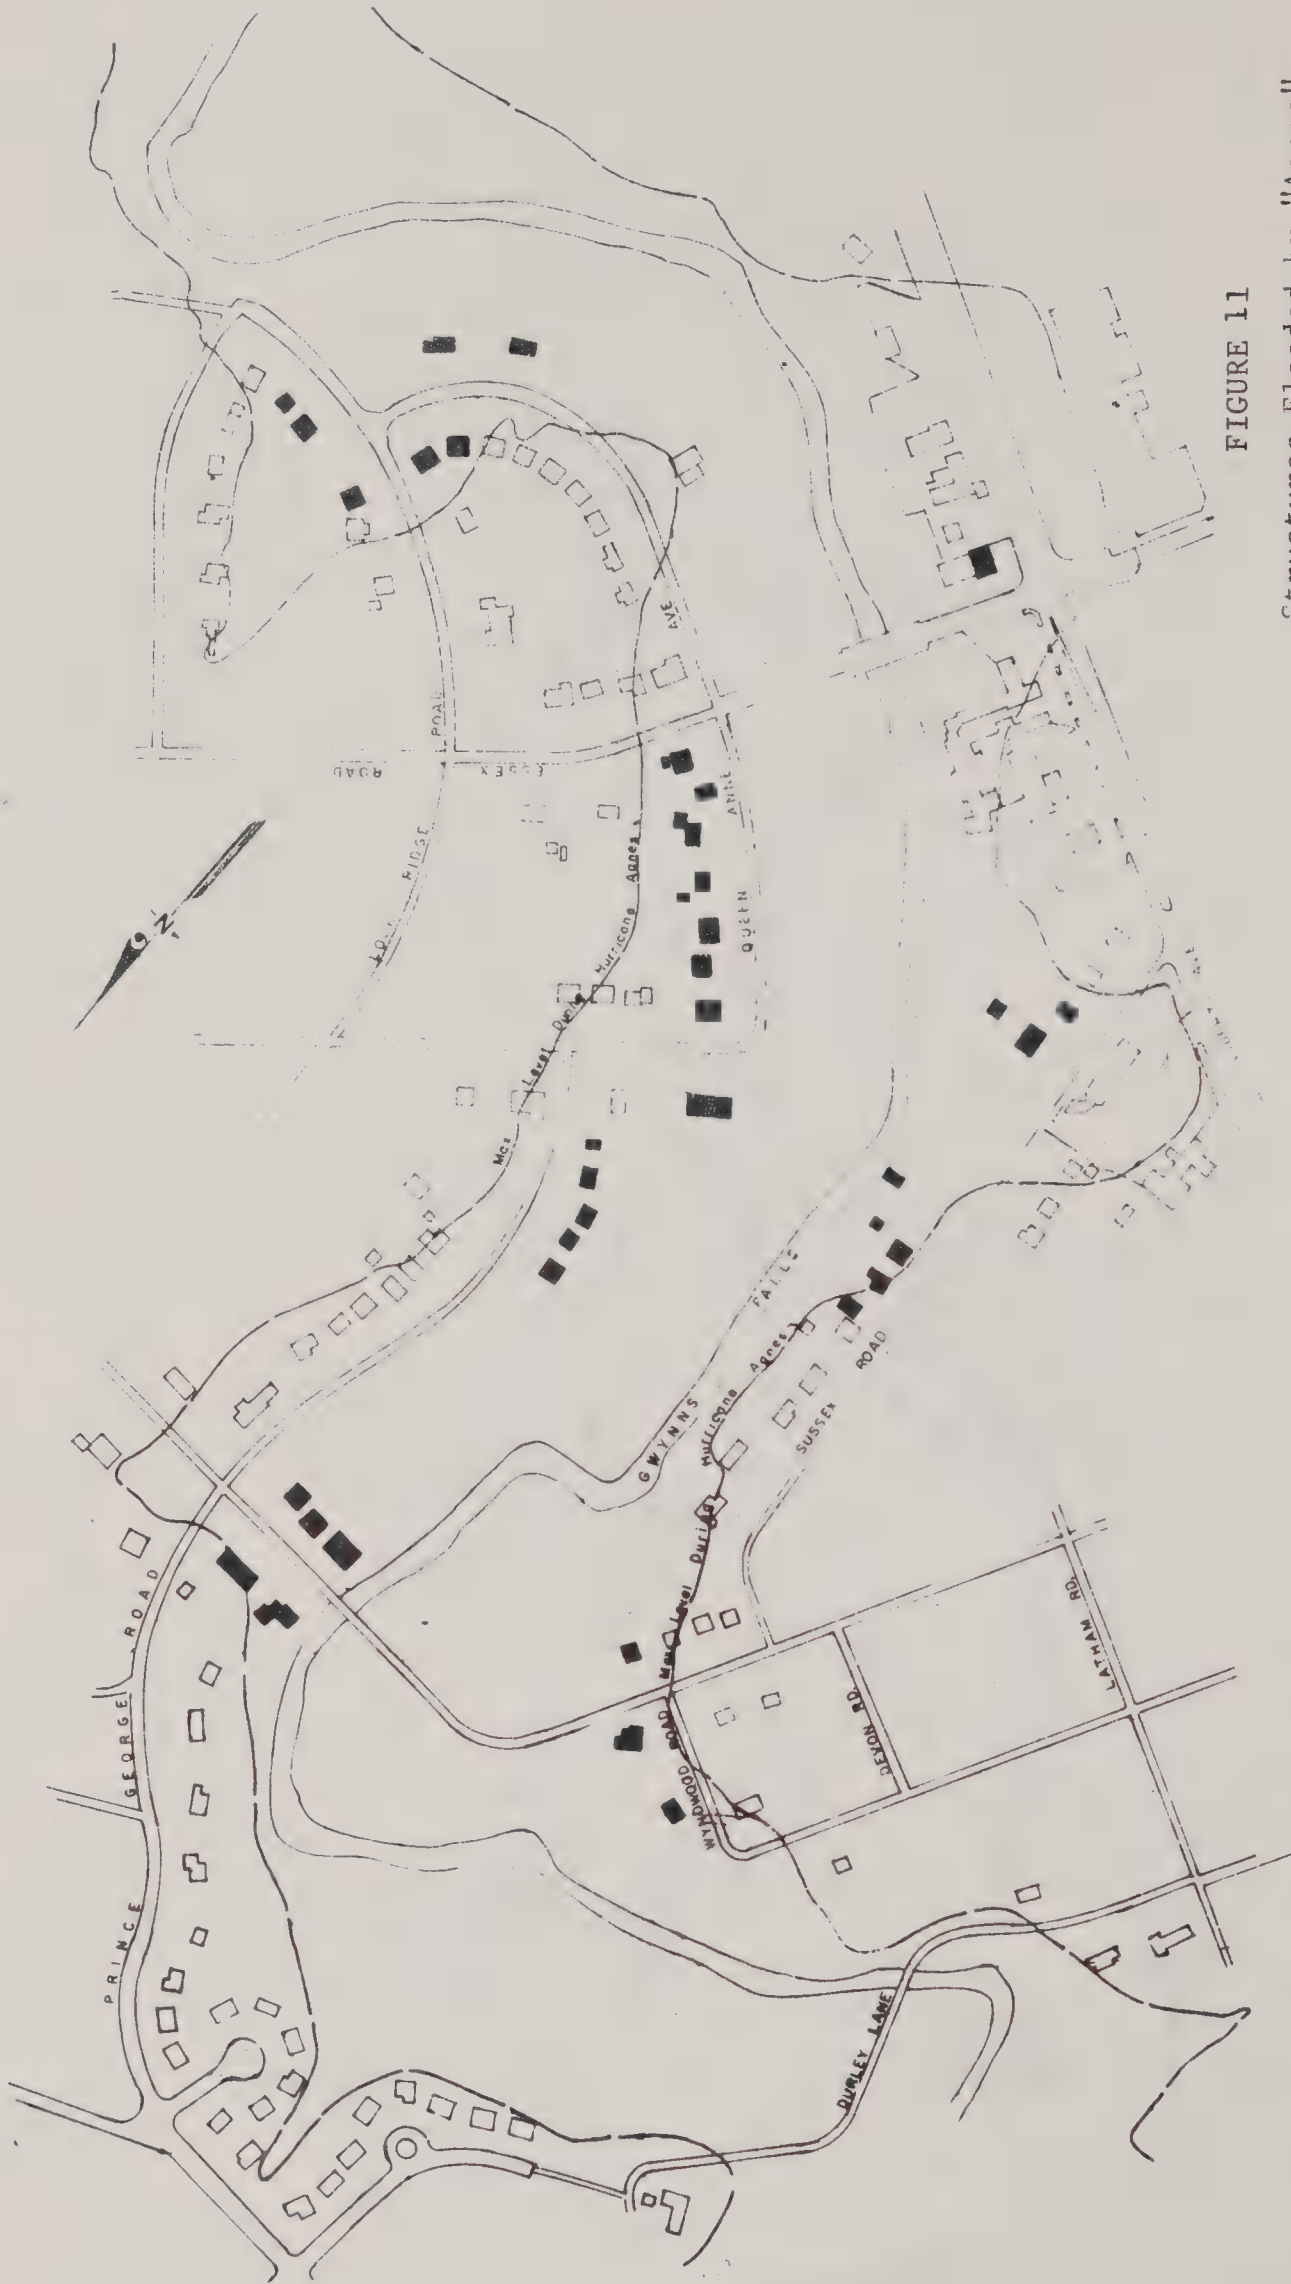
FIGURE 11
 Structures Flooded by "Agnes"
 Gwynns Falls
 GF-11 Villa Nova

Note: Shaded structures are to be acquired as part of Baltimore County's acquisition program

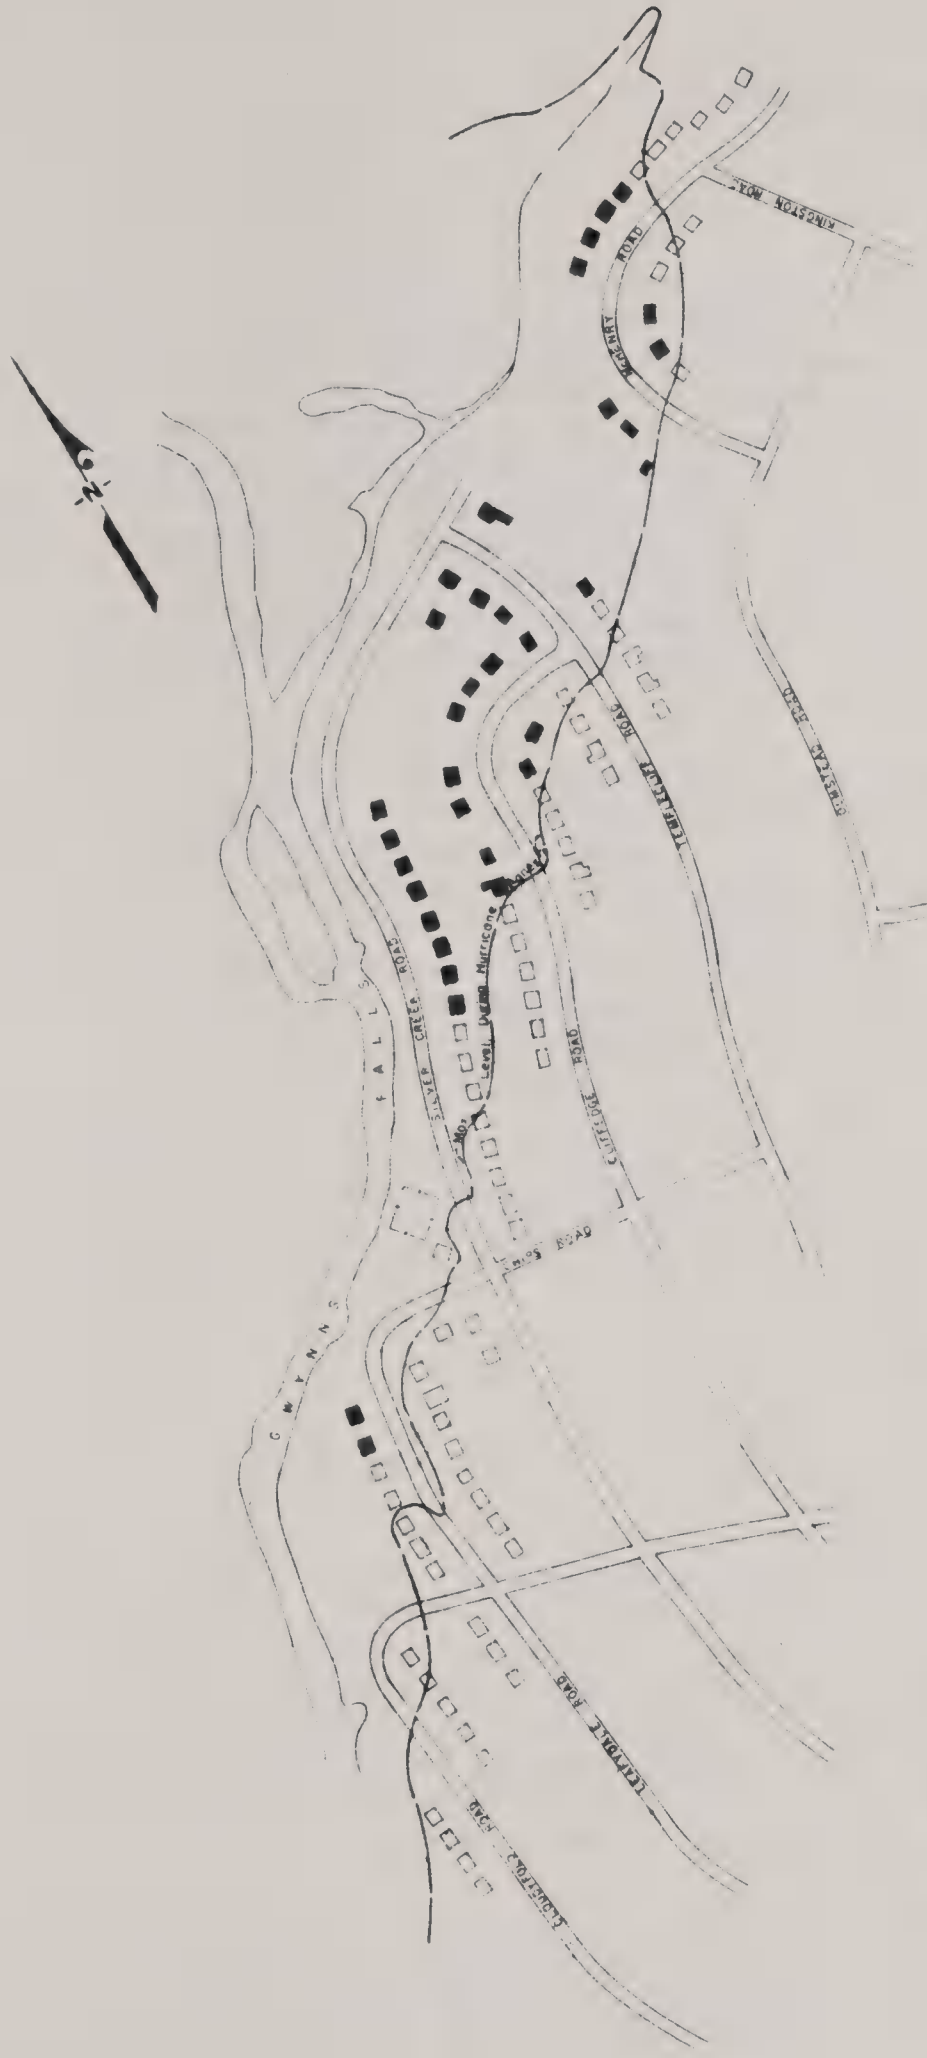
Note: Shaded structures are to be acquired as part of Baltimore County's acquisition program

FIGURE 12
 Structures Flooded by "Agnes"
 Gwynns Falls
 GF-12 Silver creek Park

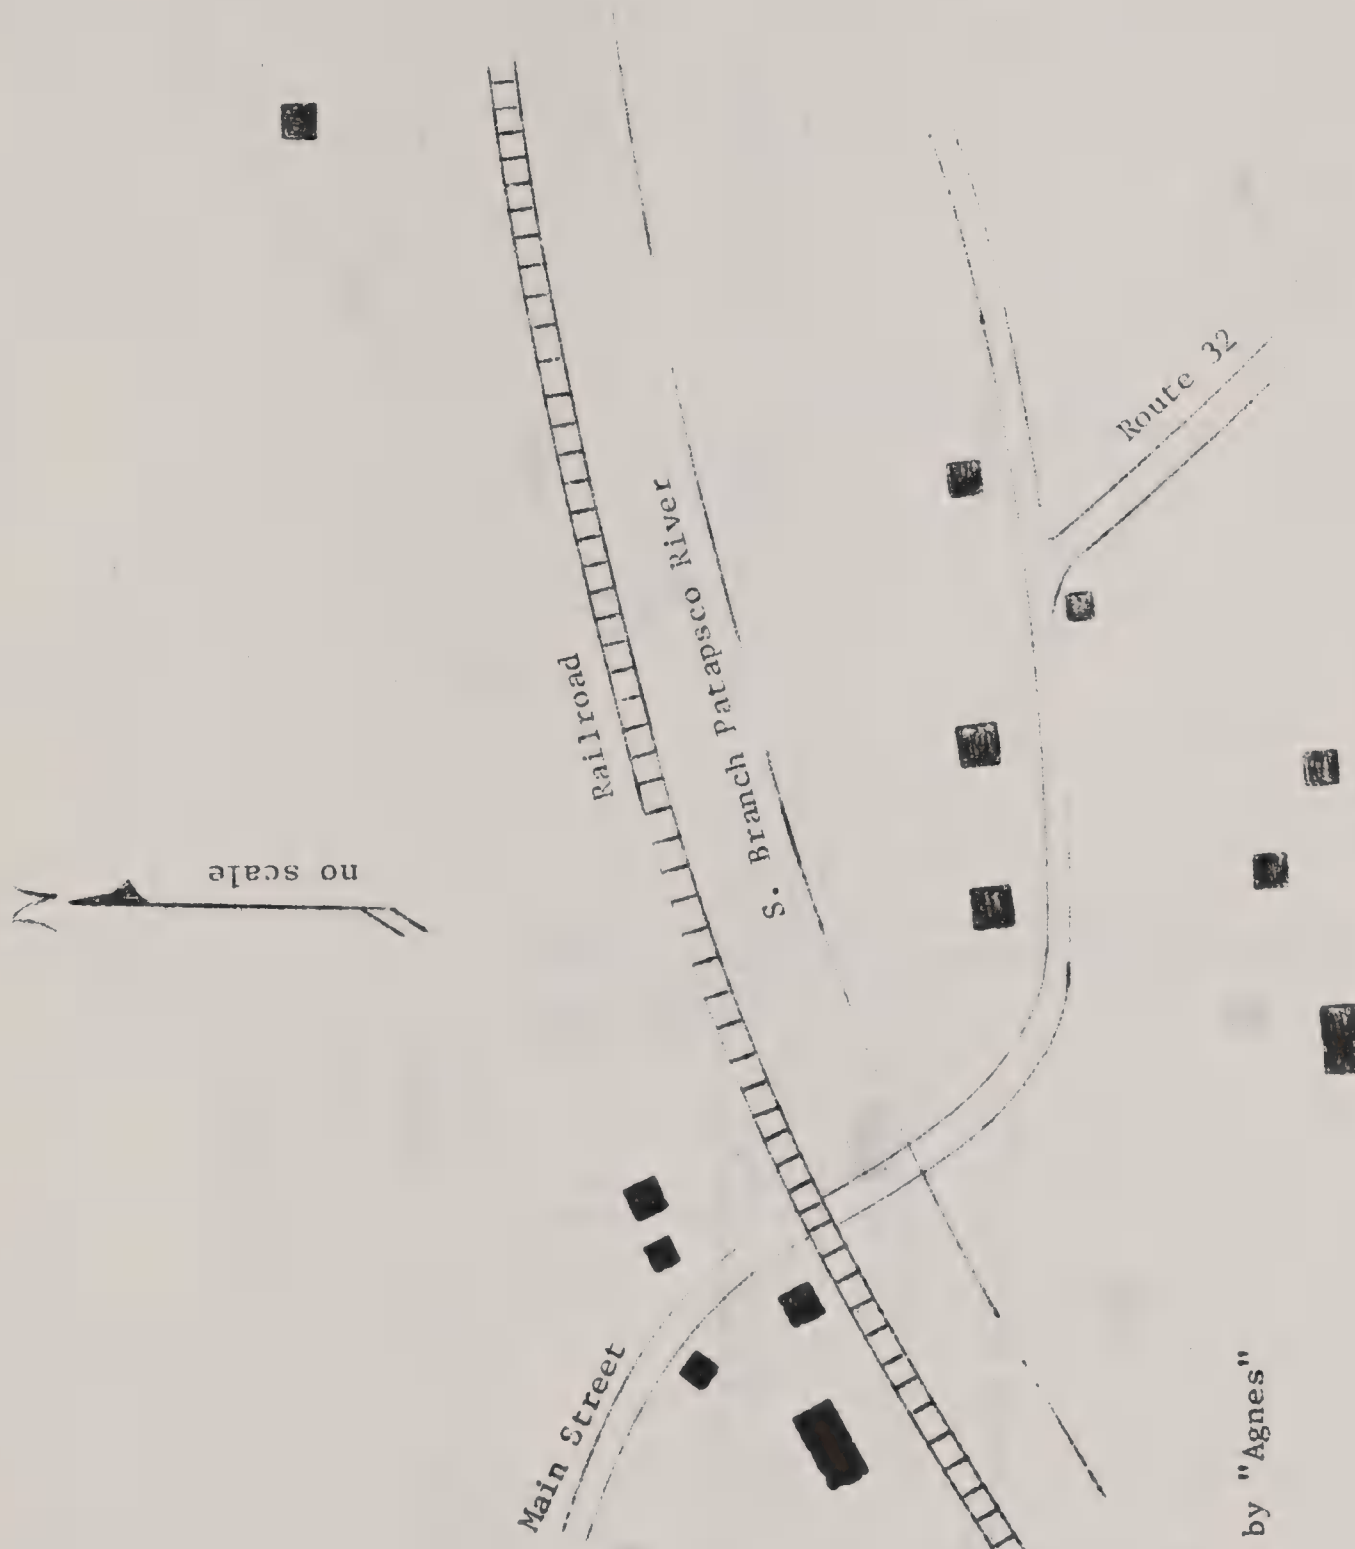
FIGURE 6
 Structures Flooded by "Agnes"
 Patapsco River
 PR-22 Sykesville

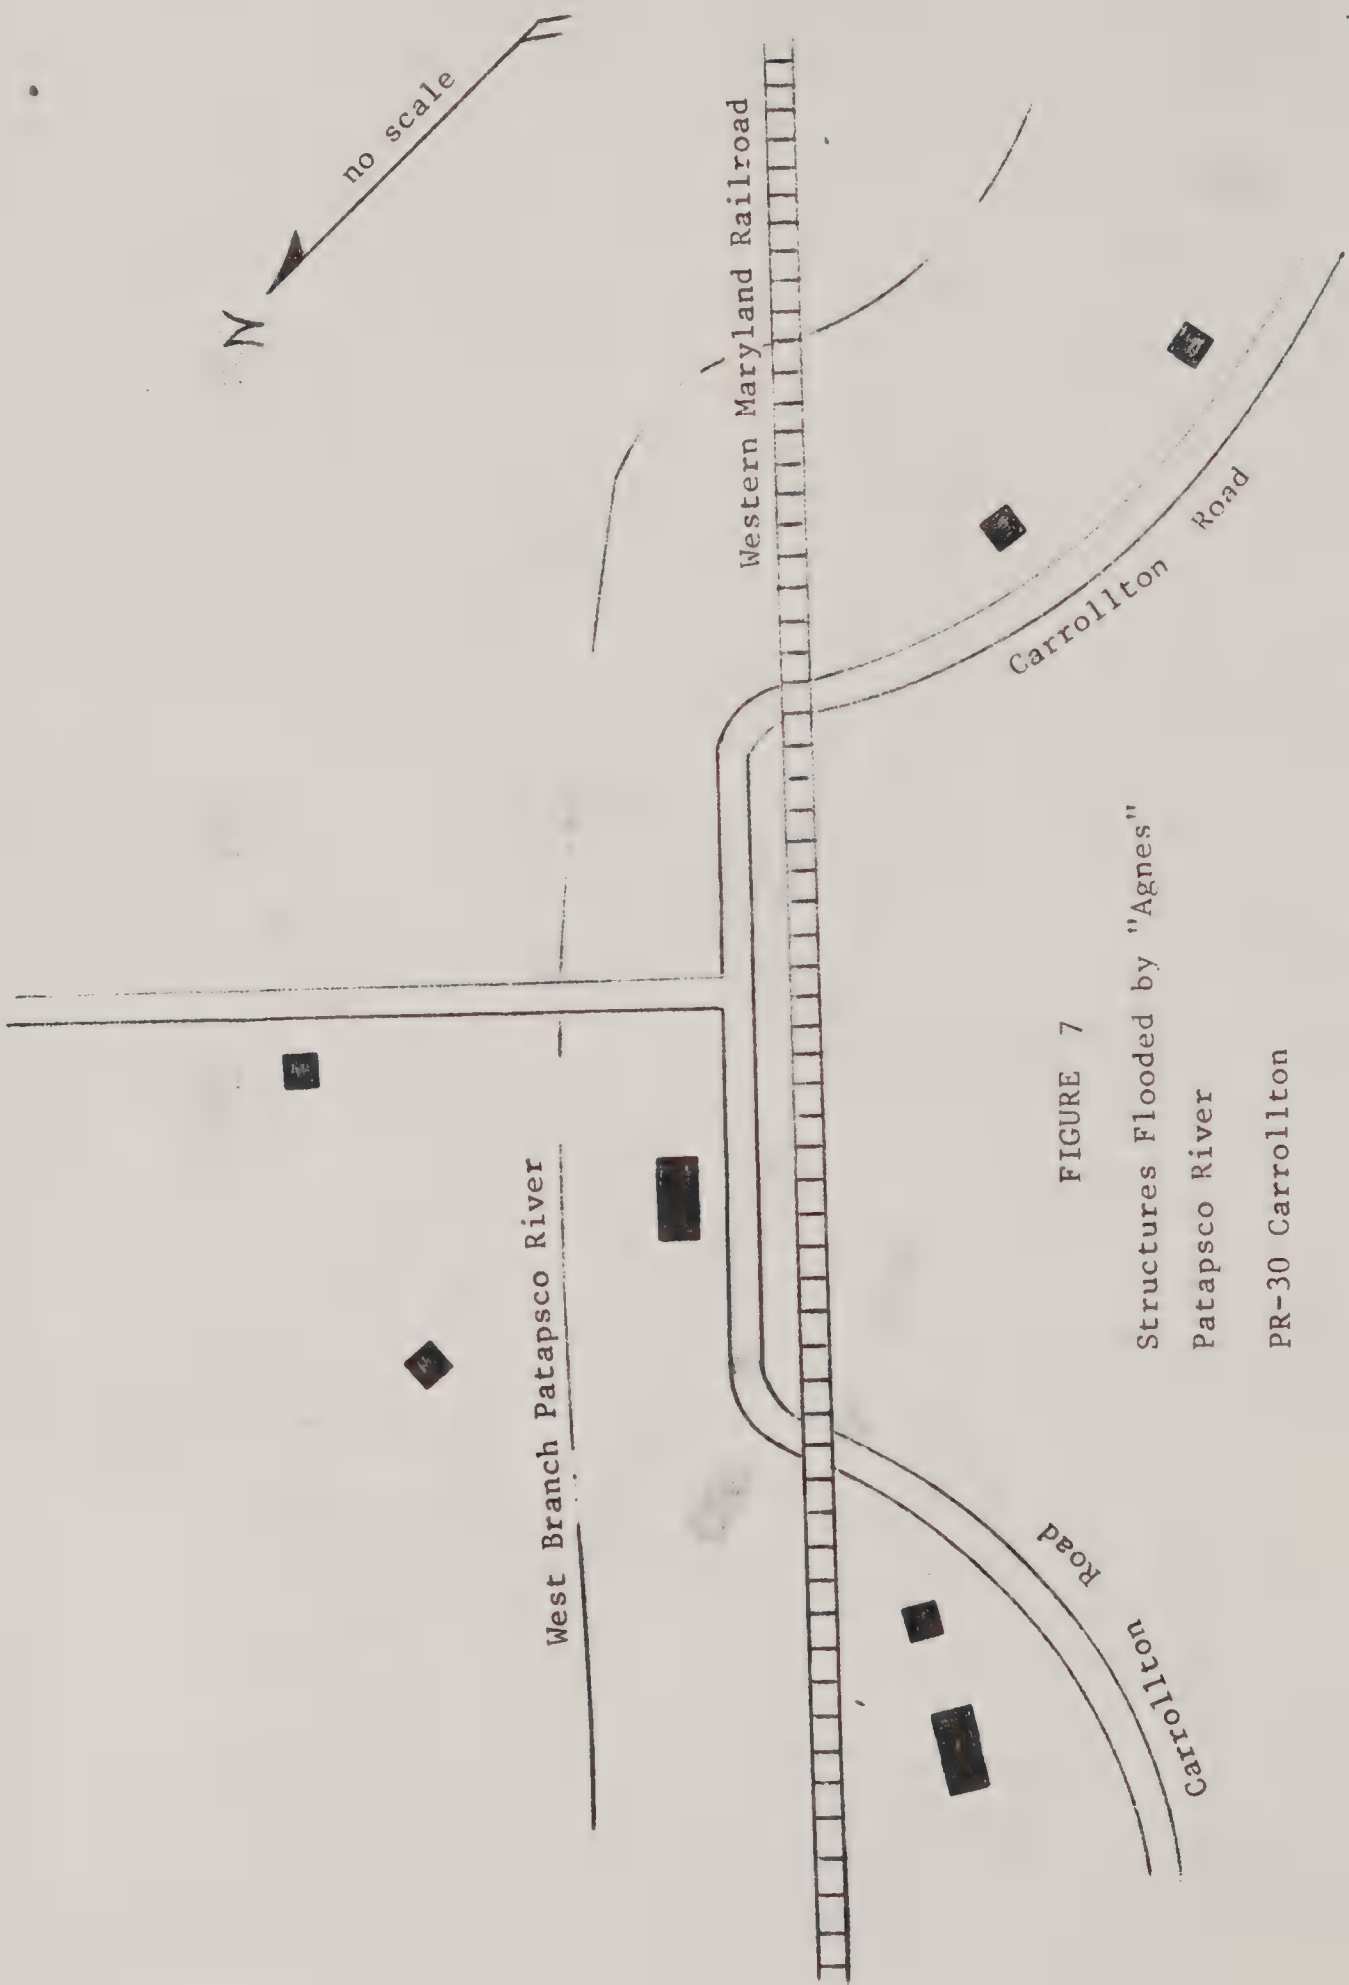
FIGURE 7
 Structures Flooded by "Agnes"
 Patapsco River
 PR-30 Carrollton

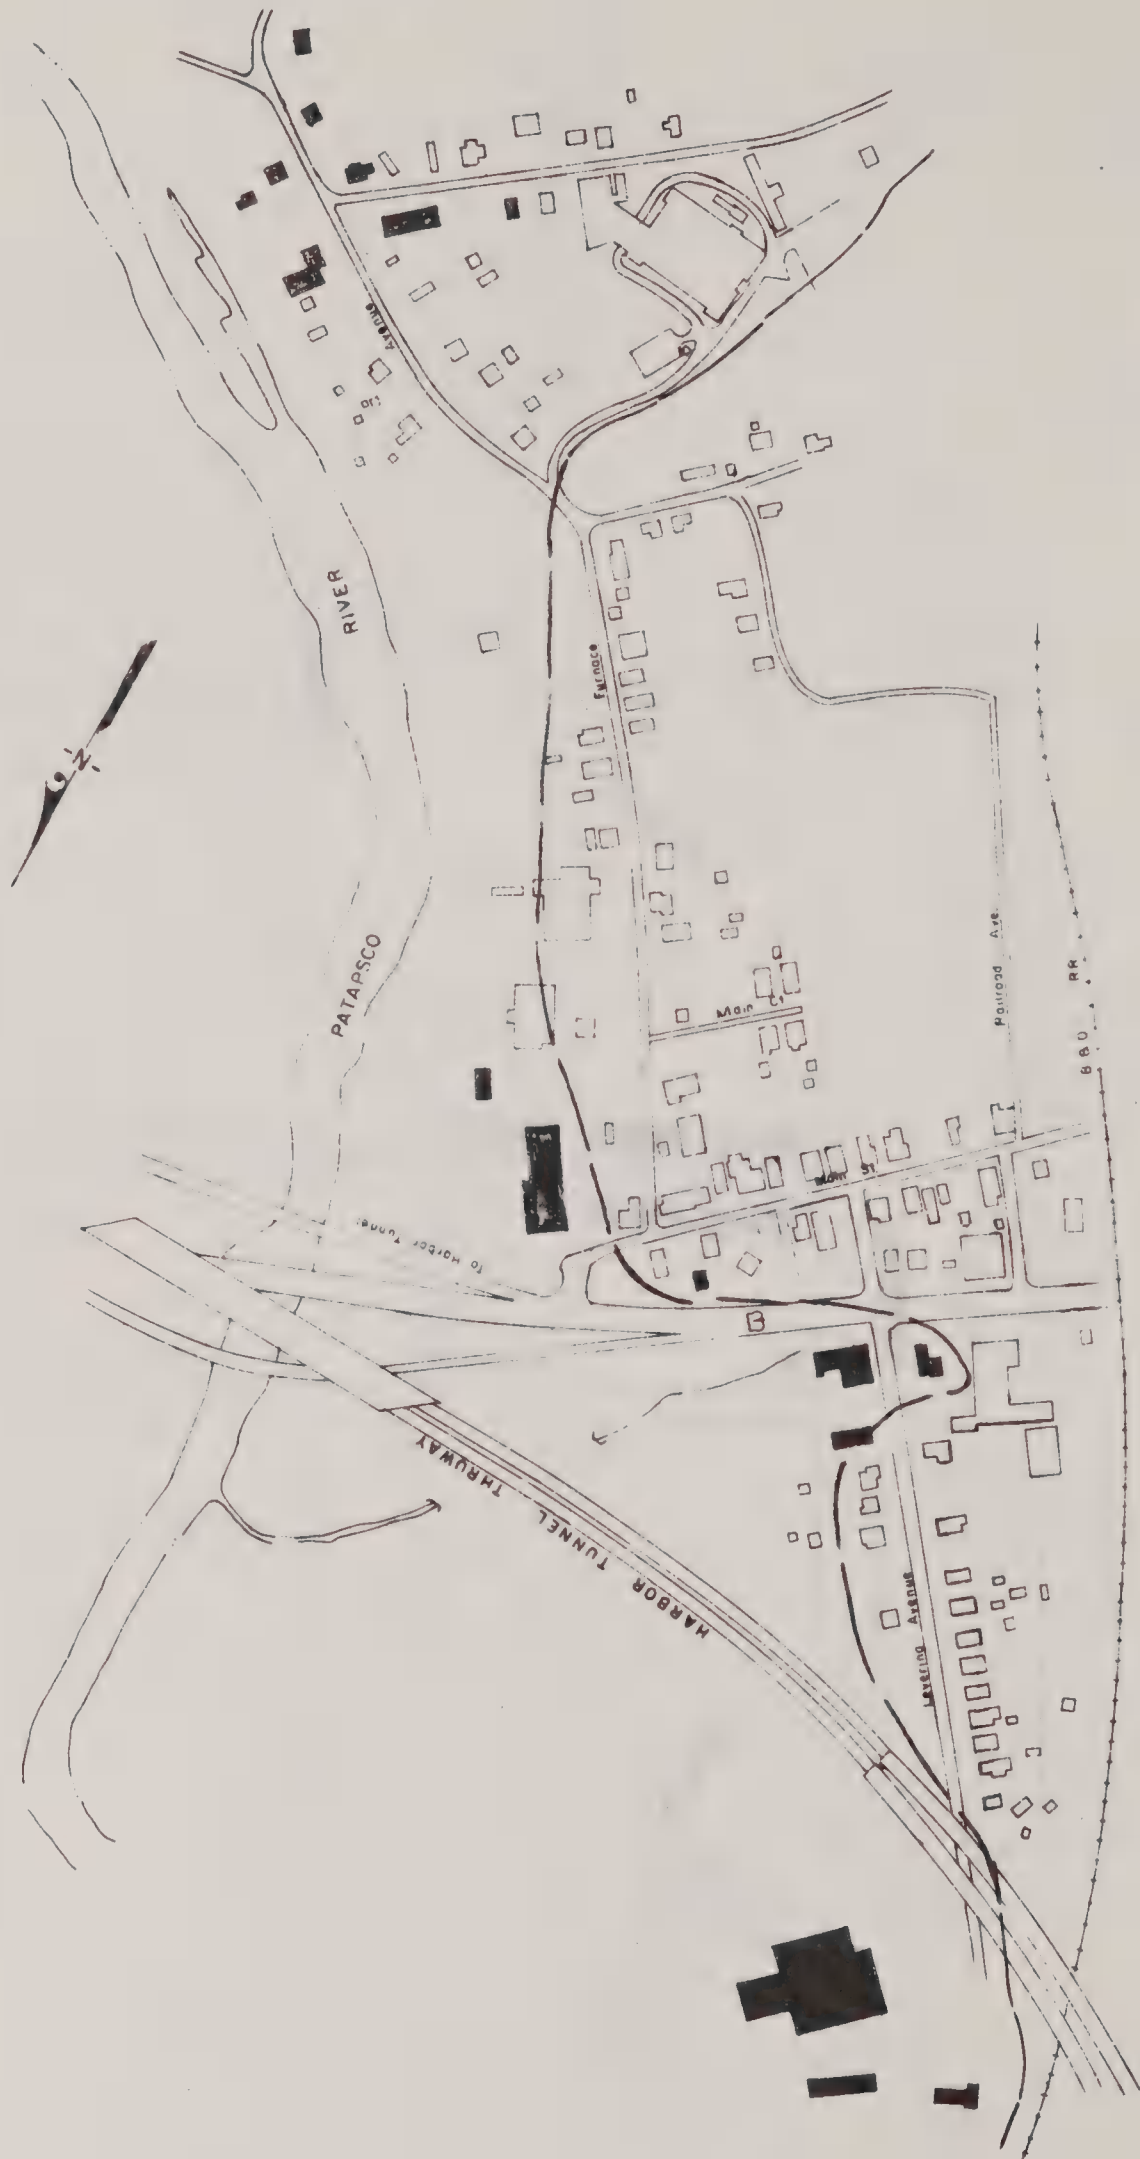
FIGURE 9
 Structures Flooded by "Agnes"
 Patapsco River
 PR-14 Elkridge

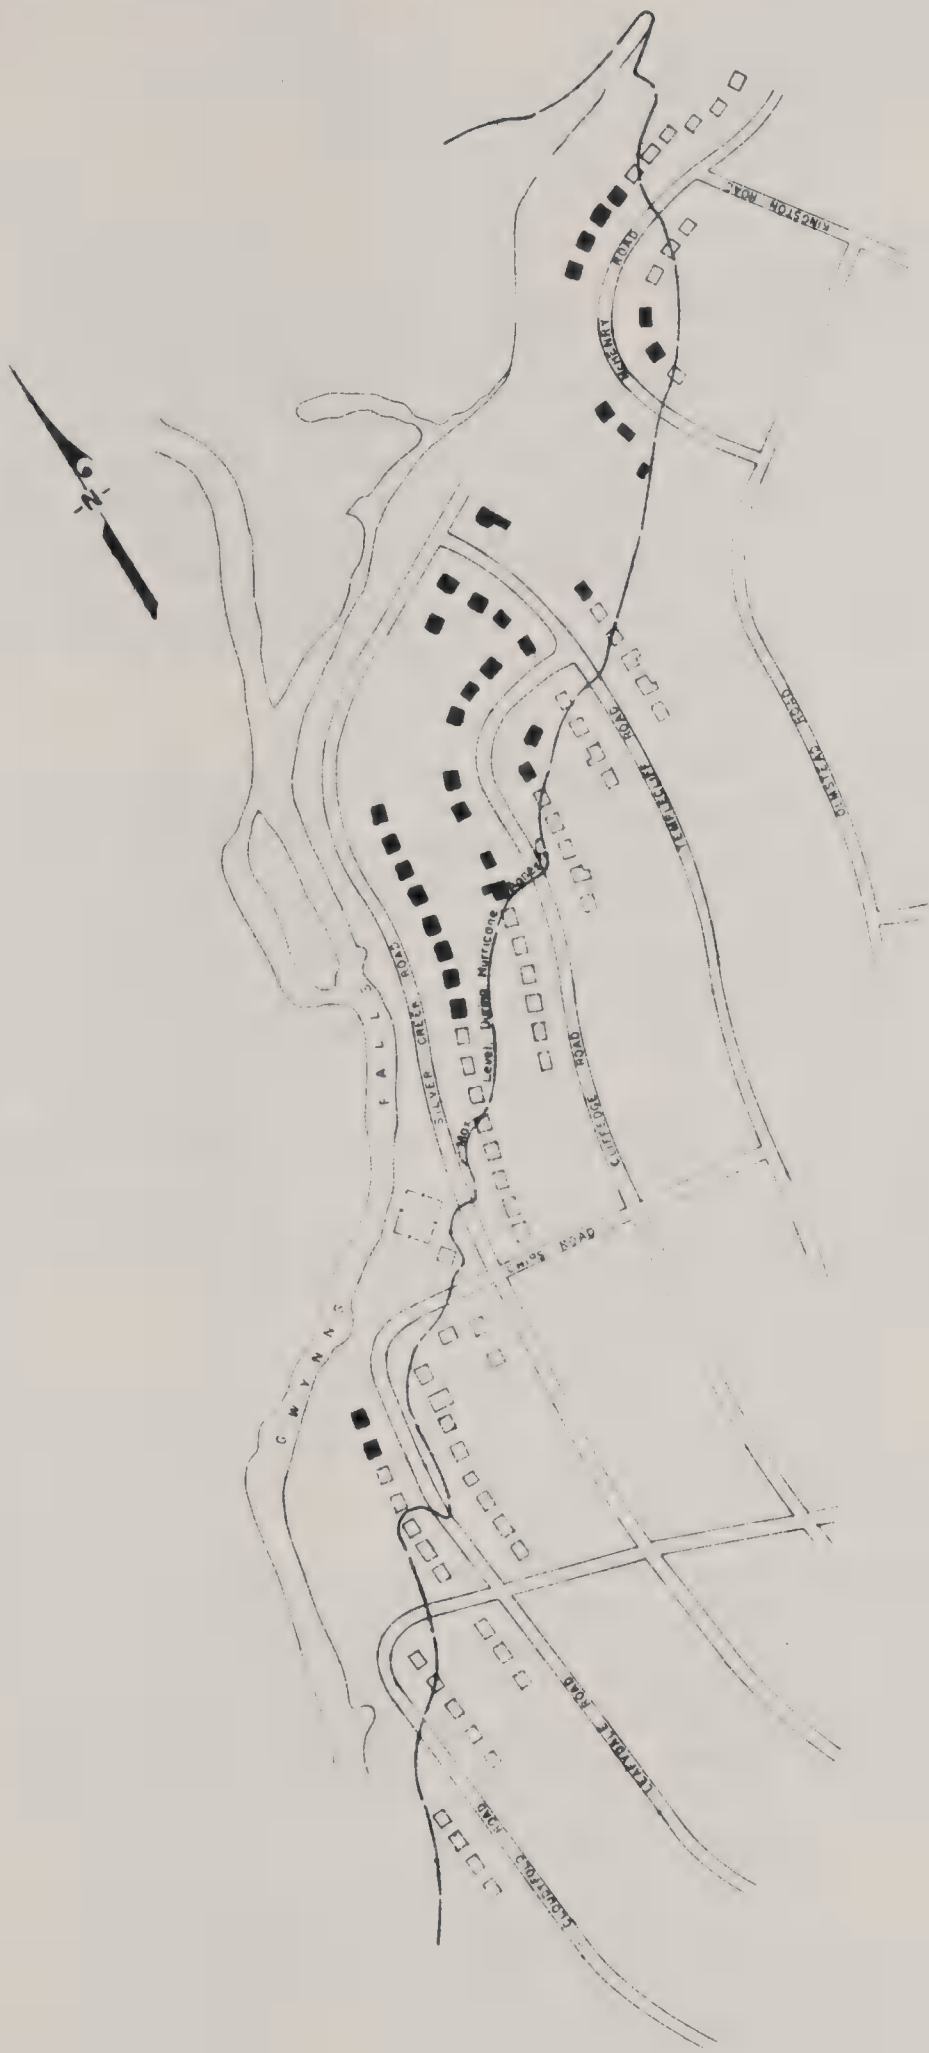
Note: Shaded structures are to be
 acquired as part of Baltimore
 County's acquisition program

FIGURE 12
 Structures Flooded by "Agnes"
 Gwynns Falls
 GF-12 Silver creek Park
