DIAGNOSTIC OF THE FACTORS REDUCING THE STORAGE CAPACITY OF THE TOUKOMTORE DAM IN BURKINA FASO

The Toukomtore dam in Burkina Faso was built as a road embankment to meet the water needs of the populations of the commune of Koubri. The dam's watershed is not immune to the various climatic and anthropogenic pressures that have caused it to fill up. The objective of this study is to identify the sources of sediment supply to the dam. To do this, the study relies on documentary research, individual interviews with agents of the deconcentrated technical services of the State and users as well as field observations. The results of the study reveal that the sediments in the dam basin come from intense gully areas, bare areas, bank erosion, market gardening plots and local drains, but also from aggregate extraction sites and brick factories. The results also show that the basin of the dam has lost its initial capacity of reception due to the phenomenon of filling. These results provide indicative elements on the potential origin of the sediments of the dam and are useful for the implementation of the recommendations that have been formulated.

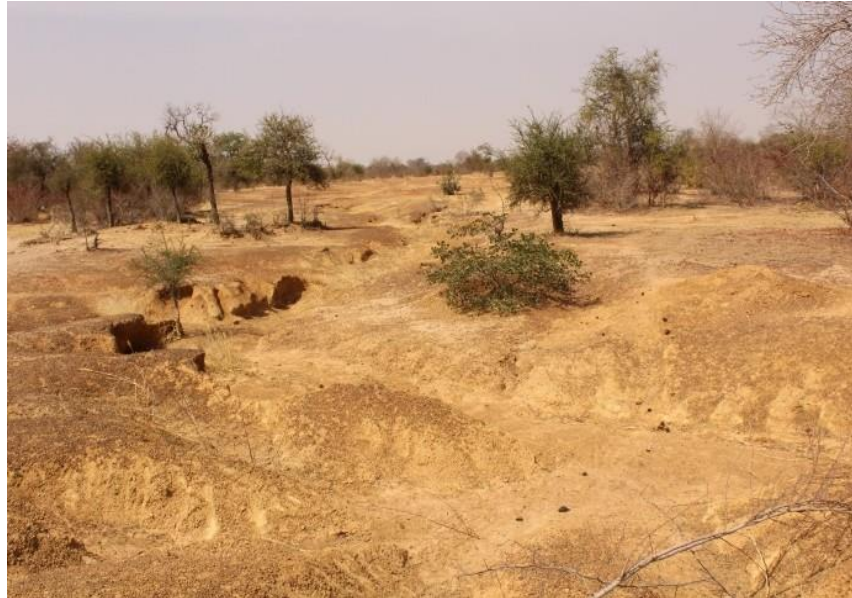
On the right bank of the Toukomtore reservoir watershed, there is a degraded zone (Photo 1). This area is called "Zipellé" in the Moore language. The vegetation is almost absent and the soils are compacted, which favors intense runoff, giving rise to numerous gullies.

Photo 1: Heavily degraded area with gullies

Action 2: Treat the bare or "zipped" areas above the reservoir by creating half-moons for sorghum cultivation. To do this, it is necessary to train producers on how to make half-moons.

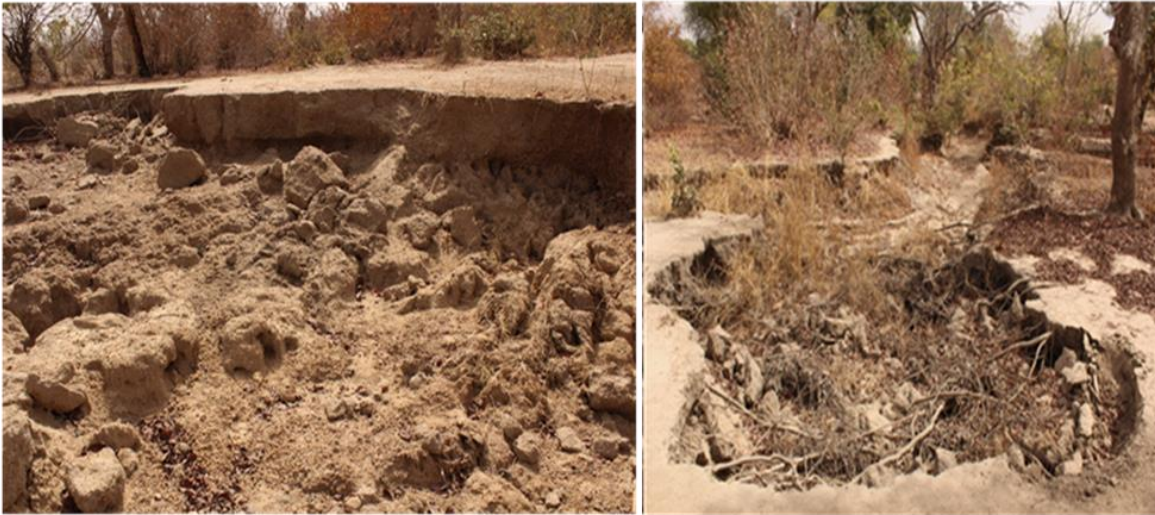
This area located above the water body is characterized by the presence of numerous gullies that expand from year to year (Photo 2). In the rainy season, the water currents are very strong, encroaching on fields, tracks and roads. At the beginning of erosion, the gully is simply traced, but gradually it deepens and the soil becomes a real relief. These gully areas are the major sources of sediment supply to the reservoir water basin.

Photo 2: Gully area above the reservoir

Action 3: Treat the gullies located above the reservoir

When small or medium-sized gullies with restricted drainage areas are present, it is often possible to stabilize them by planting woody species across the water flow line, at a distance of 10 to 15 cm and in shallow trenches, and by protecting them with rows of stakes that are placed downstream at about 30 cm above the shrubs so that they can benefit from the retained soil. These shrub barriers, by slowing down erosion, allow the soil to pile up, which gives the spontaneous vegetation a chance to settle and take root in the soil. In order to be effective, these

Catchment reservoirs can be constructed in a large ravine or dry stream bed to control erosion and flooding and to provide a water supply for livestock and wildlife. Filtering dikes can be made from free stones (not masoned and therefore without binders). The objective is to slow down the flood waves and stop the erosion by gulying in the immediate surroundings of the dike. These are anti-erosive structures positioned perpendicularly to the gully axes, more or less anchored in the ground, and equipped or not with a weir.

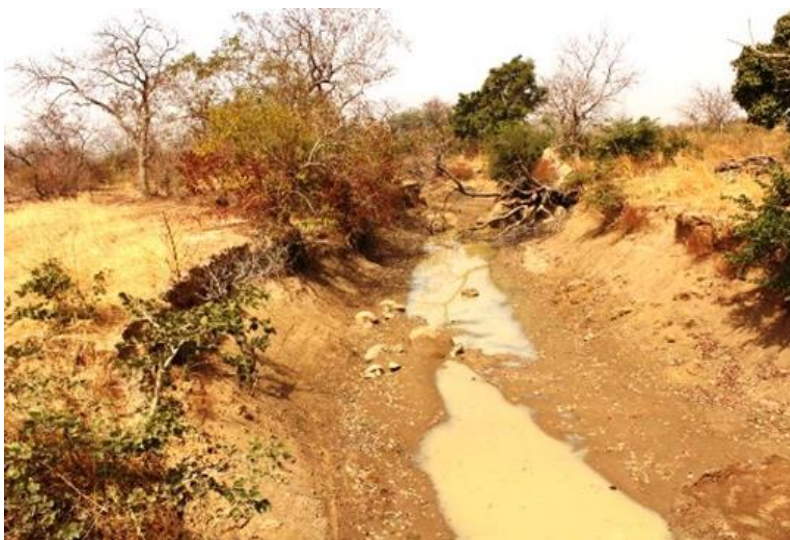
The phenomenon of bank erosion along the main stream (Photo 3) has been observed. The disappearance of the vegetation covers due to the cutting of wood and clearing of land for agricultural purposes, and the trampling of animals would explain this phenomenon.

Photo 3: Eroded main stream branch

Action 4: Revegetate banks without vegetation

- ✓ Protection of the stream banks by respecting a 50 m easement strip along the stream
- ✓ Revegetation of the stream bank.

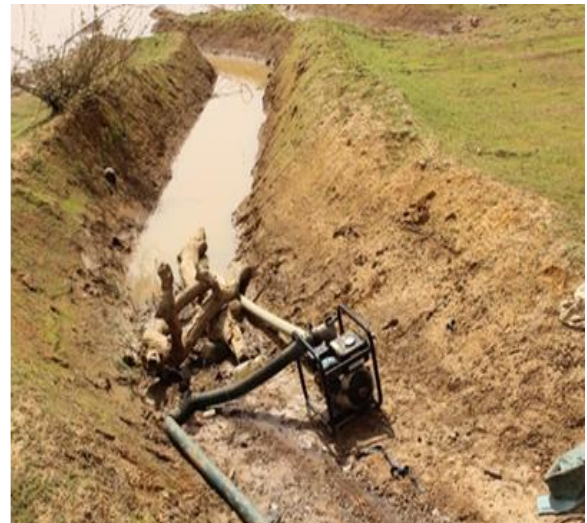
Around the water basin of the reservoir, particularly on the left bank, market gardening has developed (Photo 4) at the expense of the gallery forest. The soils loosened during the dry season constitute an important source of sediment that will be deposited in the reservoir basin during the first rains. Also, as the water in the basin recedes, farmers dig hand-dug trenches from the reservoir bed to the market garden plots in order to bring the water closer to the plot (Photo 5). These trenches dug into the riparian land are sources of sediment for the reservoir.

Photo 4: Market garden crops on the banks of the reservoir Photo 5: Water intake channel on the banks

Action 6: Develop a market gardening area for the population

To do this, it is necessary to build more suitable pipes (concrete) for market gardening activities.
