DIAGNOSTIC OF THE FACTORS REDUCING THE STORAGE CAPACITY OF THE TOUKOMTORE DAM IN BURKINA FASO

The Toukomtore dam in Burkina Faso was built as a road embankment to meet the water needs of the populations of the commune of Koubri. The dam's watershed is not immune to the various climatic and anthropogenic pressures that have caused it to fill up. The objective of this study is to identify the sources of sediment supply to the dam. To do this, the study relies on documentary research, individual interviews with agents of the deconcentrated technical services of the State and users as well as field observations. The results of the study reveal that the sediments in the dam basin come from intense gully areas, bare areas, bank erosion, market gardening plots and local drains, but also from aggregate extraction sites and brick factories. The results also show that the basin of the dam has lost its initial capacity of reception due to the phenomenon of filling. These results provide indicative elements on the potential origin of the sediments of the dam and are useful for the implementation of the recommendations that have been formulated.

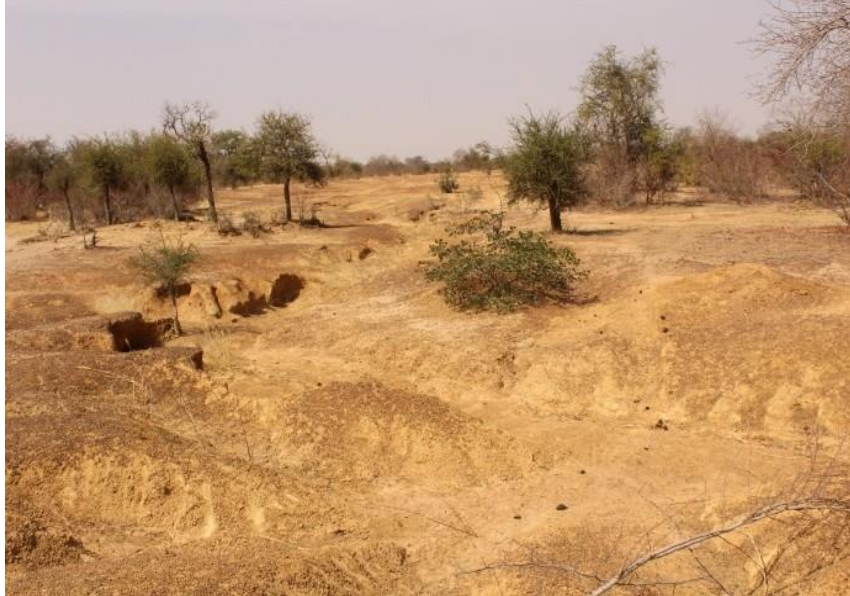
Photo 1: Heavily degraded area with gullies

Source 1: Bare areas or "Zipellé" above areas of intense gullyng

On the right bank of the Toukomtore reservoir watershed, there is a degraded zone (Photo 1). This area is called "Zipellé" in the Moore language. The vegetation is almost absent and the soils are compacted, which favors intense runoff, giving rise to numerous gullies.

Action 2: Treat the bare or "zipped" areas above the reservoir by creating half-moons for sorghum cultivation. To do this, it is necessary to train producers on how to make half-moons.

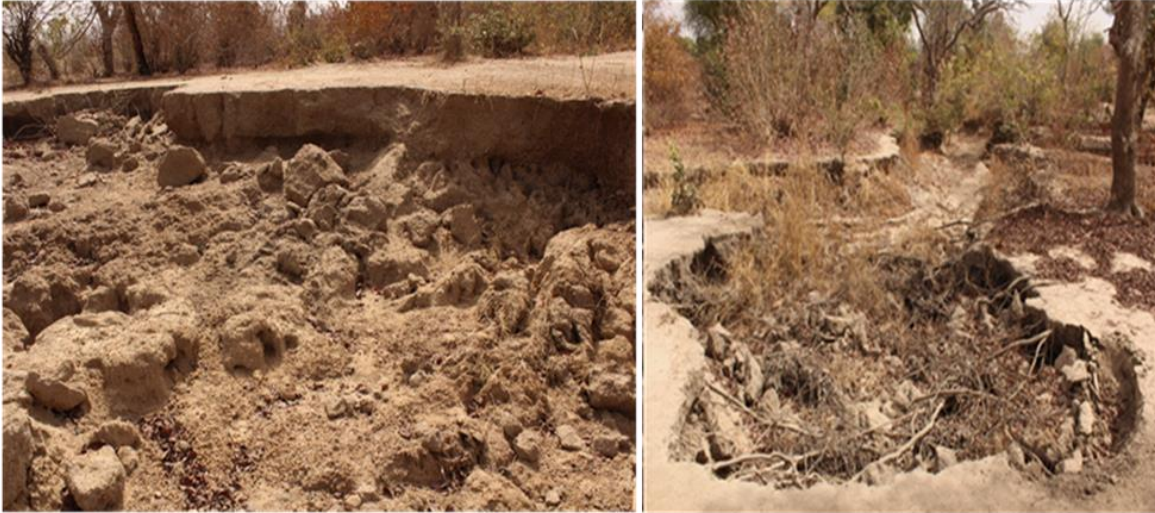
Photo 2: Gully area above the reservoir

Source 2: Areas of intense gullyng

This area located above the water body is characterized by the presence of numerous gullies that expand from year to year (Photo 2). In the rainy season, the water currents are very strong, encroaching on fields, tracks and roads. At the beginning of erosion, the gully is simply traced, but gradually it deepens and the soil becomes a real relief. These gully areas are the major sources of sediment supply to the reservoir water basin.

Action 3: Treat the gullies located above the reservoir

When small or medium-sized gullies with restricted drainage areas are present, it is often possible to stabilize them by planting woody species across the water flow line, at a distance of 10 to 15 cm and in shallow trenches, and by protecting them with rows of stakes that are placed downstream at about 30 cm above the shrubs so that they can benefit from the retained soil. These shrub barriers, by slowing down erosion, allow the soil to pile up, which gives the spontaneous vegetation a chance to settle and take root in the soil. In order to be effective, these

shrub barriers must be placed fairly close together. They should only be used in ravines that have a fairly gentle slope.

Catchment reservoirs can be constructed in a large ravine or dry stream bed to control erosion and flooding and to provide a water supply for livestock and wildlife. Filtering dikes can be made from free stones (not masoned and therefore without binders). The objective is to slow down the flood waves and stop the erosion by gulying in the immediate surroundings of the dike. These are anti-erosive structures positioned perpendicularly to the gully axes, more or less anchored in the ground, and equipped or not with a weir.

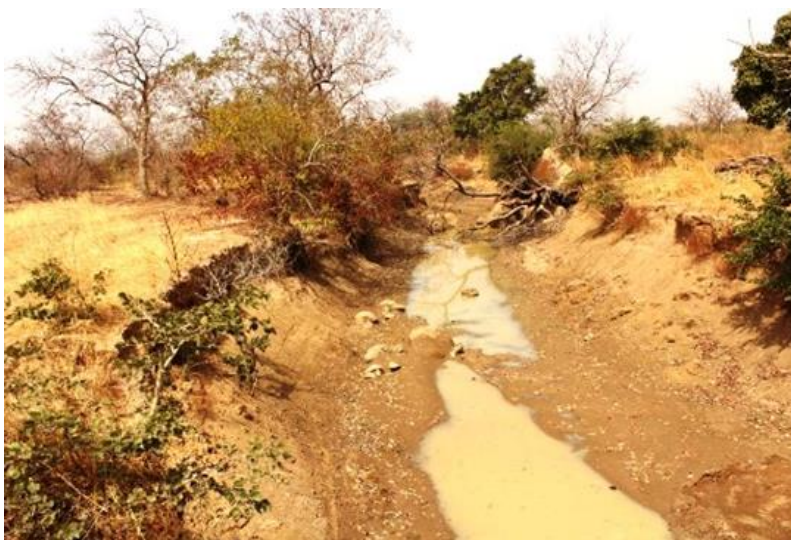
Source 3: Streambank erosion

The phenomenon of bank erosion along the main stream (Photo 3) has been observed. The disappearance of the vegetation covers due to the cutting of wood and clearing of land for agricultural purposes, and the trampling of animals would explain this phenomenon.

Photo 3: Eroded main stream branch

Action 4: Revegetate banks without vegetation

Two options have been retained:

- ✓ Protection of the stream banks by respecting a 50 m easement strip along the stream
- ✓ Revegetation of the stream bank.

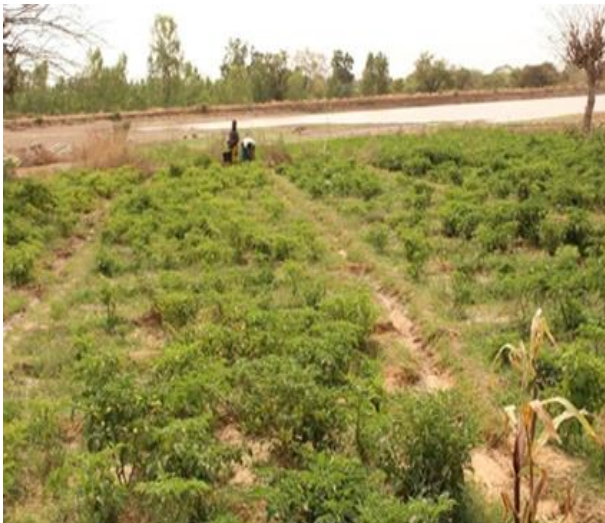
Around the water basin of the reservoir, particularly on the left bank, market gardening has developed (Photo 4) at the expense of the gallery forest. The soils loosened during the dry season constitute an important source of sediment that will be deposited in the reservoir basin during the first rains. Also, as the water in the basin recedes, farmers dig hand-dug trenches from the reservoir bed to the market garden plots in order to bring the water closer to the plot (Photo 5). These trenches dug into the riparian land are sources of sediment for the reservoir.

Photo 4: Market garden crops on the banks of the reservoir Photo 5: Water intake channel on the banks

Action 6: Develop a market gardening area for the population

To do this, it is necessary to build more suitable pipes (concrete) for market gardening activities.

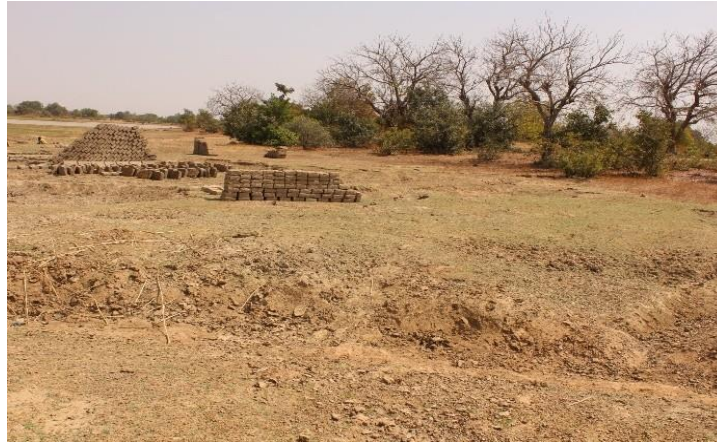
Photo 6: Brick-making site in the reservoir bed

Source 5: Brick making sites on the reservoir bed

The removal of banco and the making of bricks are activities observed in the field. Indeed, the high demand for bricks for house construction has allowed this income-generating activity to develop in the village (Photo 6). This activity contributes to loosening the soil and promoting the transport and deposition of sediments in the reservoir basin.

Action 7: Identify favorable sites for brick production

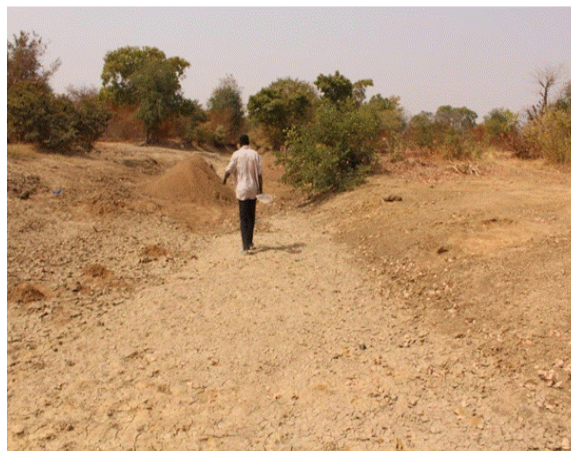
Photo 7: Sand collection in the main stream

Source 6: Sand collection sites on the river bed of the reservoir

With the expansion of the city of Ouagadougou located less than 50 km away, the demand for sand and gravel has become very important for the construction of buildings. As a result, the collection of sand from the main river and from the basin and its commercialization is an important source of income for the population. These aggregates are collected on the bed of the main river or on the banks. Dump trucks that are responsible for removing these aggregates create paths along the banks, loosening the soil and promoting water erosion and sediment deposition in the reservoir (Photo 7).

Action 8: Identify sites suitable for sand collection
