# **Social and Institutional Factors Influencing the Performance of Tank Irrigation System – A Study of Uthiramerur Tank in the Indian State of Tamil Nadu**

**Original Research Article**

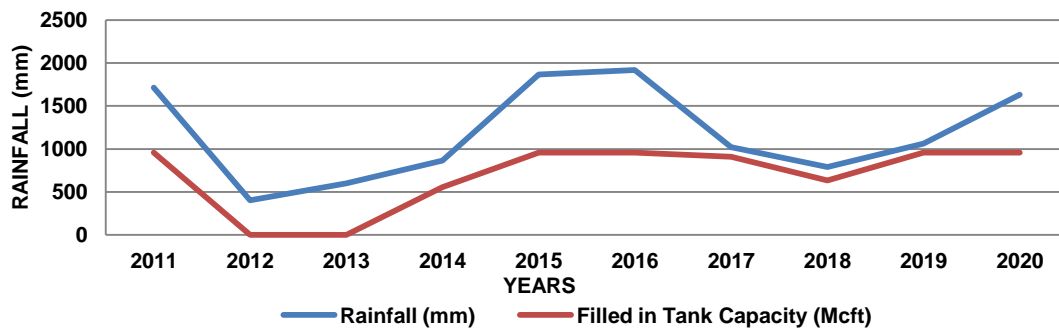
**Fig. 1. Relation between rainfall and filled in capacity of the tank**

S. No.	Period	Uthiramerur Tank			
		Rainfall (mm)	Actual Tank Capacity (Mcft) (ATC)	Filled in Tank Capacity (Mcft) (FTC)	Performance in Capacity Filled (%)
1.	2011	1712	958.8	958.8	100
2.	2012	404	958.8	0	0
3.	2013	600	958.8	0	0
4.	2014	864	958.8	556.1	57.99
5.	2015	1867	958.8	958.8	100
6.	2016	1920	958.8	958.8	100
7.	2017	1023	958.8	908.6	94.76
8.	2018	789	958.8	632.8	65.99
9.	2019	1064	958.8	958.8	100
10.	2020	1632	958.8	958.8	100

The relationship between the rainfall and Uthiramerur tank's capacity is presented below in the Table 2. It shows that whenever the rainfall was above 1000 mm, the tank was filled to its total capacity and conversely rainfall of below 1000 mm was not sufficient for the tank to meet its total capacity.
