BUILDING DECAY ASSOCIATED WITH RAIN SEEPAGE

# BUILDING DECAY

# RAIN SEEPAGE

**Technical Bulletin 1356**

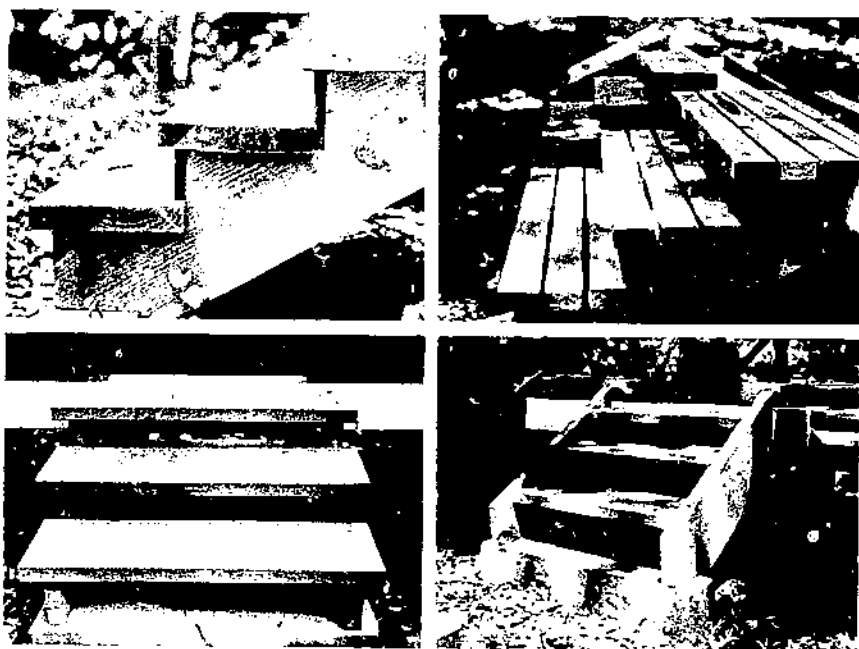
F. 510282-85

The implications are clear. In areas of high rainfall, exterior wooden steps should be made of all heartwood of highly decay-resistant species or of preservatively treated wood. In regions of low rainfall, such woods as Douglas-fir heartwood will give acceptable service, particularly if designs minimize seepage.

FIGURE 6. Different step designs included conventional carriages with and without risers, solid and split treads, and cleated carriages.

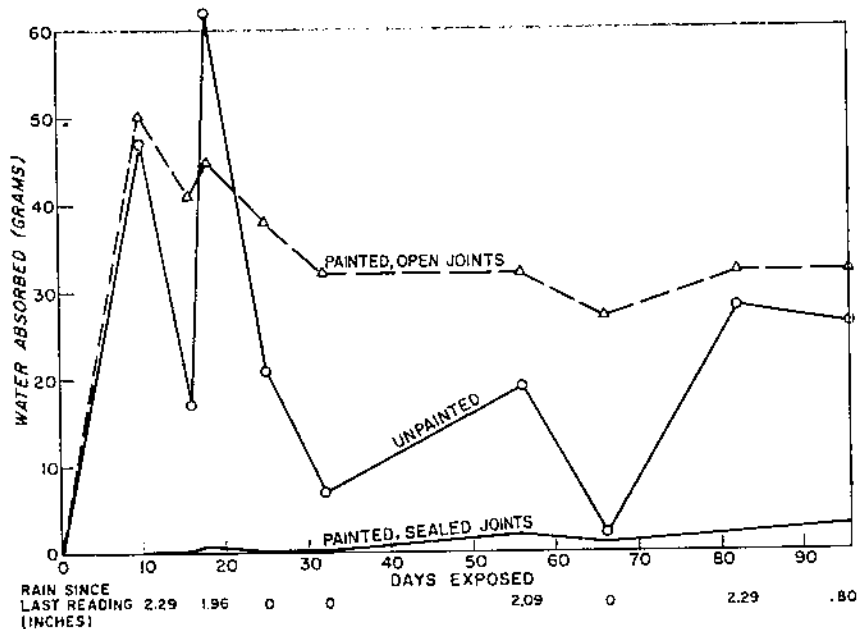
During 3 months' exposure (fig. 11) the units with sealed joints absorbed very little water. The unpainted units absorbed considerable water during rains but lost it during dry weather. The painted units with open joints

FIGURE 11.—Rain seepage into joints of step rails abutted to newels, expressed as water absorbed in excess of air-dry weight.

absorbed less water but retained so much between rains that they usually had a higher moisture content than the unpainted units.

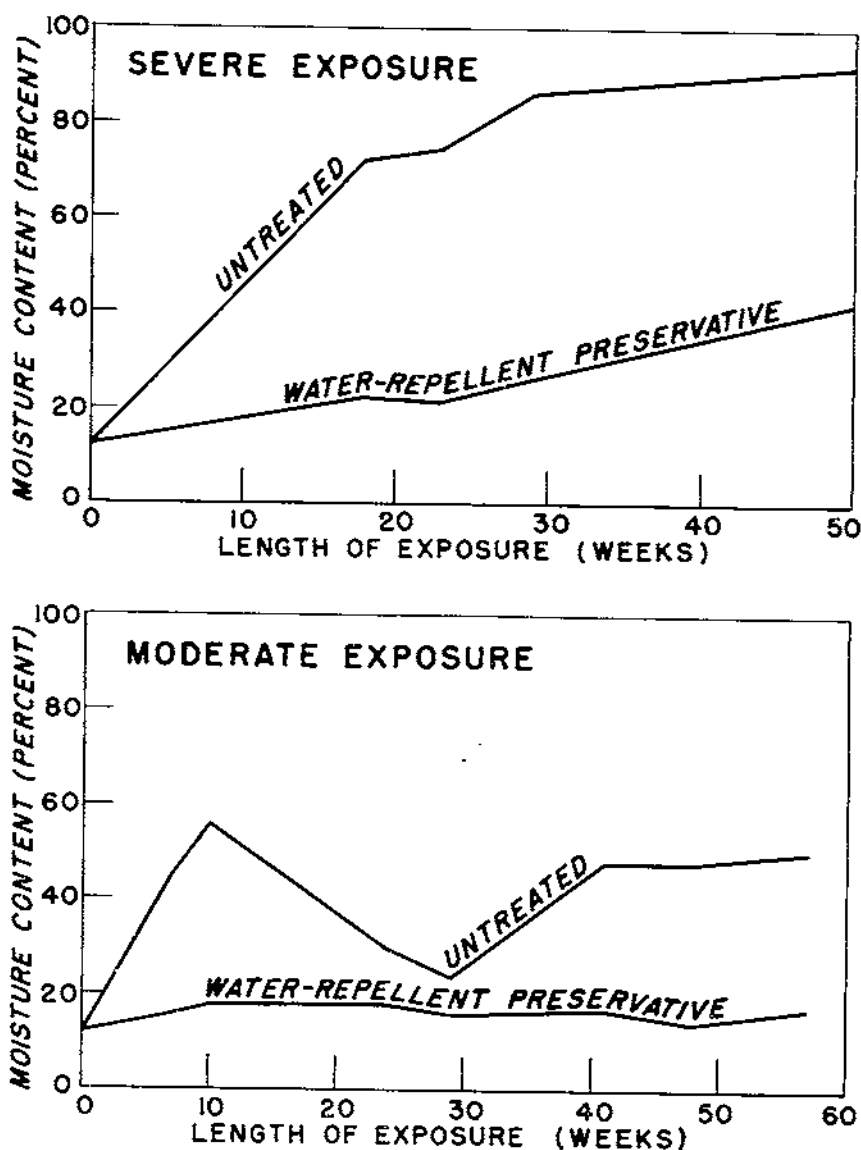
Except for the step study, few data were secured on the effect of a water repellent on wood exposed to moderate to high hazards. Weights were taken on simulated boxes and boards of southern pine; some data were previously presented (28). Moisture uptake in treated boxes closely piled to restrict drying between showers (fig. 12) gradually rose to about 40 percent by the end of the first year (fig. 13). This is too high for building lumber. When boards were stacked so as to dry between showers, the water repellent kept the moisture content below 20 percent (fig. 13).

FIGURE 13.—Wetting of pine wood—untreated and that given a 3-minute dip in a water-repellent preservative. *Top*, under severe exposure. Simulated boxes are closely piled to restrict drying between showers (fig. 12 bottom). *Bottom*, under moderate exposure. Boards are stacked on edge to permit full exposure to rains, but considerable drying between rains (fig. 12 top).

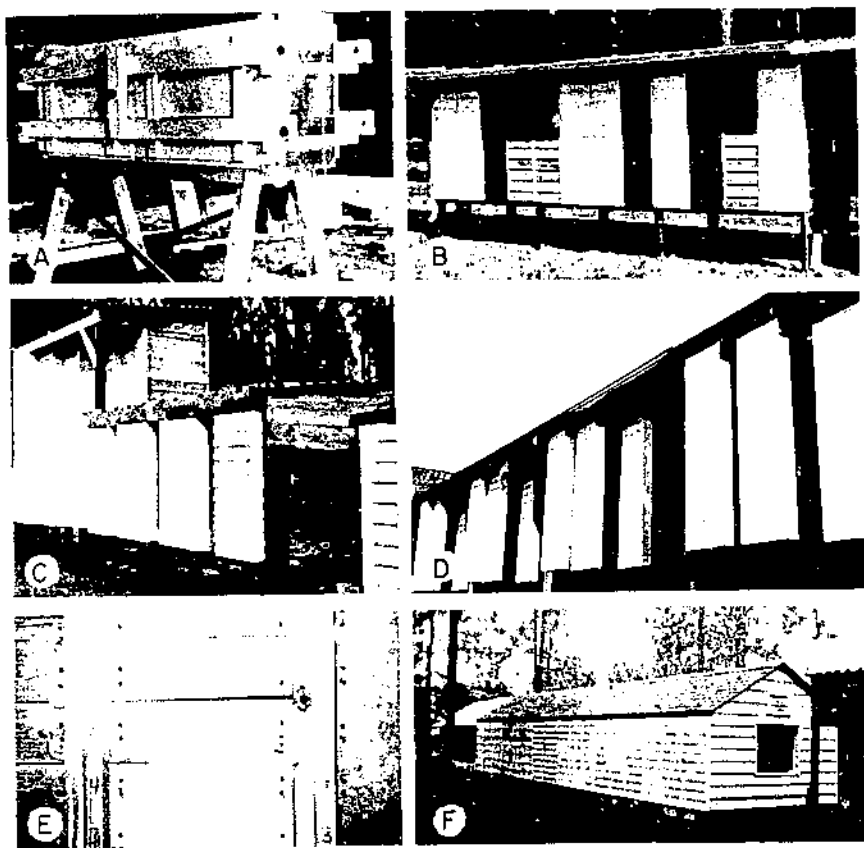
F 510286 86, 512502, 510289 90

FIG. 16.—Some of the study exposures: *A*, Siding applied to box simulates wall construction; the panels are held in place with 2 by 1's; *B*, painted and unpainted siding under a 12-inch roof overhang; *C*, various roof overhangs and corner designs; *D*, roof overhang and eaves; *E*, electrodes inserted through sheathing from back; *F*, building, with test-panel side.

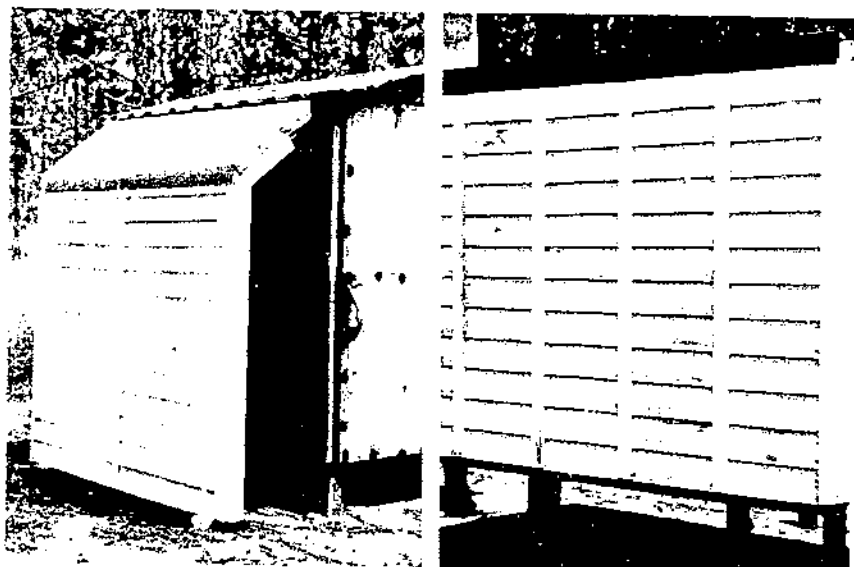
F-510291-92

FIGURE 15. Other study units: *Left*, Preliminary tests on end treatments; *right*, typical panel for studying water-repellent treatments.

*Study 2.*—Bevel siding (untreated, with a 3-minute dip in 5-percent pentachlorophenol alone or with a water repellent, and with ends given a heavy coat of white-lead paint) was exposed to rainwetting (fig. 15). During 3 years of exposure the water repellent was effective in preventing wetting; the end paint reduced wetting somewhat; and the preservative without a water repellent had practically no effect (table 5).

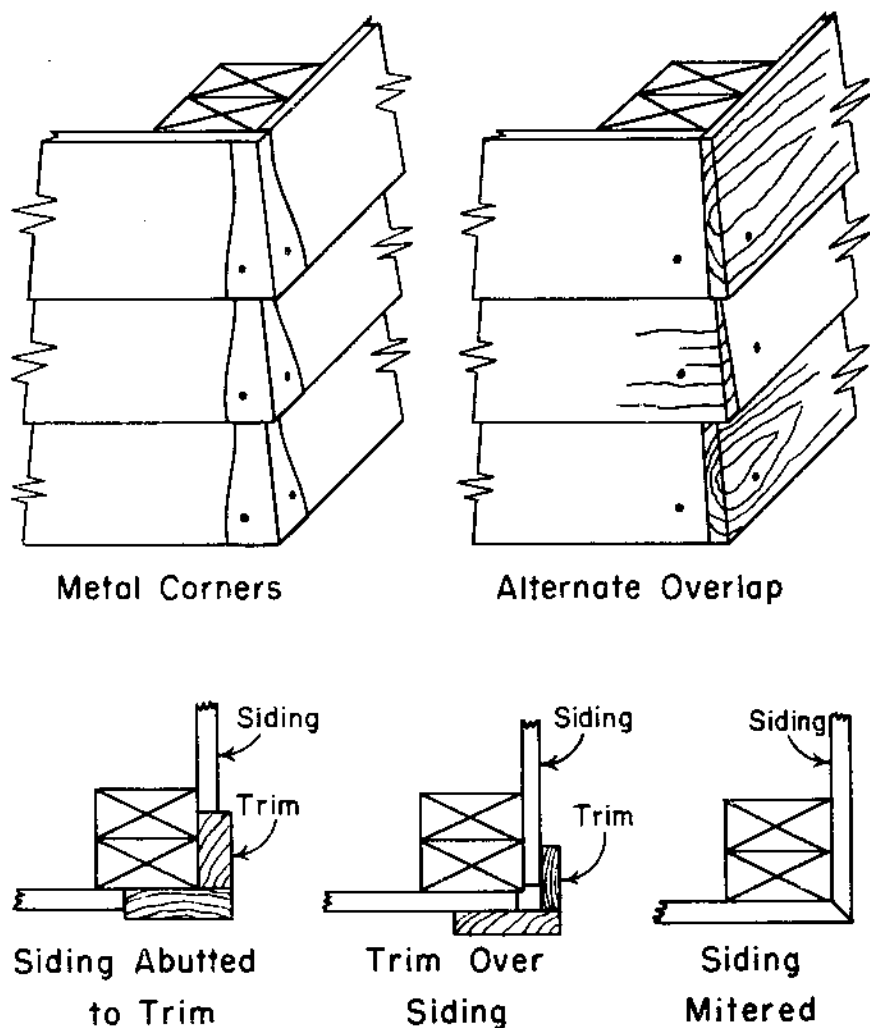
FIGURE 16.—Types of corner designs studied.

*Study 3.*—Two tests were made with panels of painted bevel siding applied with different corners. In test 1 (fig. 16) the corner designs were alternate overlap, mitered, siding abutted to the trim, and trim laid over the siding end. In the second test the trim over the siding ends was replaced with metal corners (fig. 16).

Only the metal corners gave practical control of seepage (table 6). Ordinarily, trim is not placed over the ends of bevel siding, probably because trim merely touches the bottom drip edge of each siding piece and thus permits easy entry of rainwater. As shown later, this trim placement is satisfactory with drop siding. The effectiveness of the metal corners suggests that rainwetting under the conditions of this study was mainly at the end joints of bevel siding and not by capillary movement over the lap joint, as occurs under some conditions (see section "Physics of Water Entry").

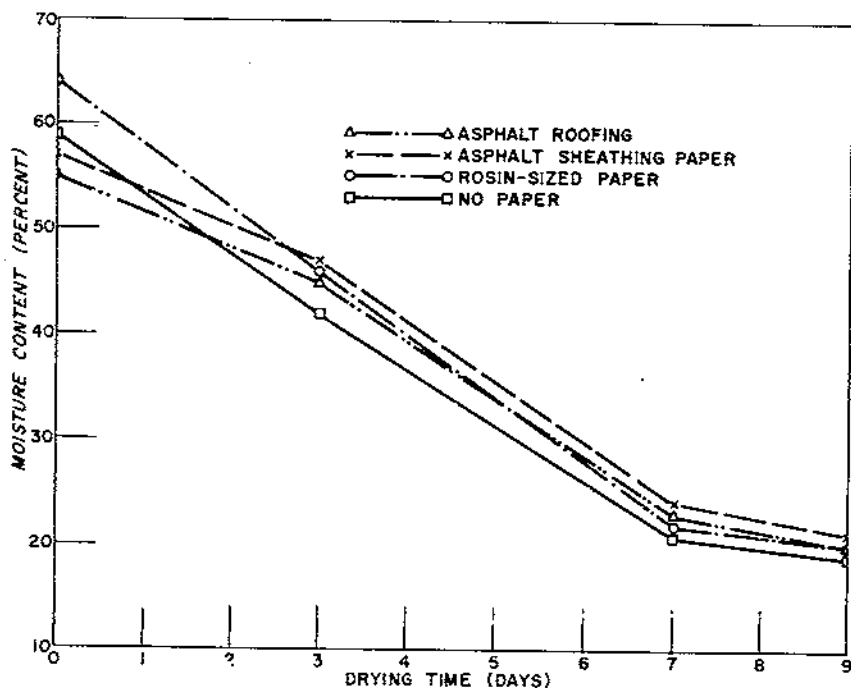
The wet siding dried rapidly when unpainted, and the type of paper had essentially no effect on the rate (fig. 17).

FIGURE 17.—Drying rate of wet unpainted siding over different sheathing papers without rigid sheathing.

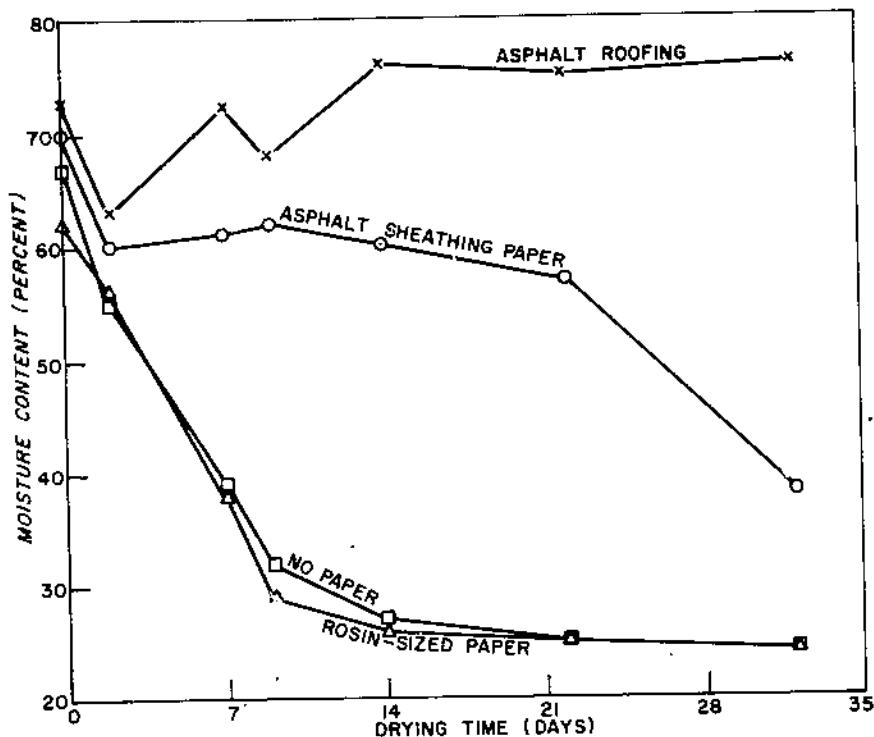
After painting, the wet panels without paper and over the rosin-sized paper dried fairly fast, and the panel over the asphalt sheathing paper dried considerably more slowly. The panel over the vapor barrier did not dry (fig. 18); the increase in moisture after a slight initial drop represents not an increase in total water but merely a rearrangement within the wood.

This study clearly showed that siding with the usual oil paint film, when wetted by rain seepage, dries mainly to the inside, and that the type of sheathing paper can radically affect the rate of inward migration of water vapor.

FIGURE 18.—Drying rate of wet painted siding over different sheathing papers without rigid sheathing.

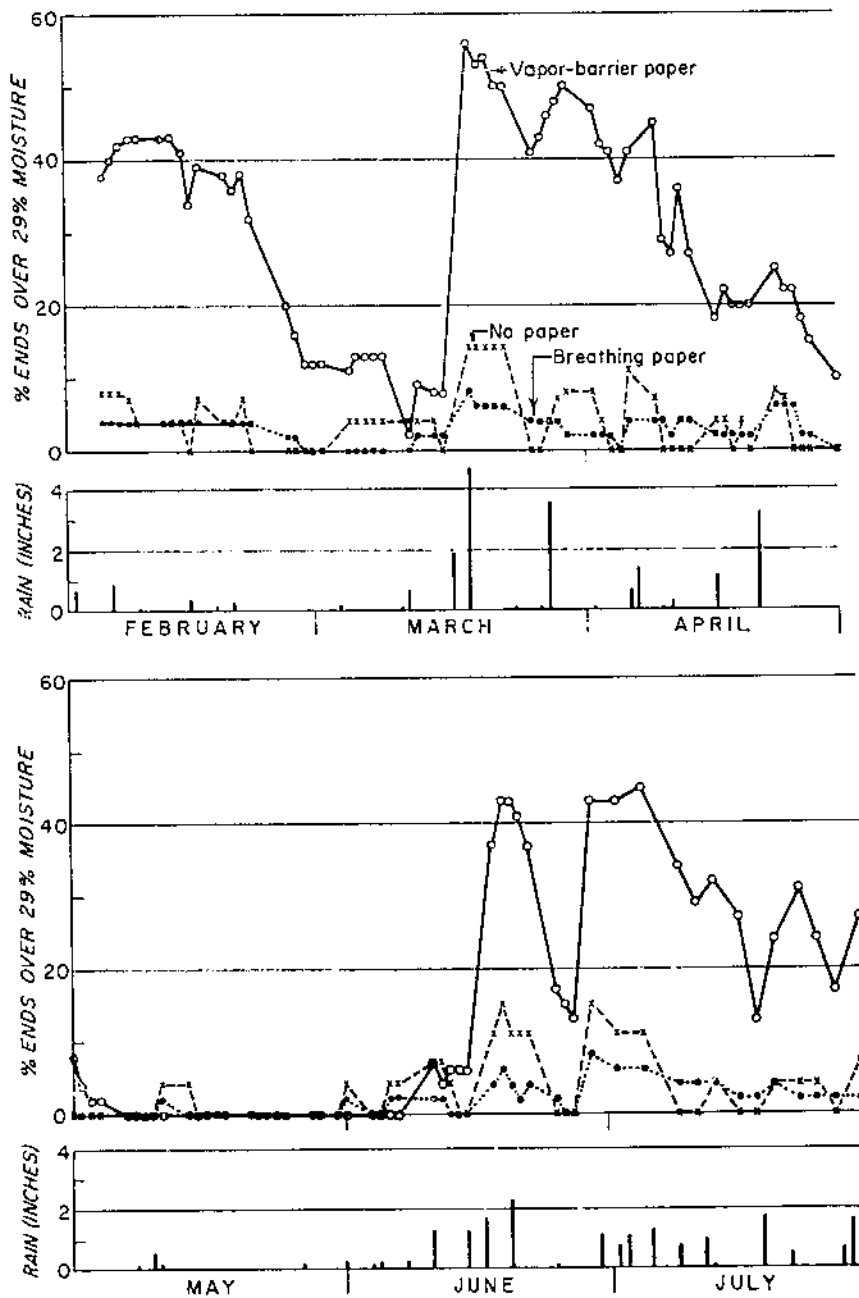
The effect of the breathing paper on moisture accumulations is illustrated in figure 19, which shows all readings taken during a 6-month period of the third year, when rainfall was slightly above normal.

FIGURE 19.—Effect of vapor barrier and breathing papers on the moisture content of pine drop siding. Average readings during the third year after construction.

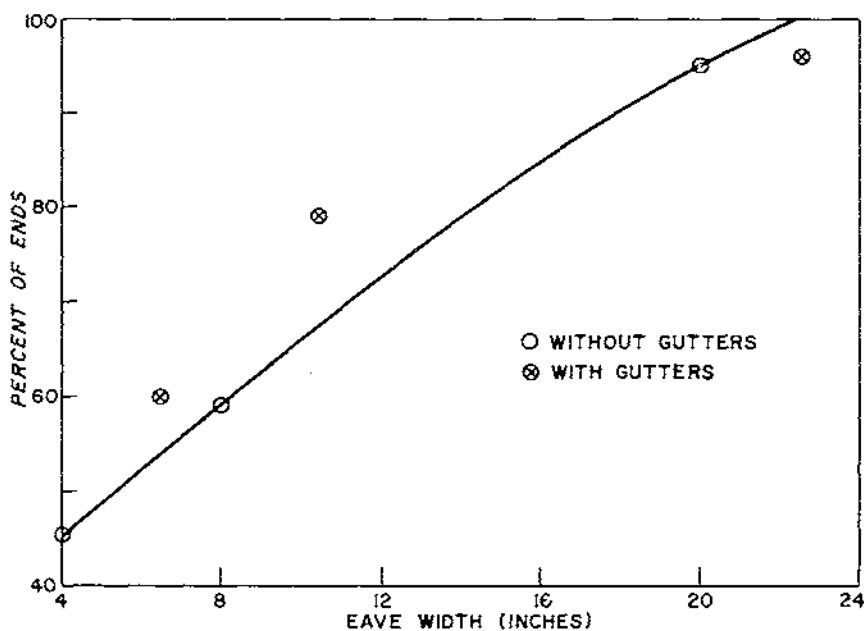
FIGURE 21.—Effect of gutters on rainwetting, as determined by proportion of siding ends with less than 20 percent moisture content. The curve is drawn through the points for panels without gutters.

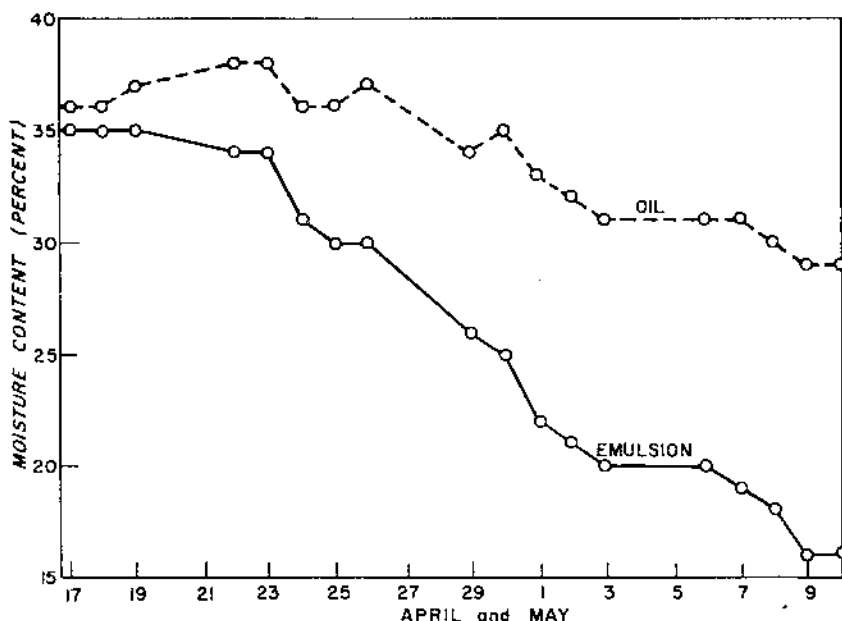
FIGURE 23.—Rate of drying of drop siding painted with oil-base and emulsion paint after artificial wetting.

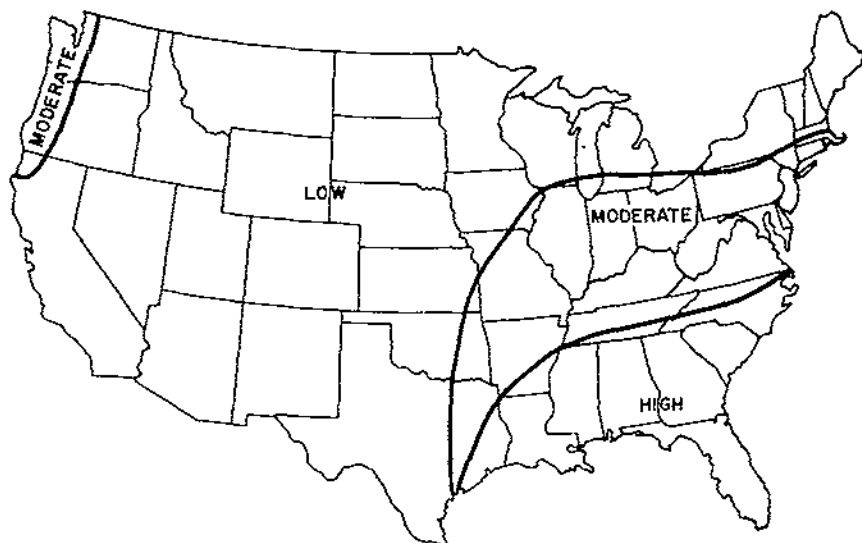
The hazard from rain seepage varies from practically none in desert areas to very high along the gulf coast. For practical purposes, however, the United States can be divided into three hazard zones (fig. 27) based on observed conditions of buildings, length of the warm season, and amount of precipitation as rain. Melting snow on roofs increases seepage only slightly.

In the high-hazard zone extreme care is needed in designing buildings to prevent seepage. As will be pointed out, some relaxation in design is possible in the moderate zone; in the low-hazard area seepage is generally minor, and damage can be prevented by simple means.

FIGURE 27.—Hazard zones for rain seepage.
