USDA TECHNICAL BULLETINS
FLOW OF WATER IN DRAINAGE CHANNELS

UNITED STATES DEPARTMENT OF AGRICULTURE
WASHINGTON, D. C.FLOW OF WATER IN DRAINAGE CHANNELS¹THE RESULTS OF EXPERIMENTS TO DETERMINE THE ROUGHNESS COEFFICIENT n IN KUTTER'S FORMULABy C. E. RAMSER, *Drainage Engineer, Division of Agricultural Engineering, Bureau of Public Roads*

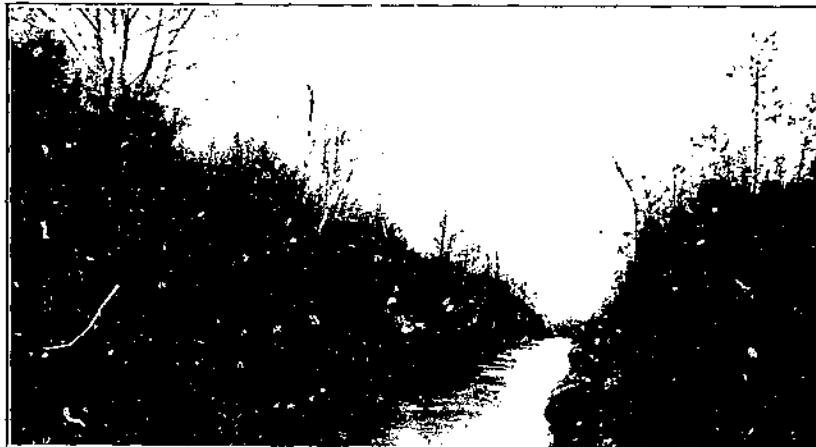
A, Old Town Creek dredged channel near Tupelo, Miss., looking up slope course, before clearing, 1913; B, Same view as A above after clearing, 1914; C, Mud Creek dredged channel near Tupelo, Miss., looking up slope course, 1913. (See Table I)

An experiment for determining the effect upon the flow in the channel, due to the clearing of brush and other resistances to flow, was conducted on Old Town Creek. No clearing was done for the measurements during 1913. One side slope of the channel and part of the bottom were practically covered with small saplings, brush, and cane, and were quite irregular. The other side slope was comparatively smooth and uniform. For the measurements during 1914 all brush, logs, and other obstructions were cleared from the course of the channel and for 500 feet above the upper end and for the same distance below the lower end of the slope course, so that a comparison could be made as to the relative values of n before and after clearing. The slope of the left bank was quite regular while that of the right bank was extremely irregular, a condition due to the growth of brush causing the bank to erode unevenly. The soil in the bottom and sides of the ditch was quite hard. The views shown in Plate 1 give a good idea of the conditions existing in the channel before and after clearing. (See also fig. 1, A, for average cross section of the channel.)

A good idea of the condition and regularity of the channel can be obtained from Plate 1, C. Although in the same valley, the soil is decidedly different from that found in Old Town Creek. This part of the bottom land is made up of sediment carried from the eastern part of the Mud Creek watershed, where the soil contains considerable sand. The soil in the channel is a sandy, waxlike clay that erodes very easily. This was a comparatively new channel at the time of these experiments, the ditch having been finished in January, 1913; and, although it had eroded to some extent, it had retained its original uniform slope and comparatively uniform cross-sectional area. (Figs. 1, B and 2, B.)

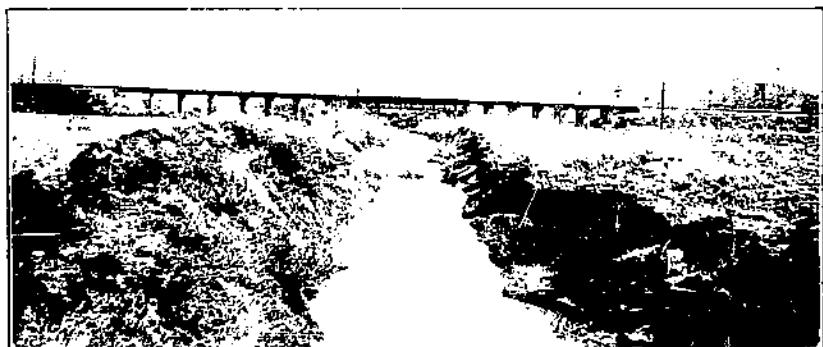
A, Twenty Mile Creek dredged channel near Baldwyn, Miss., looking down slope course, 1913; B, Chawippah Creek dredged channel near Shannon, Miss., looking up slope course, 1913; C, Coonewah Creek dredged channel near Shannon, Miss., looking down slope course, 1913. (See Table 1.)

42	Apr. 4, 1913	10.6	36.7	850.0	286.2	2.97	5.05	0.000620	48.0	0.043	Course, straight; 450 feet long. Cross section, rather gradual variations in shape; for variations in size, see fig. 2, E. Side slopes, very irregular. Bottom, irregular and uneven. Soil, clay loam. Condition, some grass and other vegetation on side slopes; bottom free from growth. Constructed, May, 1909. (Pl. 2, C and fig. 1, E.)		
		12.0

The slope course on Twenty Mile Creek was rather short, being 324 feet in length, and was located below the highway bridge 1 mile east of Baldwyn, Miss. (Pl. 2, A, and figs. 1, C and 2, C.) The lower part of the channel was quite smooth and regular, but the upper part and edge of bank were irregular. The channel is eroding rapidly, and many stumps along the banks have been undermined and fallen into the channel. Table 1 shows the hydraulic elements and the values of n obtained for Twenty Mile Creek. The value of n increases as the stage increases, due no doubt to the irregularities in the wetted perimeter for the higher stages. The soil in the channel is a waxy clay loam, and in some parts of the channel contains considerable sand.

Slope measurements for Chawappah Creek were made on a rather short course (320 feet long) between the highway and railroad bridges, one-half mile south of Shannon, Miss. The gaging section was located at the highway bridge. The view of Chawappah Creek for low water (pl. 2, B), shows very well the condition of the channel. The soil varies from a sandy loam to a waxy clay, and the sides and bottom were quite hard. The channel is eroding very rapidly, which is partly the cause of the turbulent water surface and the resulting comparatively high values of n . The average value obtained for n was about 0.035. (Figs. 1, D and 2, D.)

Only one observation for slope was made on Coonewah Creek. The value computed for n was 0.043. Plate 2, C, shows the course on which the slope was measured and the condition of the channel. The soil is quite similar to that found on Chawappah Creek, but erosion has not been as active as on the latter. (Figs. 1, E and 2, E.)

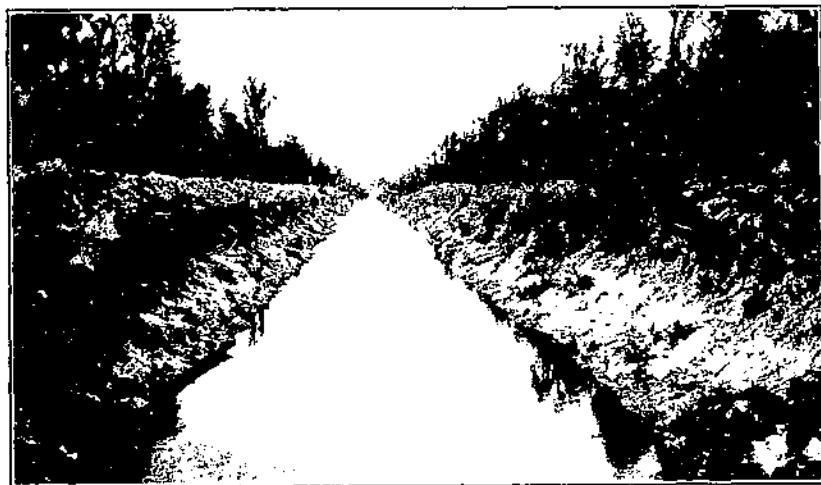
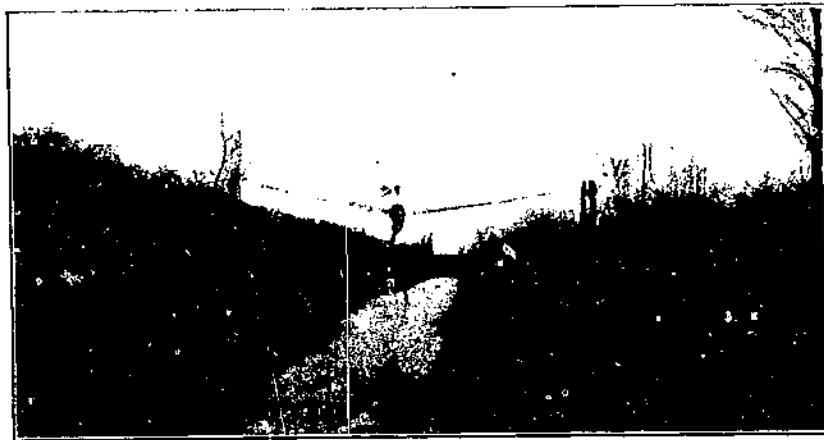
A, Bogue Phalia dredged channel near Helm, Miss., looking up slope course, 1915; B, Bogue Phalia natural channel near Heads, Miss., looking up slope course, March, 1926; C, Pecan Bayou dredged channel near Shuw, Miss., looking up slope course, 1915. (See Table 2)

The condition of the channel in March, 1926, is shown in Plate 4, B. It is believed that there was less vegetation at high stages on the right bank (left side of view) when the first measurements were made, in 1924. The left-side slope was quite clean, smooth, and regular and the right-side slope was irregular, subject to caving, and partly covered with vegetation, conditions very similar to those existing in 1915. (See fig. 3, D for average cross section.) There was somewhat more variation in cross section than in 1915. (Fig. 4, D.)

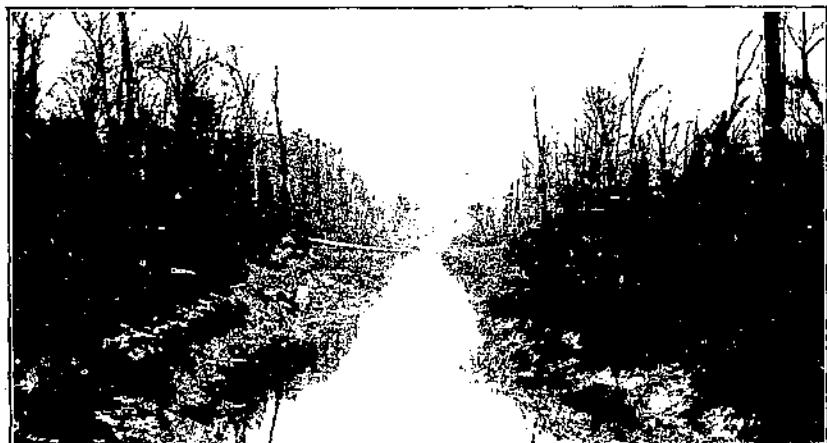
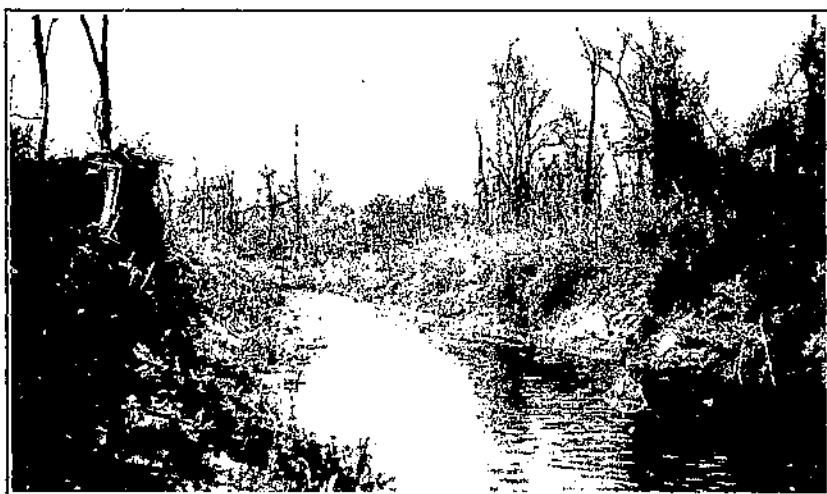
A, Bogue Hasty dredged channel near Shaw, Miss., looking up slope course, 1915; B, same location as A above, looking up slope course, March, 1929; C, East Bogue Hasty dredged channel near Shaw, Miss., looking up slope course, 1915. (See Table 2)

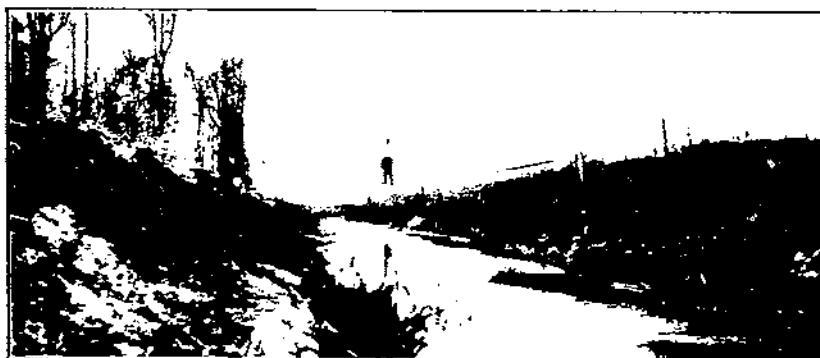
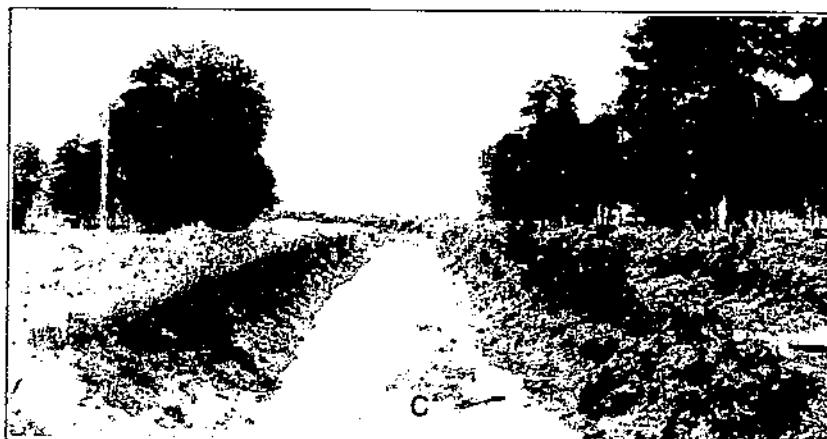
A, West Bogne Hasty dredged channel near Shaw, Miss., looking up slope course, 1915; B, same location as A above, looking up slope course, August, 1921; C, Horseshoe Bayou dredged channel near Cleveland, Miss., looking down slope course, May, 1921. (See Table 2)

A straight slope course of 1,020 feet was used on this channel. Accurate discharge measurements were obtained from a specially constructed suspension foot bridge. Conditions for measurements on this channel were very good. The bottom of the channel was rather rough and irregular, and there were two small sand bars where water

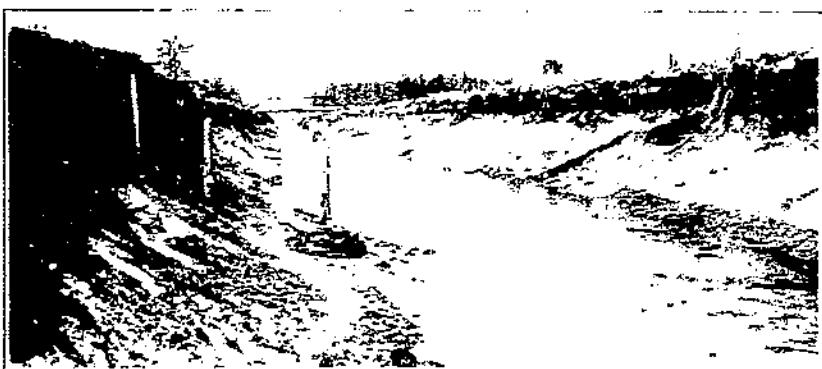
A. South Forked Deer River dredged channel at Bolivar Levee Road near Jackson, Tenn., looking down slope course, 1917. B. South Forked Deer River dredged channel, near Henderson, Tenn., looking up slope course, 1916. C. North Forked Deer River dredged channel near Trenton, Tenn., looking down slope course, 1916. See Table 3.

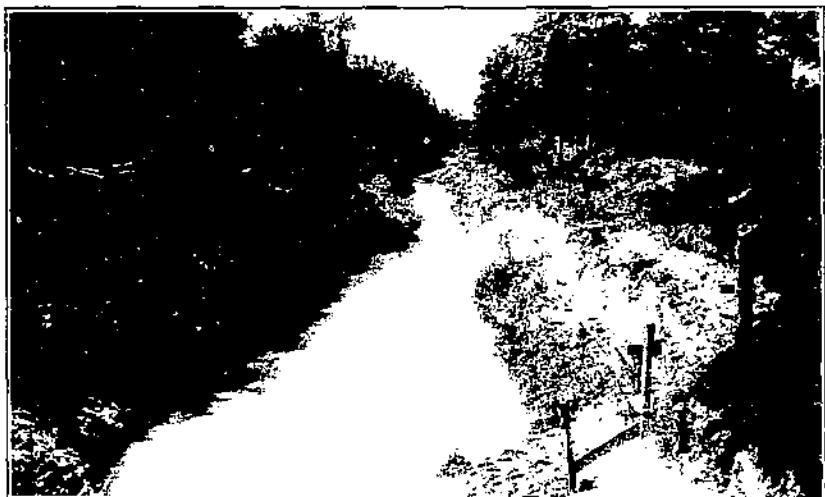
A, Huggins Creek dredged channel near Finger, Tenn., looking up slope (date, 1917). B, Sugar Creek dredged channel near Henderson, Tenn., looking up slope (date of 1917). (See Table 3.)

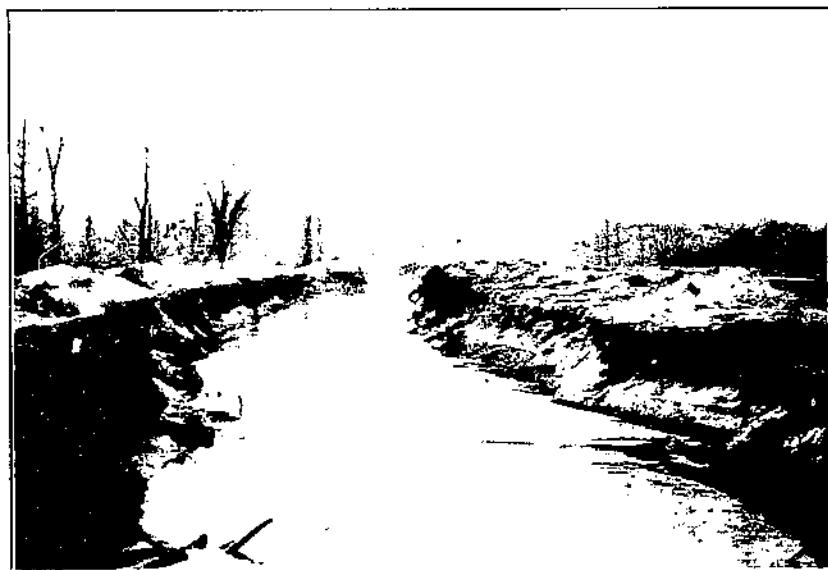
A, Cypress Creek dredged channel near Bethel Springs, Tenn., looking up slope course, 1917; B, South Forked Deer River dredged channel at Campbell's Levee near Jackson, Tenn., looking down slope course, 1916. (See Table 3)

Experiments were conducted on the river channel at the Campbell's levee road, near Jackson, to determine the values of n for three different but consecutive courses, viz: Old channel (straight and crooked) and new, irregular, dredged channel. The relation of these courses as to location and alignment is shown in Figure 7. A good comparison for the courses can be made, since the values of n for the different courses were computed from the same discharge measurements, made from a suspension footbridge at the upper end of the old straight course, so that any error in discharge would not materially affect the relative values of n . The results obtained, and a detailed description of the three different courses, are given in Table 3, measurements 63 to 76. (See pl. 9, B, and pl. 10, for views of

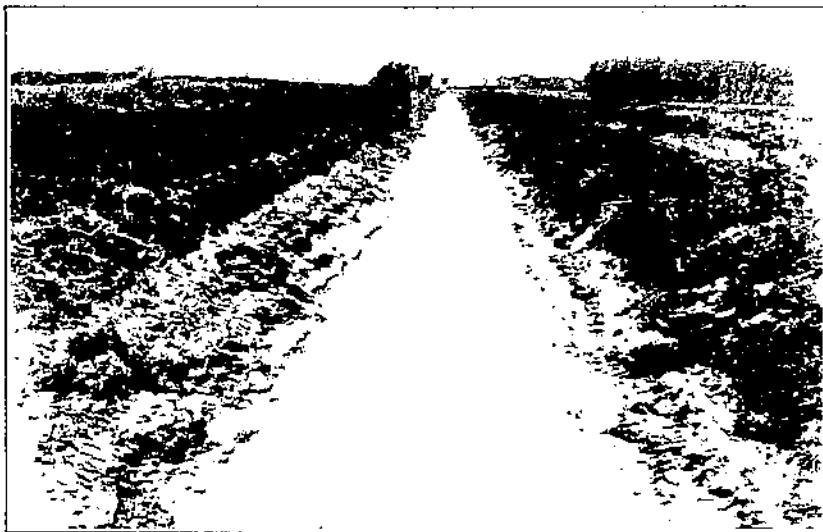
A

A, Pigeon Creek dredged channel near Crescent, Iowa, looking down slope course, 1917; B, Little Sioux River cut-off dredged channel near Purm, Iowa, looking up slope course, 1916; C, Same view as B above, 1917. (See Table 4)

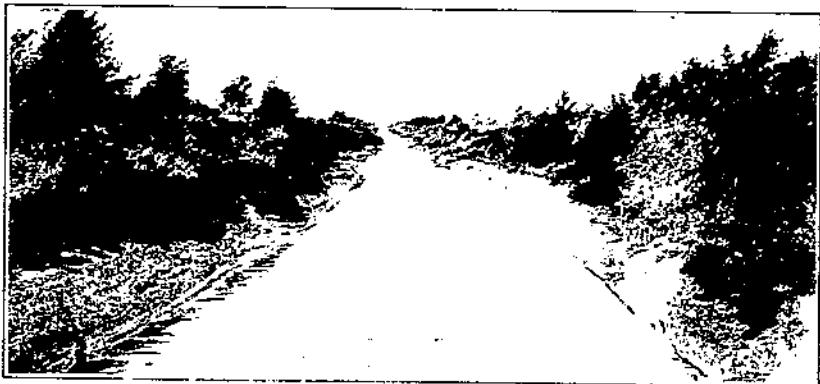
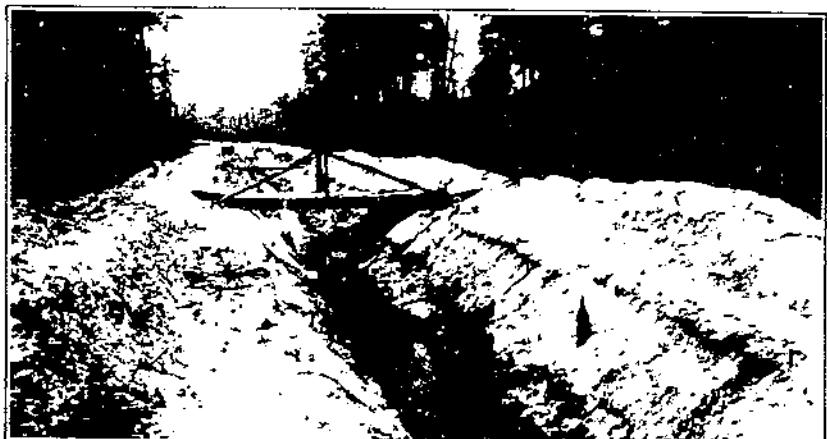
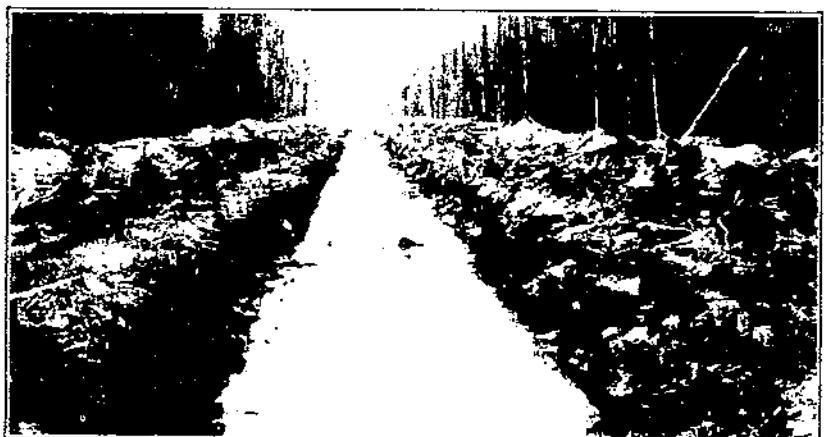
A, Monona Harrison dredged channel near Omaia, Iowa, looking up slope course, 1916 (see Table 4); B, Turkey Branch dredged channel near Pembroke, N. C., slope course, 1915 (see Table 5); C, Back Swamp dredged channel near Lumberton, N. C., slope course, 1915 (see Table 5).

A view of the slope course on the Monona-Harrison ditch, near Onawa, is shown in Plate 13, A. This view was taken looking upstream from the gaging station, which was located at the highway bridge on the Turin-Onawa road. The length of the slope course was 948 feet. Experiments were made during the years 1916 and 1917, and not much difference was found in the size and condition of the channel for the two sets of measurements.

A straight course 200 feet long was selected for slope measurements on the Turkey Branch Channel just above the Atlantic Coast Line Railroad southwest of Pembroke. This channel is small and was hand-dug. (Pl. 13, B and fig. 10, A.) At the time of the experiments the channel was very uniform in cross section for a bankful stage; it had regular side slopes and was free from growth of any kind. The values of n obtained were only for very low stages. As may be seen from Table 5, the average maximum depth for the channel at bankful stage was 5.0 feet, and only 0.95 foot for the

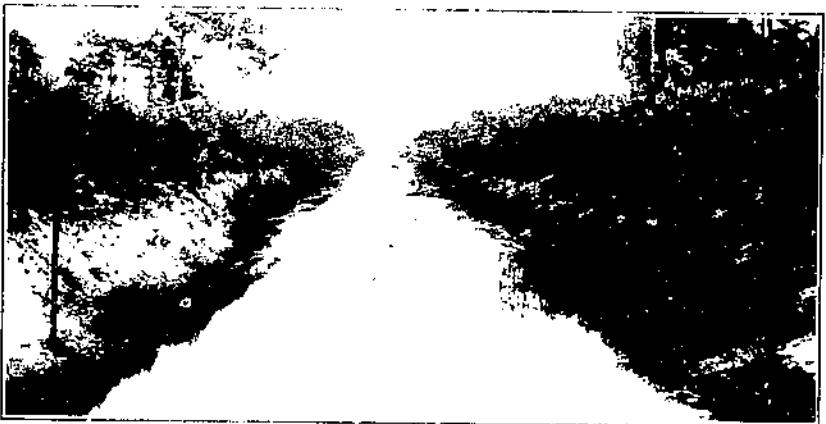
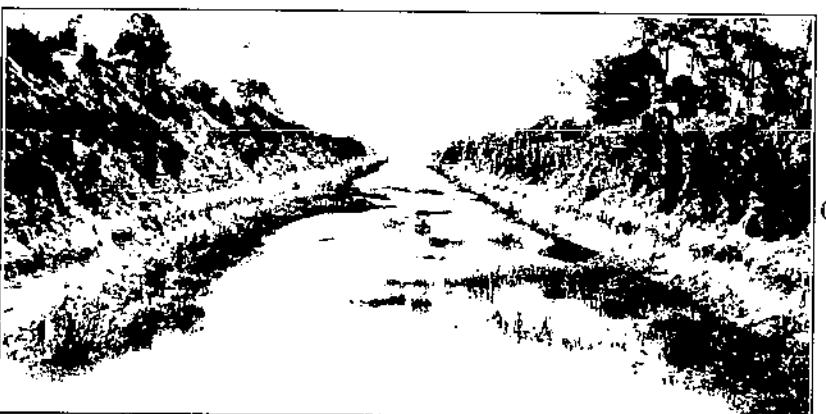
A, Main dredged channel near Fellsmere, Fla.; this view, adjoining the slope course in 1917, represents fairly well the condition of the channel along that course; B, main dredged channel near Fort Pierce, Fla., slope course, 1917; C, same slope course as B above in 1920; channel enlarged by redredging in 1918. (See Table 6)

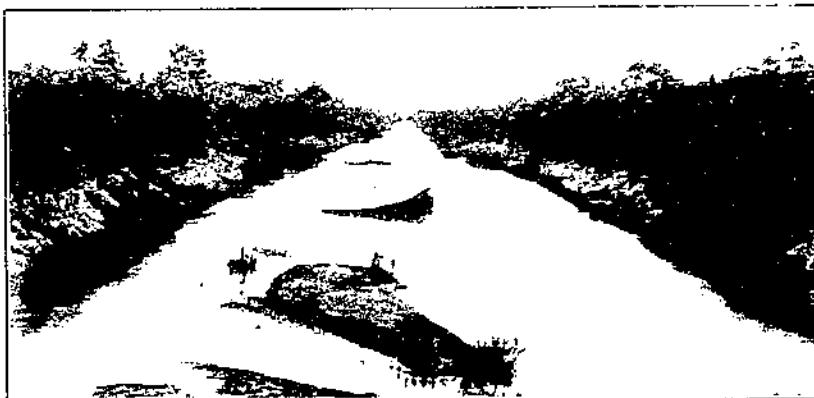
A, Main dredged channel near Vero, Fla., slope course, 1917; B, lateral dredged channel No. 2, near Port Pierce, Fla., slope course A, 1917; C, lateral dredged channel No. 2 near Port Pierce, Fla., slope course B, 1917. (See Table 6)

Gagings of this channel were made from a suspension footbridge near Vero. The upper end of the slope course, which was 1,000 feet long, was located about 40 feet downstream from the gaging station. The bottom was sandy, and there were several flat, broad sand bars in the channel during low water. (Pl. 16, A and fig. 12, D.) There was some vegetation in the channel, which can be seen in the view just referred to. The cross-sectional area of the channel was quite uniform except for the lowest measurements, Nos. 16 and 17. (Table 6 and figs. 13, D; 13, E and 13, F.) The side slopes for the three low-stage measurements made during 1916 were fairly regular, but for the three highest stage measurements Nos. 19, 20, and 24, made at about half-bankful stages, the slopes were quite rough and irregular owing to the fact that large lumps of the bank had sloughed off.

Values of n were determined for two courses of this lateral channel, course A being in good condition and course B in very poor condition. The gagings were made from suspension footbridges. A good idea as to the shape, condition, and uniformity of these channels can be obtained from Plates 16, B and 16, C and Figures 12, J; 12, K; 13, J; and 13, K.

Course A was straight and was 503 feet long; it was located at a place where the channel passed through a ridge of hard clay. The side slopes of the channel were probably about as they were left by the excavating machine and showed no evidence of erosion or sloughing off. As may be seen from Plate 16, B, there was some vegetation in the channel. The rather high values of n obtained for this channel were probably due to the presence of vegetation and to the abrupt variations in cross section.

Course B was straight and was 500 feet in length. This course was located in one of the so-called sand ponds. The soil is sandy and easily eroded. The banks have been washed in, and considerable material had been deposited in the channel. The cross section was very broad and shallow as compared with that for course A. (Fig. 12, K.) There was considerable vegetation, covering the entire perimeter of the channel, as may be seen by referring to Plate 16, C. The values of n obtained are very high, due no doubt principally to the presence of vegetation.

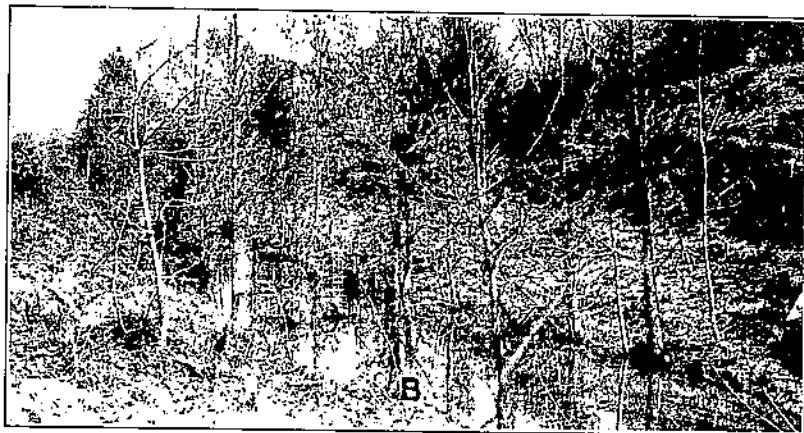
A, Dredged Ditch No. 43 of Cypress Creek drainage district, near Arkansas City, Ark., looking up slope course, July, 1925; B, dredged Ditch No. 16 of Cypress Creek drainage district, near Arkansas City, Ark., looking down slope course, March, 1925; C, same slope course as B, above, looking downstream, showing growth and heavy foliage in June, 1926. (See Table 7)

A good view of the condition of the channel at the time the measurements were made is shown in Plate 17, A. The channel was in about the same condition as the dredge had left it, there being practically no vegetation in the channel. The bottom and side slopes were somewhat irregular. The cross section of the channel was fairly uniform at high and intermediate stages, but varied considerably for low stages. (Figs. 14, A and 15, A.)

This ditch was dredged in June 1918, and the growth of vegetation in the ditch has never been cleared out. The view in Plate 17, B, shows that there were fairly large trees in the channel. This view represents the condition along the slope course during the winter and spring months. Plate 17, C, shows the trees with heavy foliage in the channel and represents the condition during the summer and fall months. The growth in the channel consisted principally of

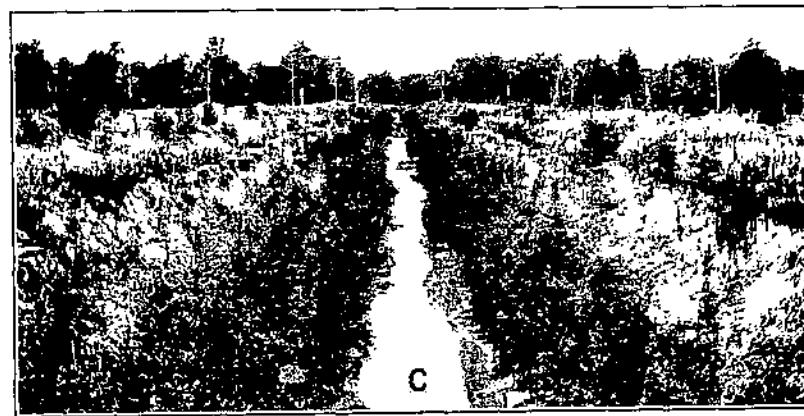
A, Ditch No. 19 of Cypress Creek drainage district, near Winchester, Ark., looking up slope course, July, 1926; B, Cummins Lake dredged channel, near Gould, Ark., looking up slope course, March, 1926; C, same view as B, above, showing foliage on willows in June, 1926. (See Table 7)

Gagings of this channel were made from a single-span wooden truss bridge about 4 miles north of Gould, Ark. The slope was measured on a straight course 710 feet long, just above the bridge. (See figs. 14, E and 15, E for average cross section and variation in area.) Two views of the channel are shown in Plate 18, one taken in March, 1926, and the other about three months later. The earlier view shows a thick growth of willows, about 1 year old at the time, almost completely filling the ditch outside of the low-water channel. The later view shows the willows in full leaf.

Table 7 shows that the values of n were appreciably larger when the willows were in full leaf than before the foliage appeared. These results clearly show what effect a short-time growth of willows has upon the hydraulic efficiency of a drainage ditch. The capacity of this ditch when first dredged was about 50 per cent greater than for the condition shown in Plate 18, B, and about 100 per cent greater than for the condition shown in Plate 18, C.

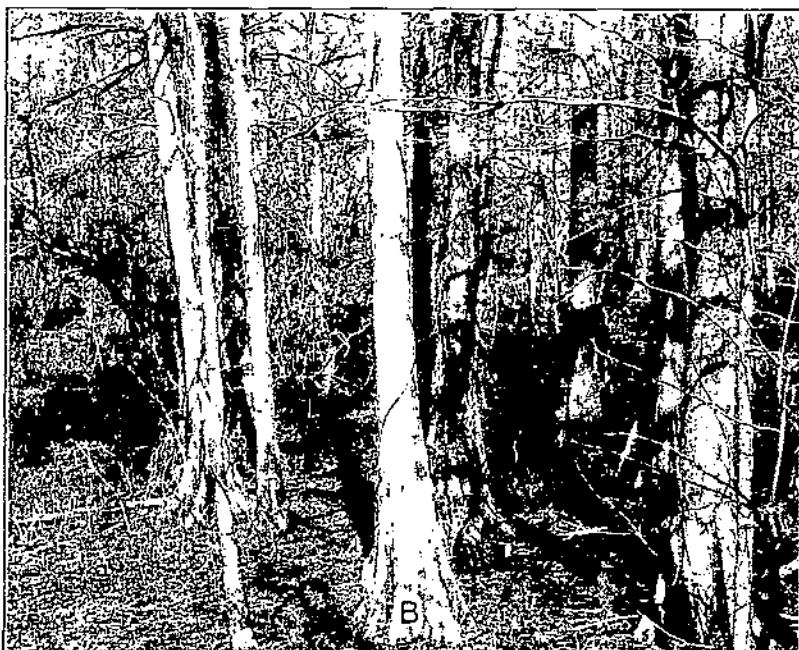
St. Francis River floodway, near Marked Tree, Ark., 1927. A, looking into slope course from east levee, 2,000 feet from upper end; B, looking upstream from gaging station, at mid length of course, 600 feet from east levee. (See Table 7)

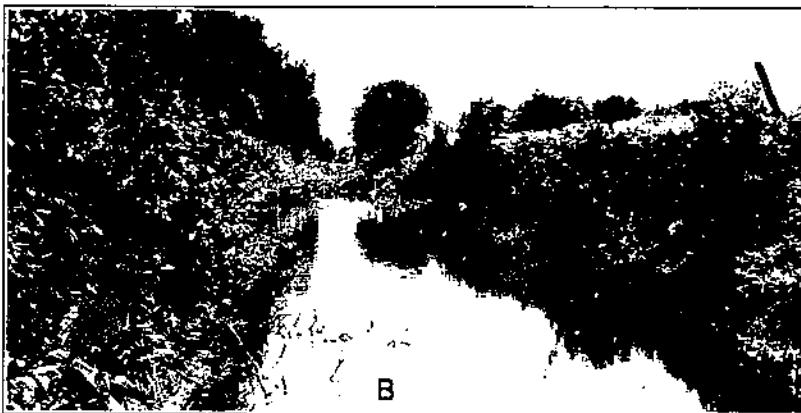
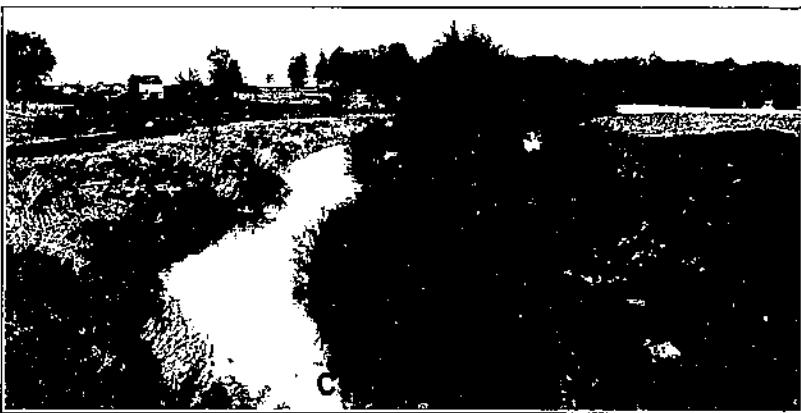
A, East Lake Fork dredged channel, near Ivesdale, IL, looking up slope course, April, 1925; B, same view as A, above, in July, 1927; C, Kaskaskia River dredged channel, near Sadocus, IL, looking down slope course, May, 1926. (See Table 9)

A view of the channel is shown in Plate 26, C. The average cross section and the variation in area are shown in Figures 19, H and 20, H. This channel is generally cleared out every two years, so there is practically no large growth in it. It was cleared out in September, 1925, shortly before the first gagings were made. (Nos. 108 to 110 in Table 9.) It will be noted that the values of n obtained for these first measurements are very low, as would be expected for a newly cleared channel. Comparison of these values with those obtained just one year later (Nos. 112 to 117) discloses a noticeable increase due to one year's growth of vegetation. The bottom part of the channel was in good condition, as vegetation does not grow on the steeper parts of the lower side slopes. This condition and the hard slippery clay in the lower part of the channel are responsible for the lower values of n obtained at low stages of flow. As the stage increases, more stalky weeds and bushy willows are encountered and the value of n increases, as may be seen from measurements 111 to 117.

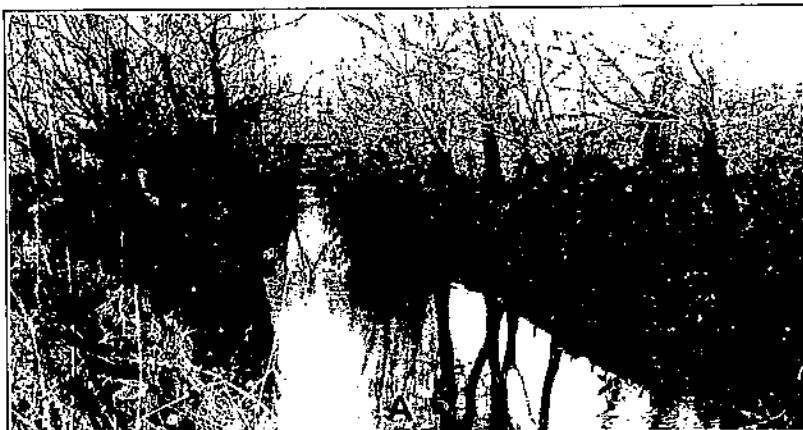
Kuskuskin natural dredged channel, near Bondville, Ill. A, Looking up lower slope course, April, 1925; B, same view as A, above, in July, 1927; C, looking up upper slope course, April, 1925.
(See Table II)
