# PERFORMANCE OF FLOOR SLABS MADE FROM WOOD AND WOOD PRODUCTS

Technical Bulletin No. 1543

Agricultural Research Service  
UNITED STATES DEPARTMENT OF AGRICULTURE

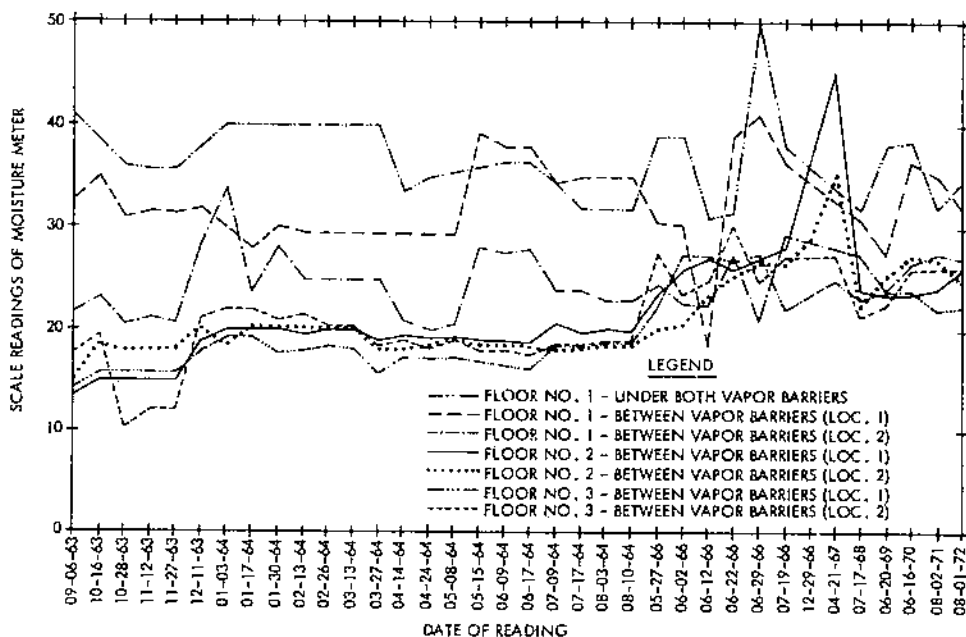
FIGURE 5. — Moisture readings in soil and between vapor barriers.

Readings of soil moisture between the polyethylene films (fig. 5) revealed no significant patterns. They fluctuated up and down but did not vary much from the initial readings. Some initially low readings increased slightly, and all moisture contents were approximately the same at the end of the test period. The curve for floor No. 1 ("under both vapor barriers") demonstrates that the moisture content of the soil under the second polyethylene film remained fairly constant throughout the test period. Meter

readings of 35 to 40 are comparable to soil moistures of 6 to 8 percent.
