PREVENTION AND CONTROL IN BUILDINGS

***Poria Incrassata* Rot:**
Prevention and Control in Buildings

by Arthur F. Verrall¹

Technical Bulletin No. 1385

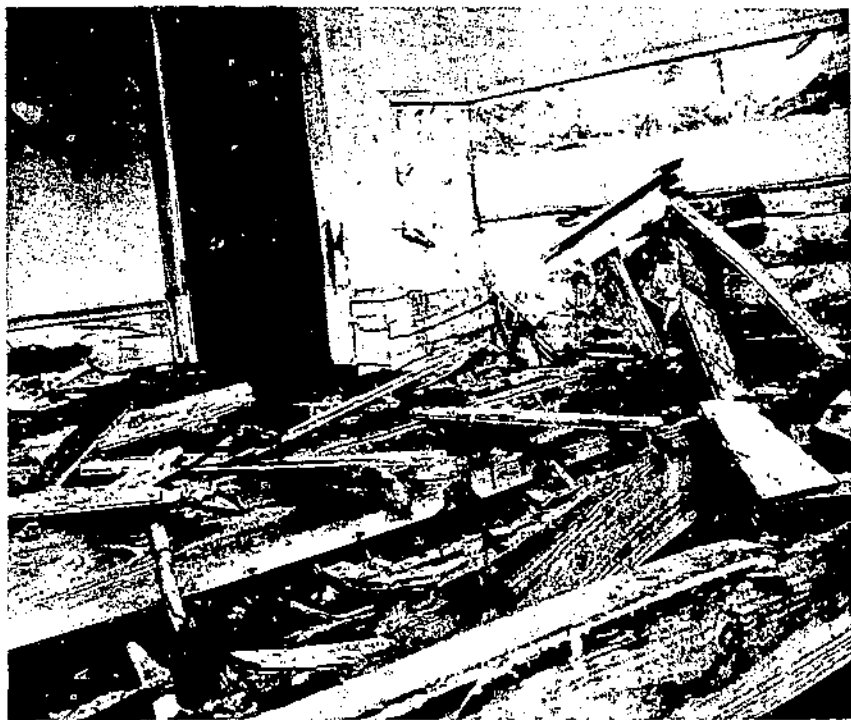
M-19037 F

Figure 5.—Framing, flooring, joists, and trim of house decayed by *Poria incrassata*.

When wood with intermediate to final decay is dried, it usually shrinks severely (fig. 5). For this reason, dry weather may cause wide cracks to open between flooring boards (fig. 6). Such cracks, or depressed areas in painted woodwork, may be the first evidence of infection.
