IIMI Working Paper No. 7

**ON PHYSICAL REMODELING AND INSTITUTION STRENGTHENING: AN EVALUATION OF THE
IMPLICATIONS OF THE PILOT FIELD CHANNEL EXPERIENCE FOR THE
REHABILITATION PROJECT AT UDA WALAWA, SRI LANKA**

Douglas J. Merrey and K. Jinapala

July 1988

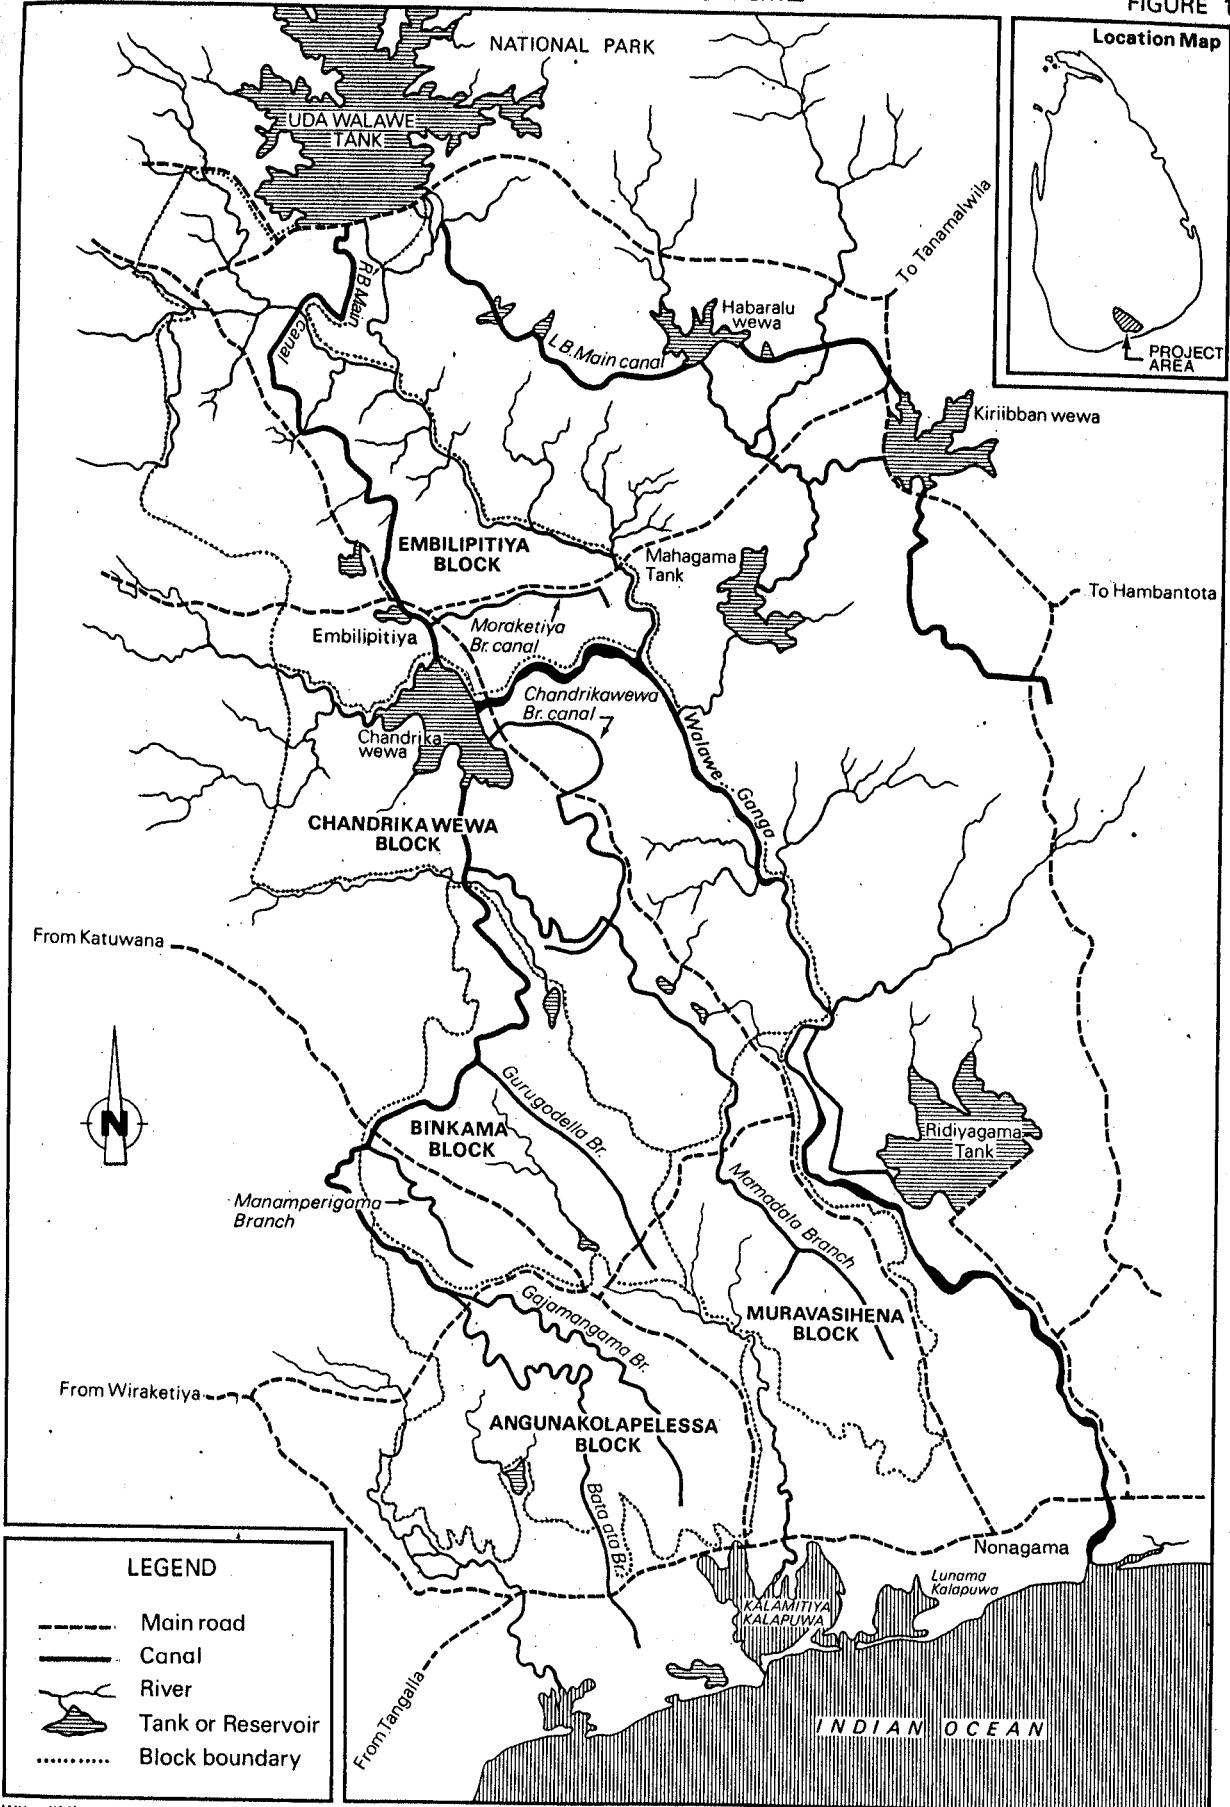
Scheme, Sri Lanka. The Walawe Scheme (see Figure 1) was initiated in 1959, and the dam completed in 1963. Two main canals were built on the right and left banks of the Walawe River. For various reasons, implementation stretched far beyond the planned three years, and the left bank system was never completed. Costs mushroomed, and from the beginning, there were numerous problems with the performance of the right bank system. The right bank was not considered completed until 1979, with a commanded (not necessarily irrigated) area of about 11,500 hectares (ha). One indication of the severity of the problems is that Embilipitiya Block at the head of the system, with 15 percent of the total area, is estimated to use 40 percent of the water. About a third of the right bank area is not irrigated.

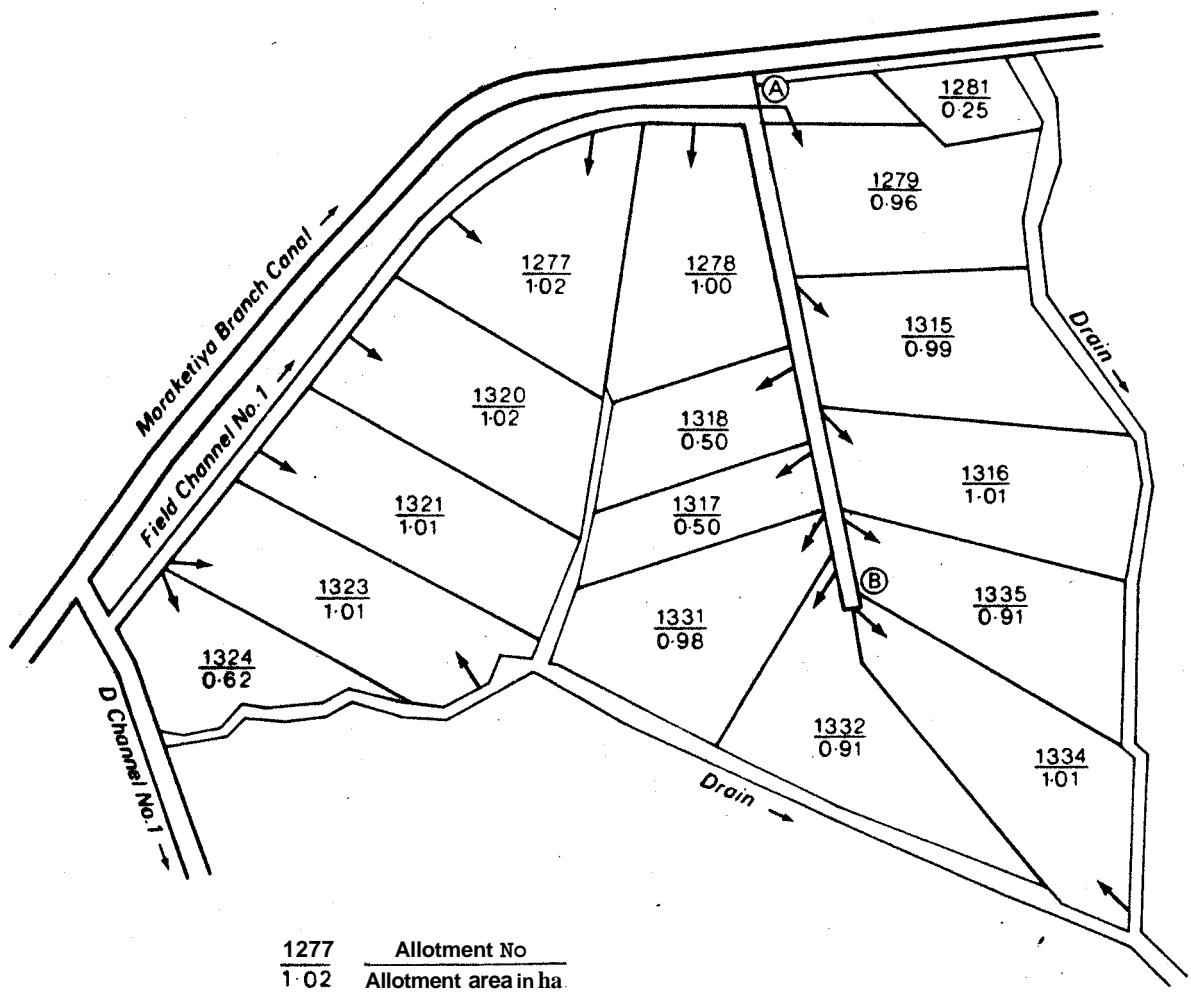
FIGURE 2
Layout of Field Channel No 1 - Moraketiya
(SCALE.- 1:4000)

- 1) new farm outlet structures were constructed, and damaged drop structures were repaired (see Figure 2; from the head to point "A" all the outlets were newly built, and the existing drop structures from point "A" to the tail ["B"] were repaired);
- 2) necessary earthwork **was** completed, and the canal capacity reduced to about **1.2 cusecs (34 liters/second)**;
- 3) a gate **was** fixed at the turnout, and the pipe **under** the road **was** changed from **1.5 feet (0.46 meter)** in diameter to **1 foot (0.3 meter)**; and
- 4) measuring devices were fixed at the FC turnout, and since this **was a** pilot project, MMP installed six temporary flumes on farm outlets **at** the head end to monitor the actual issues made to the allotments.

from one farm outlet. But the other tail-end farmers point out that this particular farmer now has the opportunity to use excess water. They suggest that two smaller pipes would be appropriate. This is now seen as a hindrance to equal water distribution (see Figure 2).

- 2) Allotment no. 1318 must get water for part of his allotment from a small canal through the adjoining allotment (no. 1278). Before rehabilitation these two farmers had two separate pipe outlets. But after resurveying for the rehabilitation, the farm outlet **of** allotment no. 1318 was included in the adjoining field. Therefore, the **allotment** no. 1318 farmer **can** take water only with his neighbor's permission. During the first season after rehabilitation, they shared water mutually, but later the 1278 farmer objected. They have both **complained** to **the** officers concerned, but action **was** not taken until recently (see Figure 2).²
