EFFECT OF ACCELERATED EROSION ON SILTING IN MORENA RESERVOIR, SAN DIEGO COUNTY, CALIF.¹

By F. F. BARNES, *assistant geologist, Sedimentation Division, Office of Research, Soil Conservation Service*, and C. J. KRAEBEL, *principal silviculturist*, and R. S. LAMOTTE, *assistant geologist, California Forest and Range Experiment Station, Forest Service*

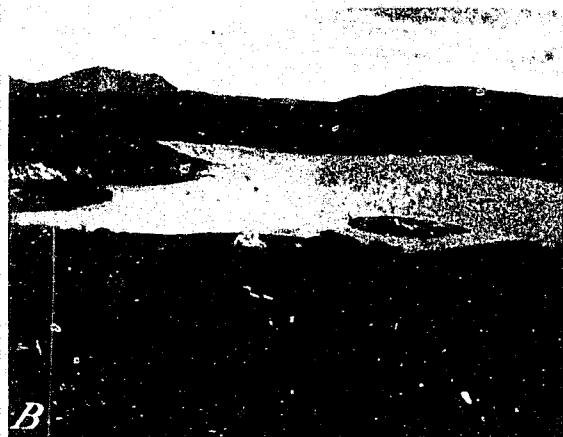
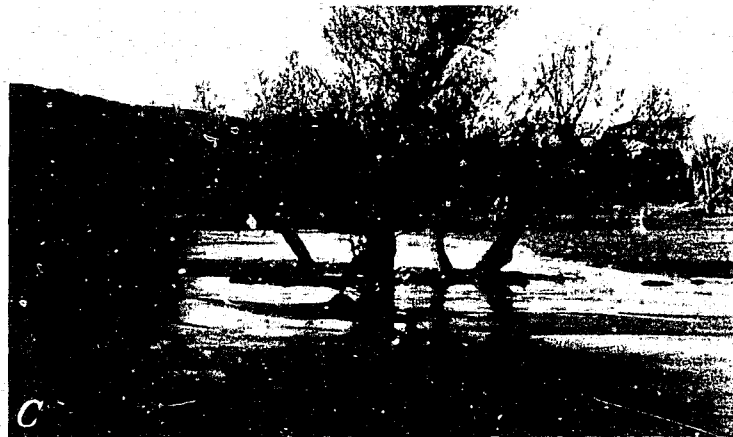
A, View of Morena Reservoir, looking west toward the dam (left) and north up Morena and Cottonwood Valleys toward the Corte Madera (center) and Laguna (right) Plateaus; *B*, view of Morena Reservoir, looking upstream over the lower basin toward the Narrows, from a point about opposite the dam; *C*, aggraded channel of Cottonwood Creek about one-half mile above the present (1938) head of backwater of Morena Reservoir.

The reservoir basin (fig. 2 and pl. 1, *A* and *B*) is about 500 feet wide at the dam, which was constructed at the upper end of a narrow, steep-walled gorge. A few hundred feet above the dam it widens abruptly to about 2,000 feet and maintains this width with little variation for 1 mile to the Narrows, formed by the convergence of two rocky spurs, where the width is only about 1,200 feet. Above the Narrows the reservoir widens again in a broad, relatively flat-bottomed basin, formed by the junction of the alluvium-floored valleys, or poteros, of

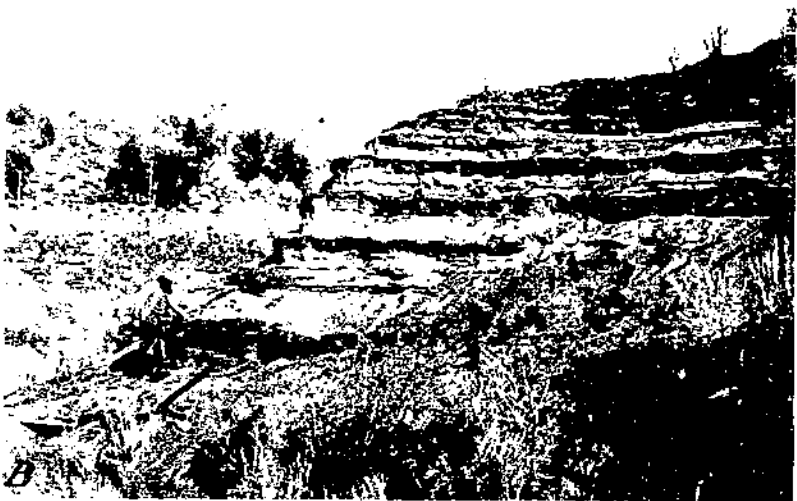
A. Hundreds of acres of potrero grassland in Cameron Valley have been sliced away in this valley trench. The meandering stream continues to eat the bank, and sparse sagebrush invades the sandy bottom. B. Unconsolidated alluvial deposits in Pine Valley, immediately west of the Morena watershed. Exposure of these strata within the last 30 years, by a valley trench originating as a wagon road on an overgrazed potrero, illustrates strikingly the swift acceleration of erosion caused by careless use of the land.

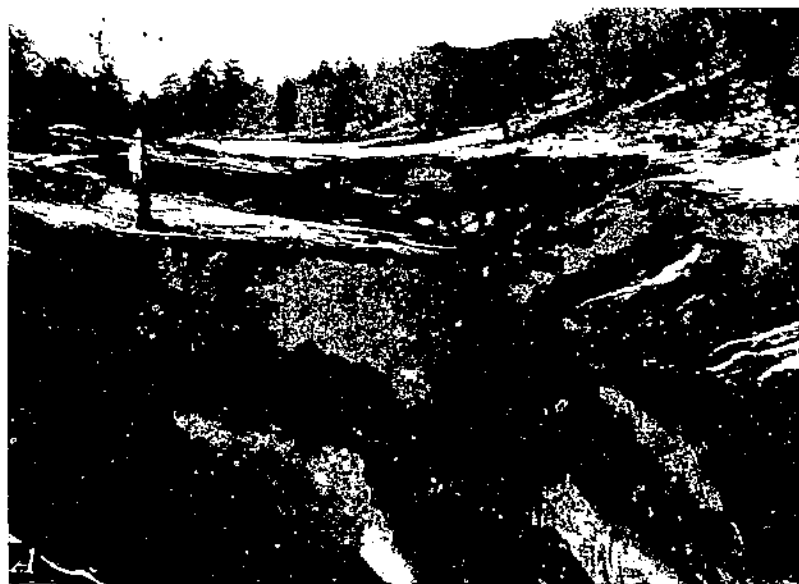
A, Actively growing valley trench in the upper Kitchen Valley. The thin grass cover is insufficient to prevent advance of the trench into the deep unconsolidated potrero deposits. *B*, Large transverse valley trench in Agua Caliente Meadow. A few weeks after this picture was taken the gully head reached the rocky slope, destroying the road and completing the bisection of the valley.

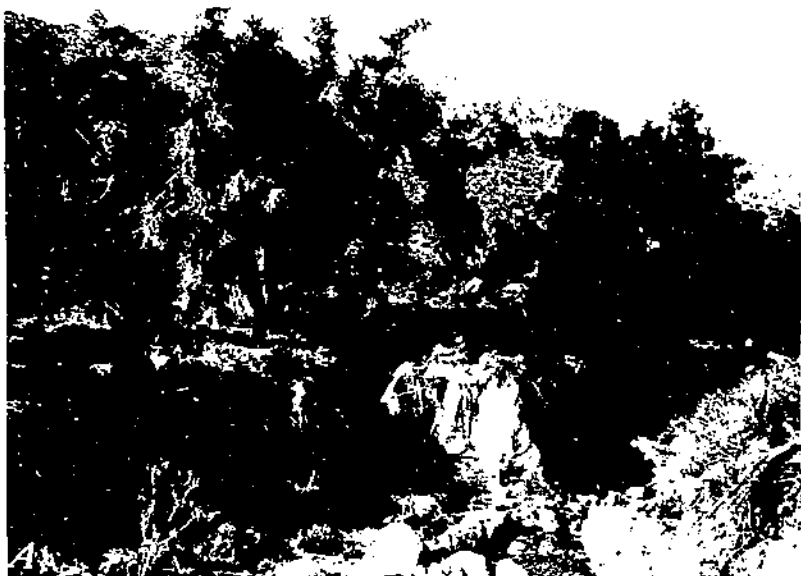
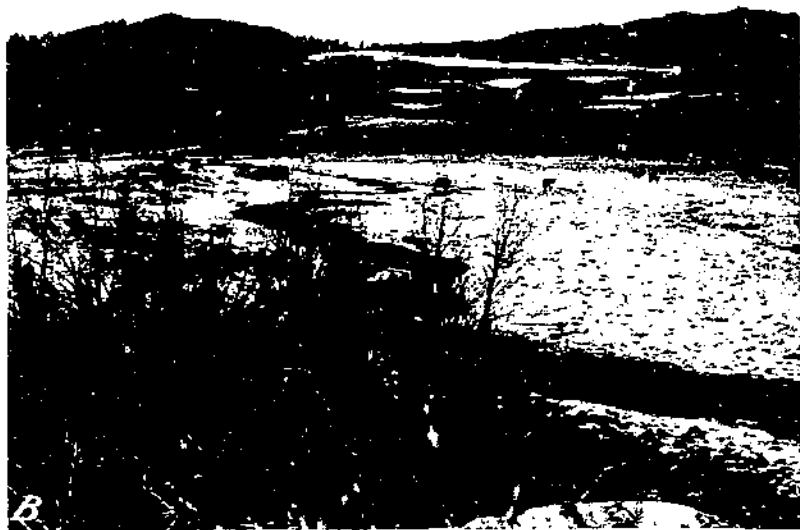
A, Valley trenches cutting headward and exposing the roots of valley oaks, despite grass cover. B, Typical potrero, or valley meadow, in the Morena drainage basin. A large trench has grown headward across the valley from the canyon on the left to the rock ledge on the extreme right. The smaller channel in the foreground follows a cattle trail.

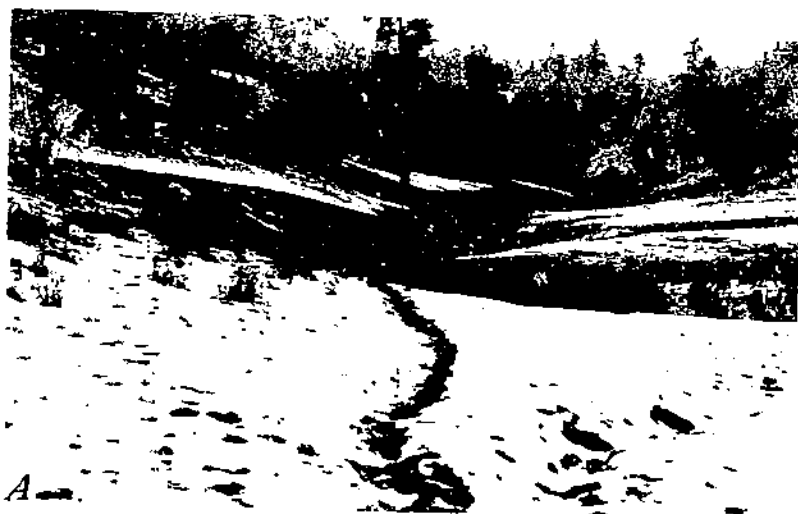
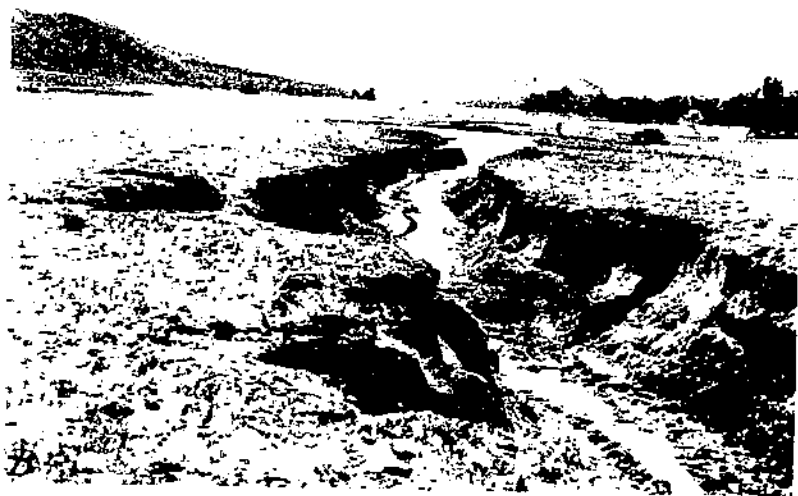
A, "Cow-trail" gullies in an early stage of development, Agua Caliente Meadow. The trees in the background are pines and deciduous oaks. B, Valley trench in heavily grazed grassland. Oak grove on the right, brush-covered slope on the left. A small earth dam (center) provides water for livestock and stops further deepening of the trench.

still active on the ground today indicate that the chief cause of gully and trench formation was the breaking of the protective sod by livestock trails at critical points and the concentration therein of run-off water from the surrounding areas of depleted cover. Indubitably, overgrazing on the potreros of the Laguna and Corte Madera Plateaus and on the lower potreros of the La Posta Plateau set the stage for the rapid valley trenching that followed heavy precipitation in the 1916 and 1927 seasons (pls. 4, B and 5, A and B).
