# **HEAT LEAKAGE THROUGH FLOORS, WALLS, AND CEILINGS OF APPLE STORAGES**

Marketing Research Report No. 315

Agricultural Marketing Service—Marketing Research Division  
UNITED STATES DEPARTMENT OF AGRICULTURE

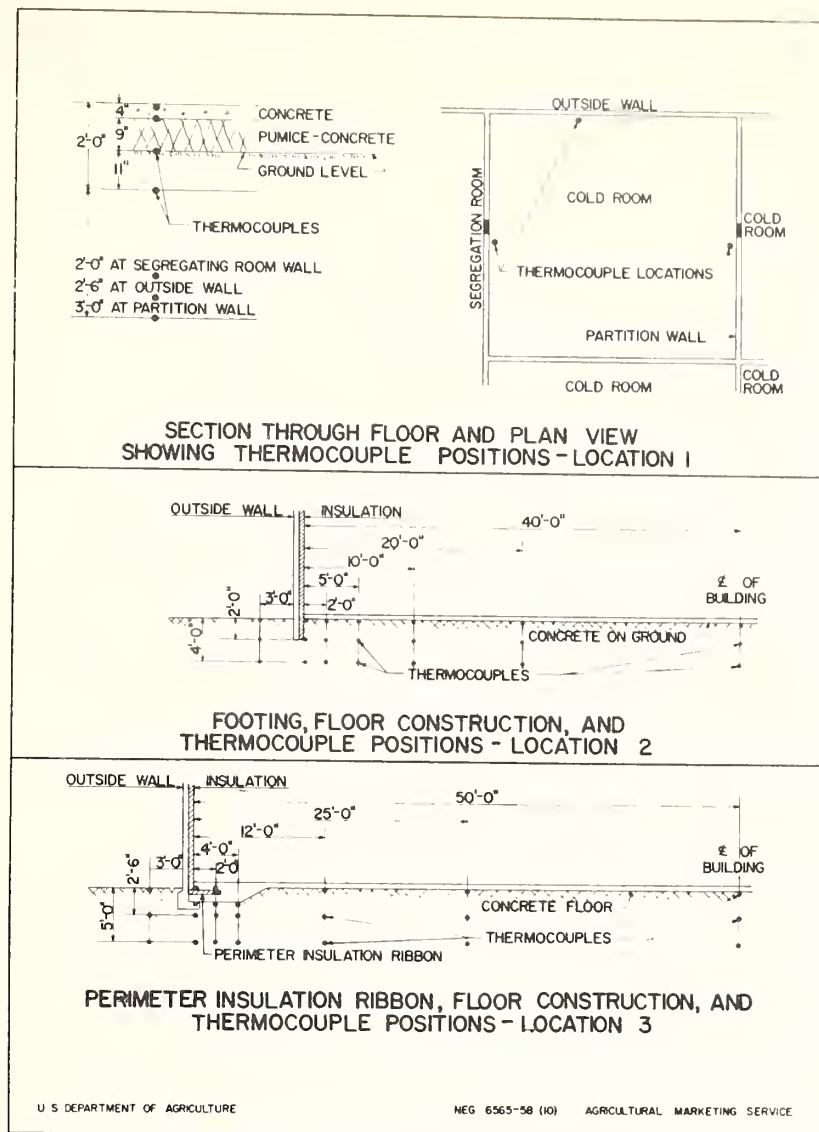
FIGURE 1

The floor of the storage (fig. 1) at location 1 consists of 9 inches of a pumice-concrete mixture laid directly on compacted soil underlaid by river gravel, with a 4-inch concrete wearing floor above the pumice-concrete mixture. At the time of construction, thermocouples were placed at the top of the concrete floor, at the top and bottom of the pumice-concrete layer, and at points 2 feet below the finished floor surface and approximately 4 feet below the surface. Three

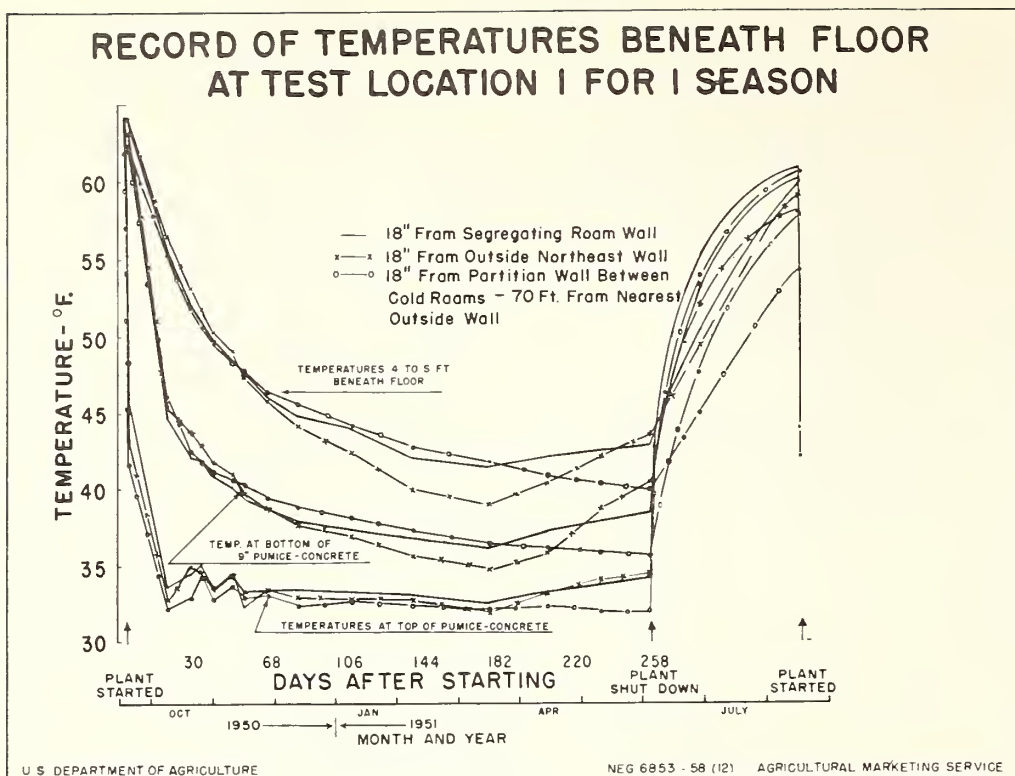
FIGURE 2

Figure 2 shows the temperatures observed during one season. The position 2 feet below the floor has been omitted from the figure. The depths of the bottom positions vary slightly; that at the segregating room is 4 feet below the floor level, that at the outside wall is 4½ feet below floor level, and that at the interior partition wall is 5 feet below floor level. The temperature designated as the top of the pumice-concrete at the last location is actually the top of the concrete floor, because the thermocouple located at the top of the pumice-concrete was destroyed during construction. At the other two locations, the difference between temperatures at the top of the concrete and the top of the pumice-concrete was slight.

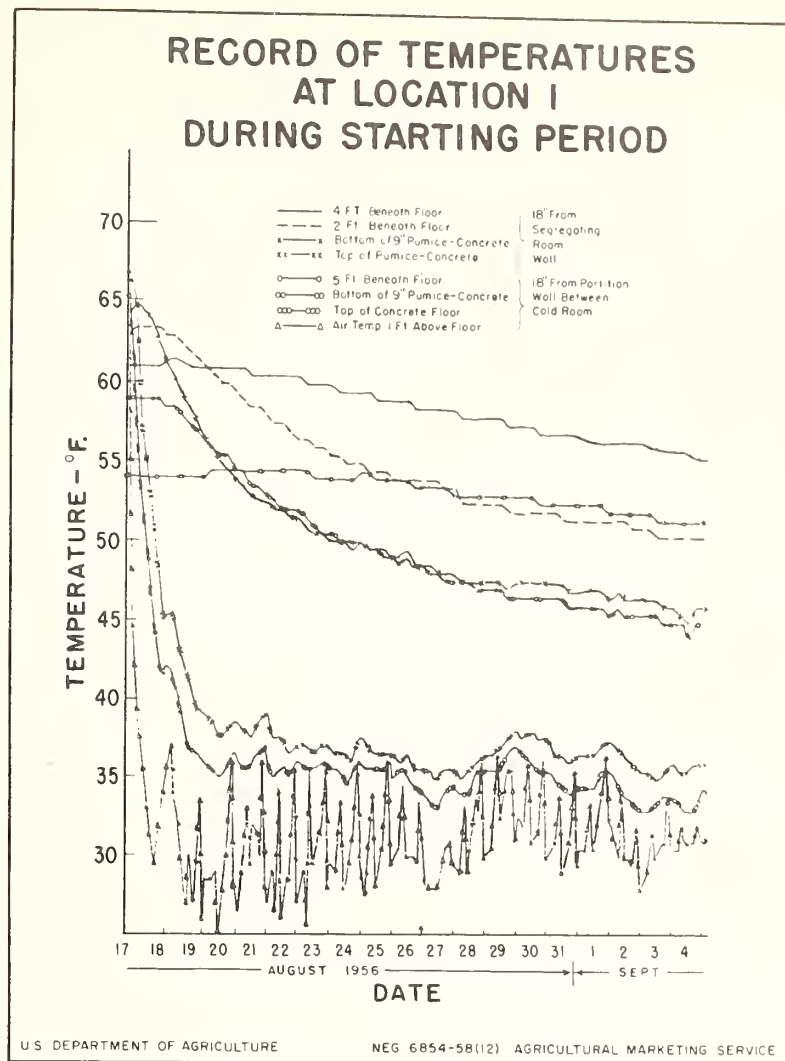
FIGURE 3

A continuous recording later was made of temperatures and heat flow from the locations near the segregating room wall and near the partition wall during the first 3 weeks of the season's operation. Figure 3 presents the temperature record obtained. During the first 2 weeks, the temperature of the top of the concrete at the segregating room wall locations was practically identical with that shown for the partition wall position. During the last week, it was slightly higher. The curves show little temperature change initially at the 4- and 5-foot depths. These temperatures also indicate that, in the position distant from the outside walls, the ground had not warmed up as much as the ground near the edges.

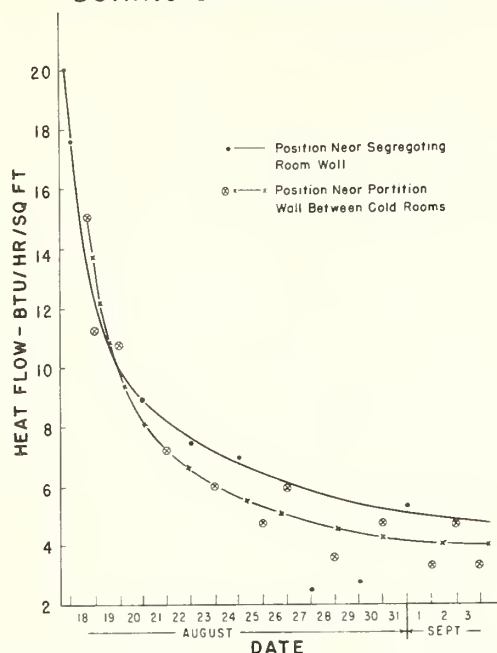
FIGURE 4

Figure 4 presents the average daily heat flow rates observed during this 3-week period. Since only one heat flow meter was available, it was moved from one position to the other, remaining

# HEAT FLOW FROM FLOOR AT LOCATION 1 DURING STARTING PERIOD

Smoothed curves have been drawn in figure 4 between the actual values of average daily heat flow. After the first 3 or 4 days, the heat flow

at the partition wall position tended to be about 1 Btu/hr/sq ft less than that observed near the segregating room wall position. The lower initial temperature of the soil beneath this position accounts for this difference.

At first, very high heat flow values were observed, but such values persisted for a comparatively short time. In 7 or 8 days, the average heat flow rate was down to about 6 Btu/hr/sq ft. From this point on, the heat flow rate declined less rapidly and was between 4 and 5 Btu/hr/sq ft after 18 and 19 days.

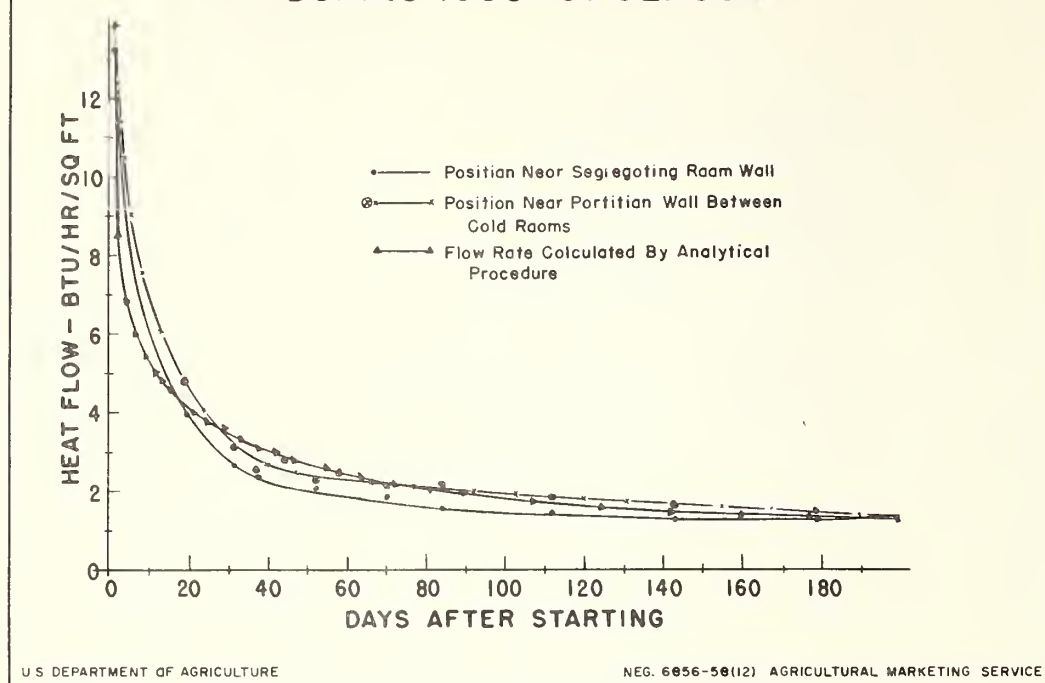
FIGURE 5

## HEAT FLOW FROM FLOOR AT LOCATION 1 DURING 1950-51 SEASON

Several periods of heat flow observation have been used to determine a conductivity of the pumice-concrete. From this value and the observed temperature differences, the heat flow has been calculated and charted for the season at the locations near the partition between storage rooms and the location near the segregating room wall. The calculation includes allowance for heat released by the pumice-concrete as well as heat conducted through the pumice; but after the first month, the amount of heat released by the pumice-concrete was negligible. Figure 5 shows the declining values of floor heat leakage encountered as the season progressed. This record is for the first season this plant was operated, starting in 1950, and in this case the ground at the position near the partition between cold rooms was as warm initially as the

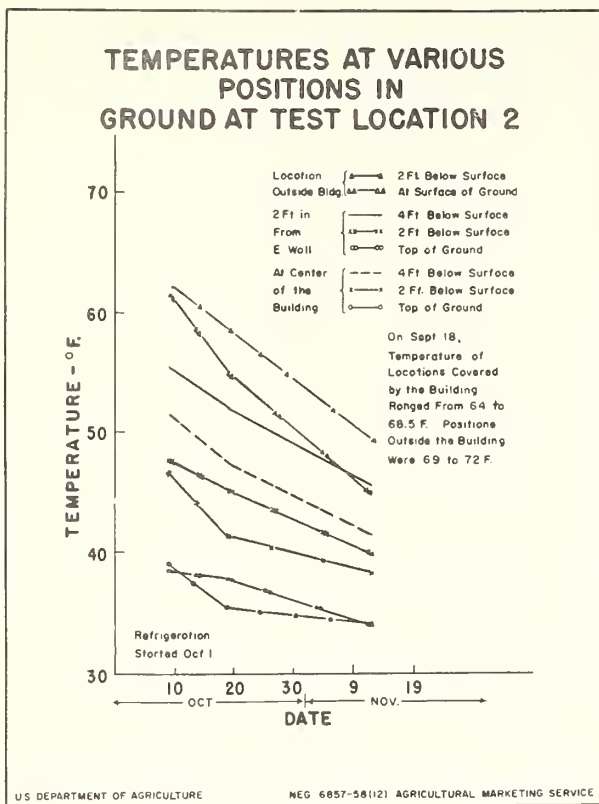
FIGURE 6

Figure 6 presents part of the temperature record obtained. A steady decline of tempera-

tures during the period of observation is apparent. The edge position shows generally warmer temperatures at the comparable depths than other positions, but the other positions are not progressively cooler as one goes from the edge toward the center. This indicates that, for the period of observation, the effect of conduction around the edge does not extend very far into the storage.

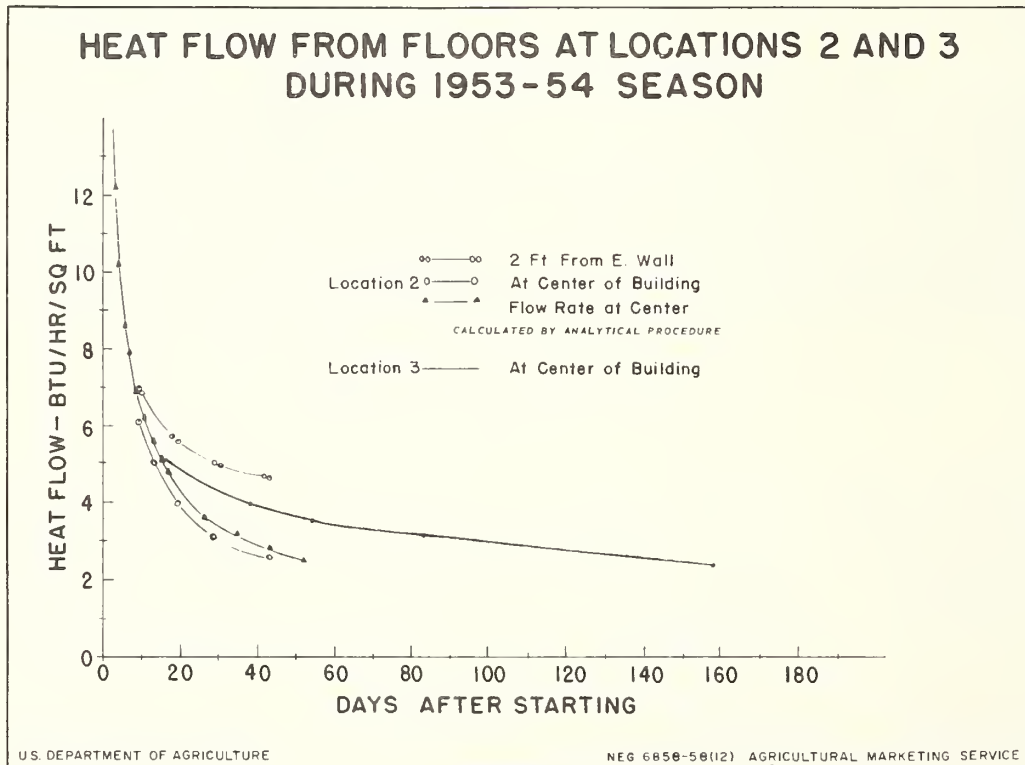
FIGURE 7

Observed heat flow records at this location are summarized in table 1. From these data and temperature observations, conductivity of the ground was determined and the heat flow for the various periods of observation was calculated. Figure 7 shows the variation of heat flow as the season progressed for the position 2 feet in from the wall and for the position at the center of the room. These calculations include the heat conducted through the earth and also the heat released from the section of ground through which temperature differences were measured.

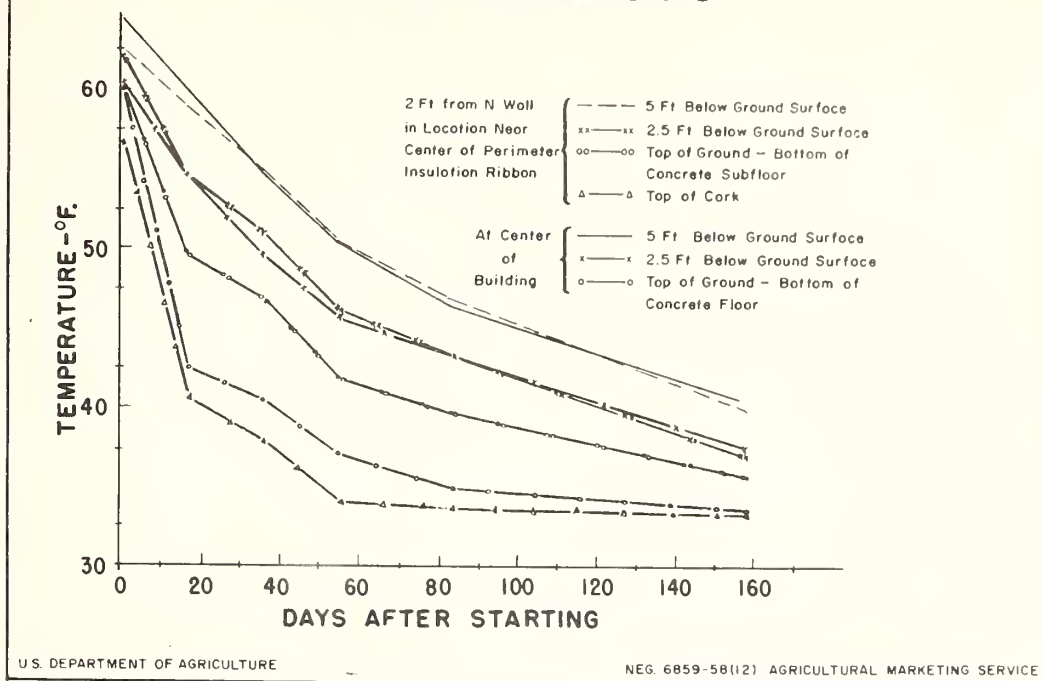
FIGURE 8

## TEMPERATURES AT VARIOUS POSITIONS IN THE GROUND AT LOCATION 3

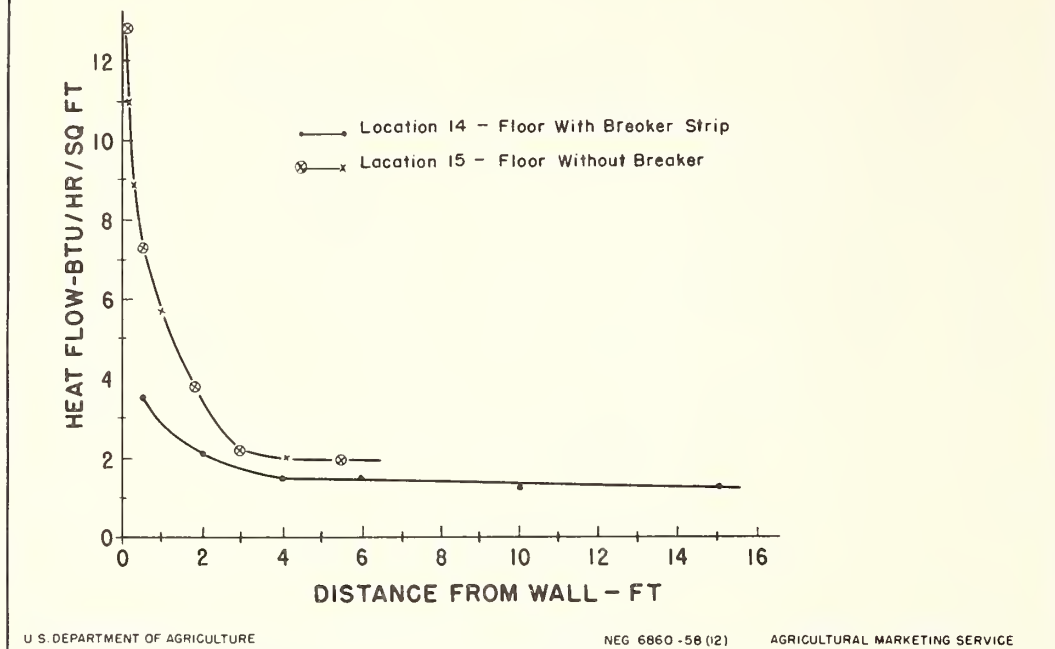
FIGURE 9

## RELATION OF HEAT FLOW RATE TO DISTANCE FROM WALL

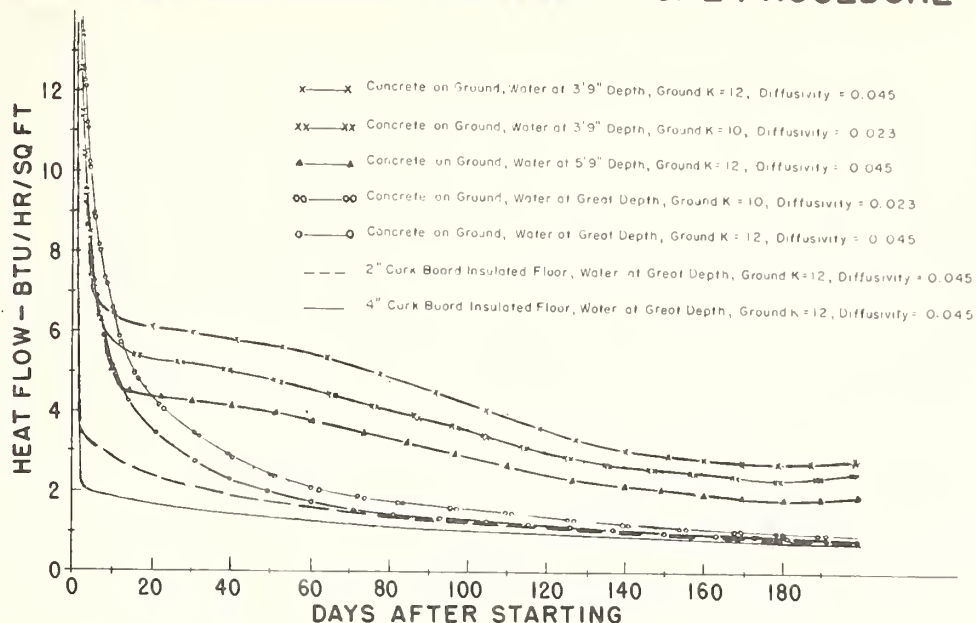
# HEAT FLOW FROM VARIOUS TYPES OF FLOORS AS CALCULATED BY THE ANALYTICAL PROCEDURE

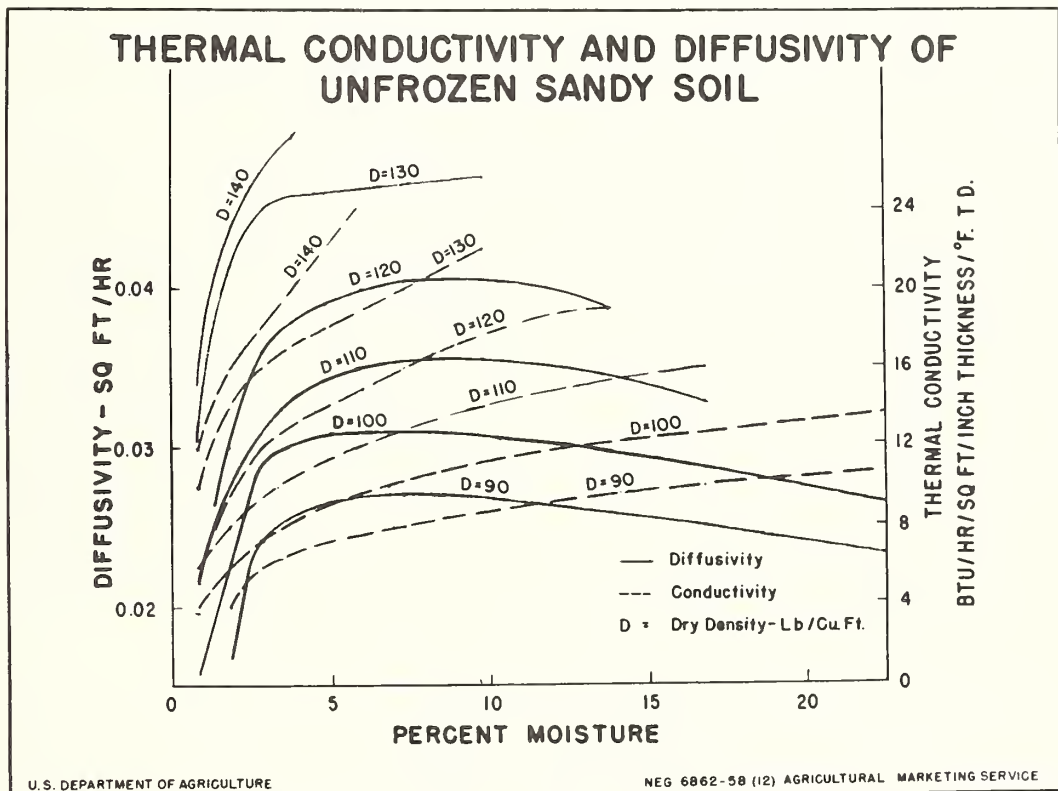
FIGURE 11

The relationship of conductivity and diffusivity for various soils is important in this discussion. Figures 11 and 12 give some information on these quantities for various soils. The data on conductivity have been taken from Kersten's [8] work and replotted as a function of moisture for different dry densities of soil. The diffusivity values have been calculated for the various densities, moisture contents, and corresponding conductivities, using a dry soil specific heat of 0.2 and a specific heat of water of 1.0. The data are shown on two charts, one for sandy or gravelly soils, the other for clay and silt soils.

## THERMAL CONDUCTIVITY AND DIFFUSIVITY OF UNFROZEN SILT AND CLAY SOILS

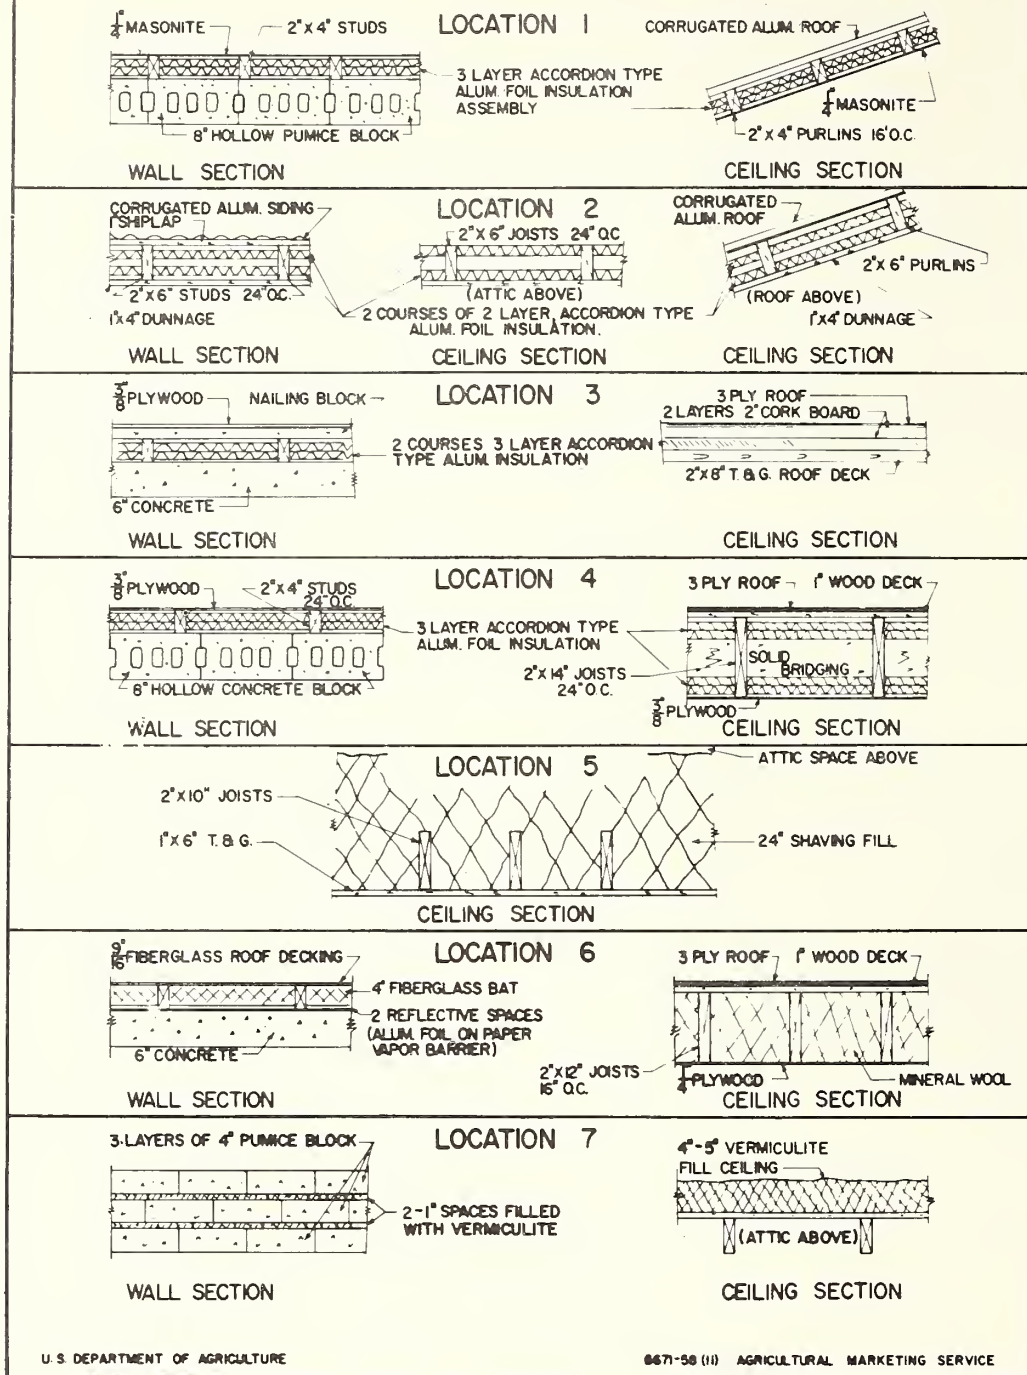
FIGURE 13

# WALL AND CEILING STRUCTURE, 7 APPLE STORAGE HOUSES

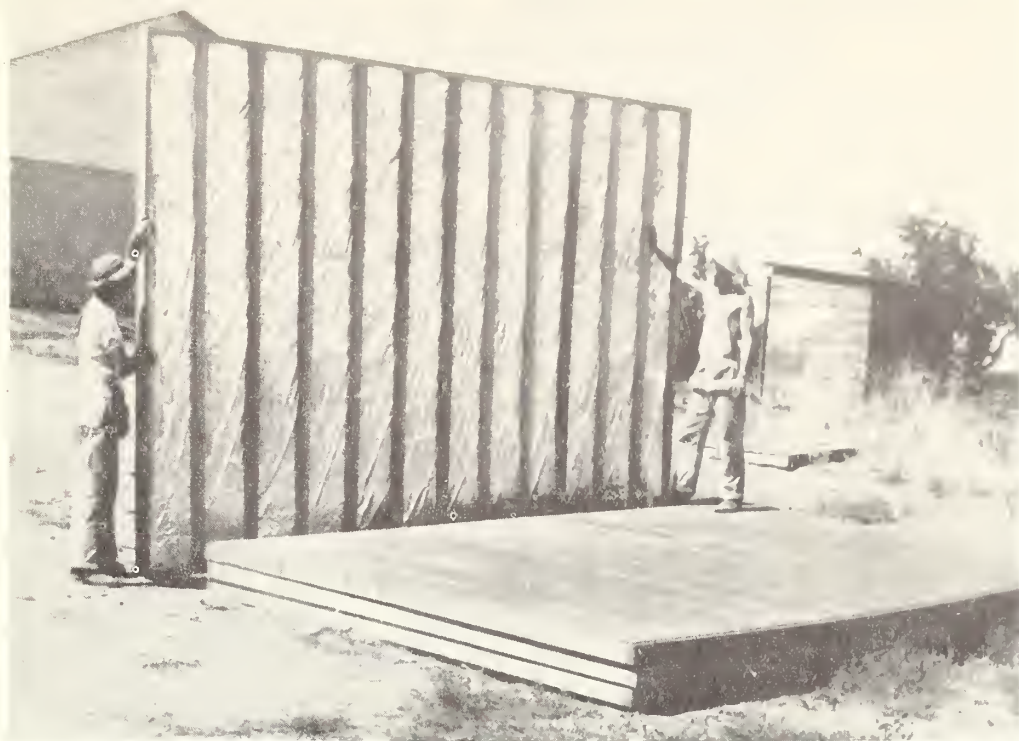
FIGURE 14.—Prefabricated insulated wall section used at location 1.

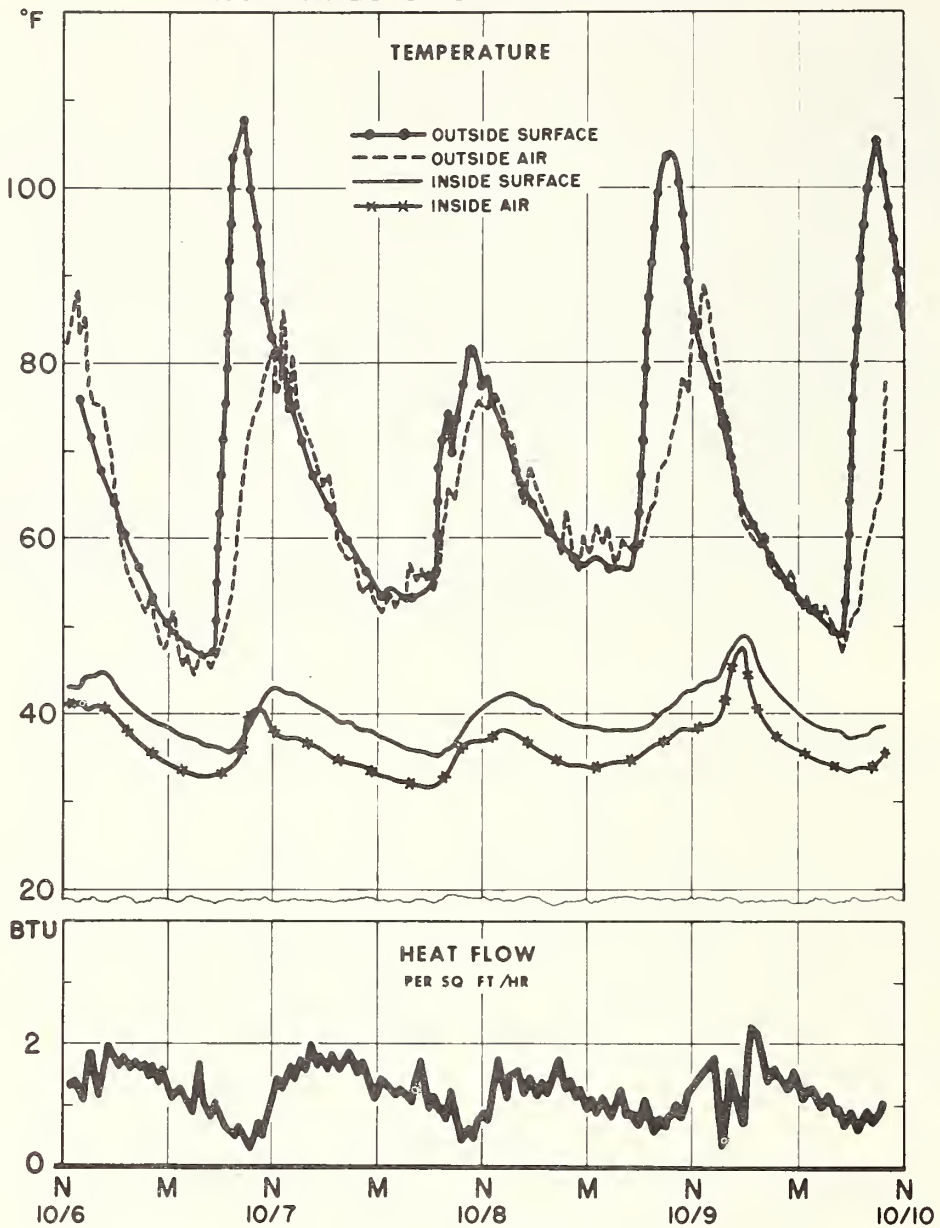
Through East Wall, Location 1 \*

## TEMPERATURES AND HEAT FLOW IN APPLE STORAGE HOUSE

\* FOIL-INSULATED, PUMICE-BLOCK WALLS.

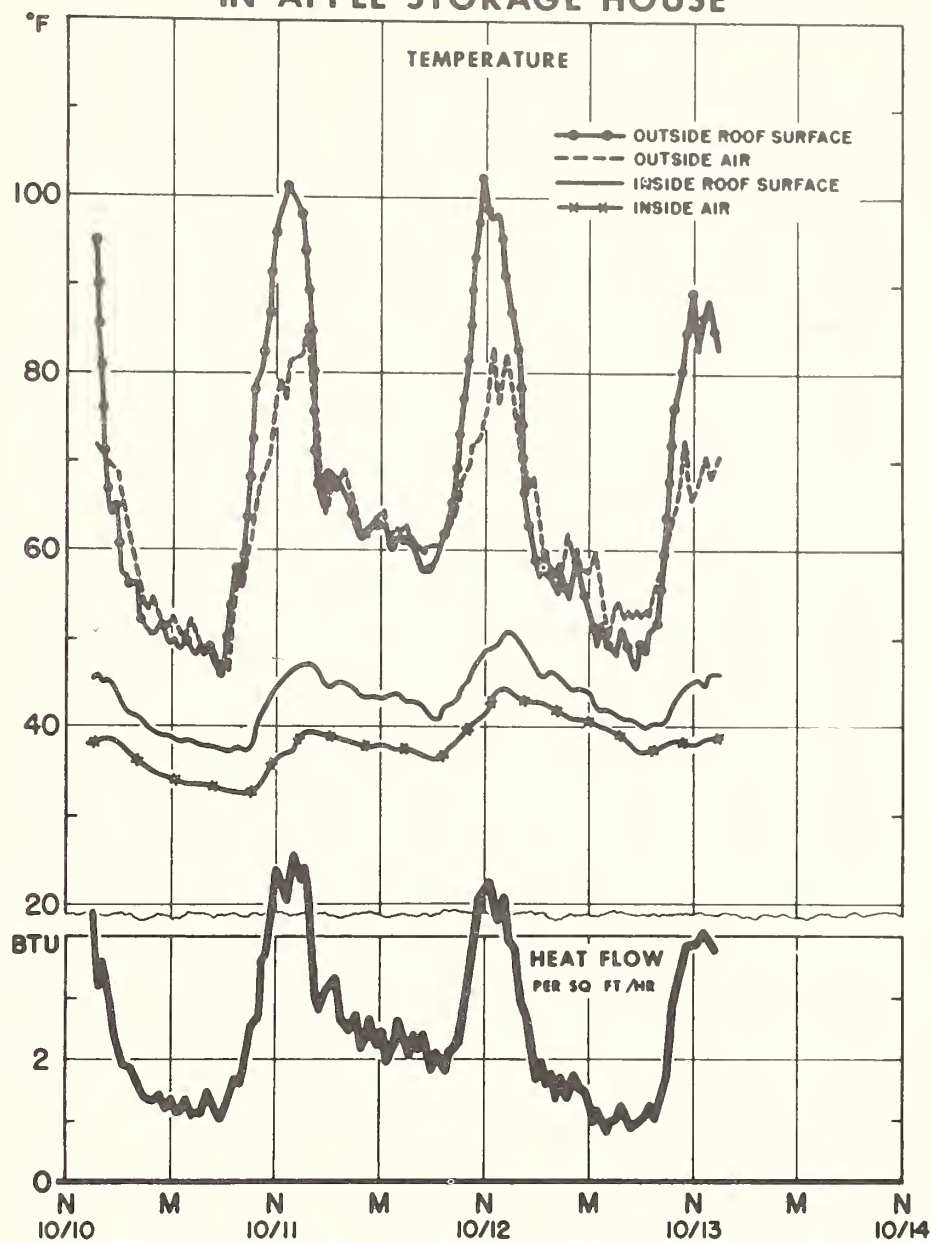
Through West Slope of Roof, Location 1\*

## TEMPERATURES AND HEAT FLOW IN APPLE STORAGE HOUSE

\* LIGHTLY CONSTRUCTED ROOF.

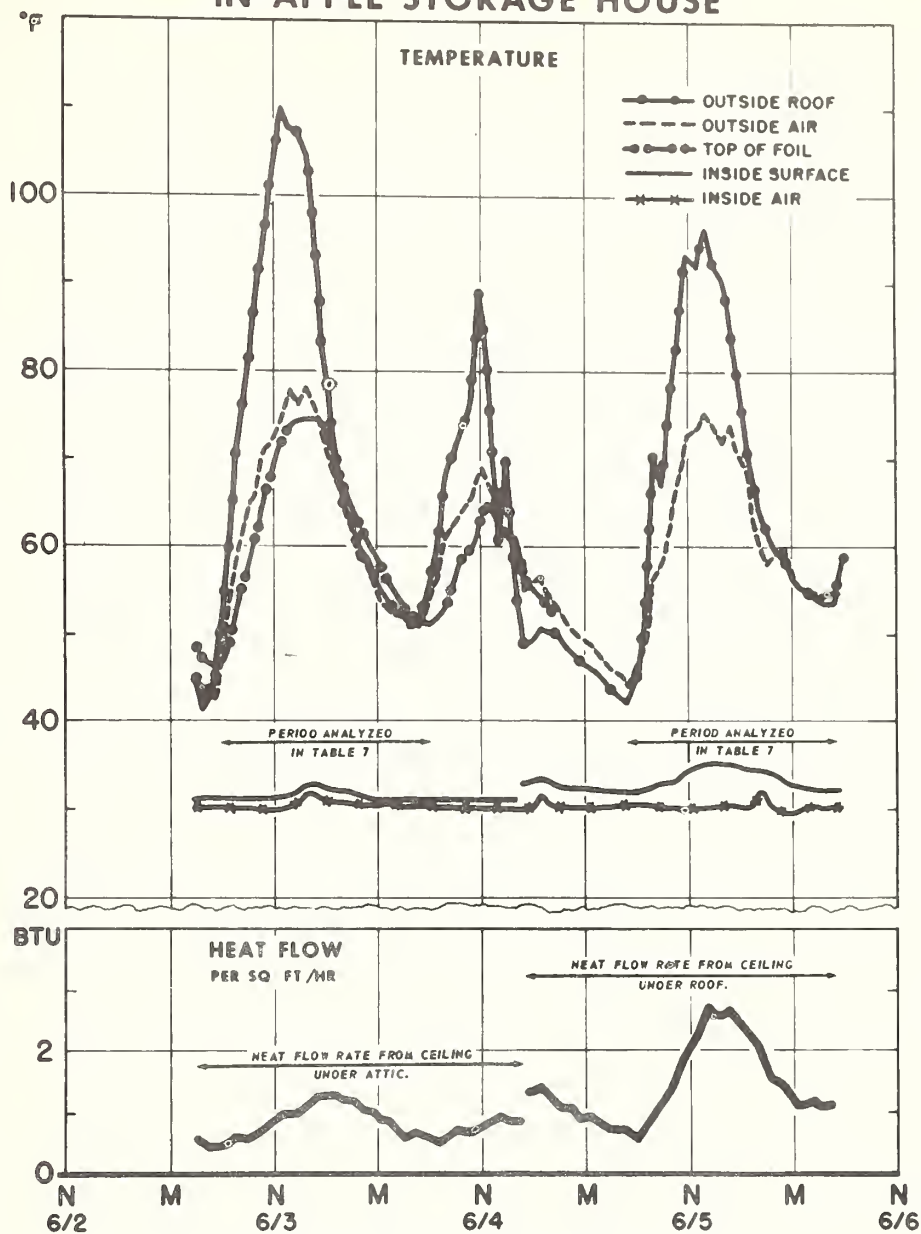
Through Ceiling, Location 2\*

# TEMPERATURES AND HEAT FLOW IN APPLE STORAGE HOUSE

\*WITH 2 COURSES OF 2-LAYER ALUMINUM FOR INSULATION AND WITH AN ATTIC.

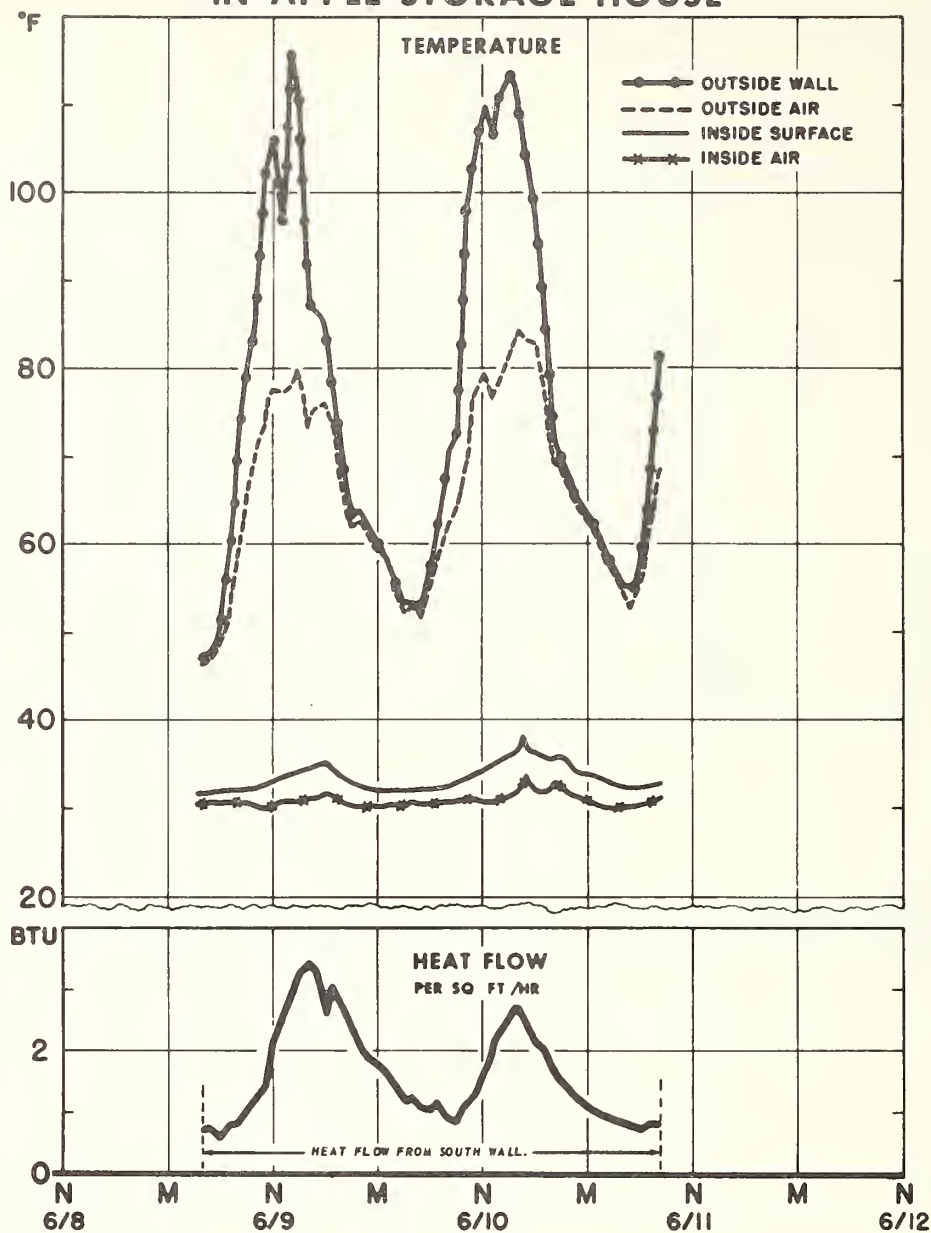
Through South Wall, Location 2\*

## TEMPERATURES AND HEAT FLOW IN APPLE STORAGE HOUSE

\*WITH 2 COURSES OF 2-LAYER ALUMINUM FOIL INSULATION AND WITH AN ATTIC.

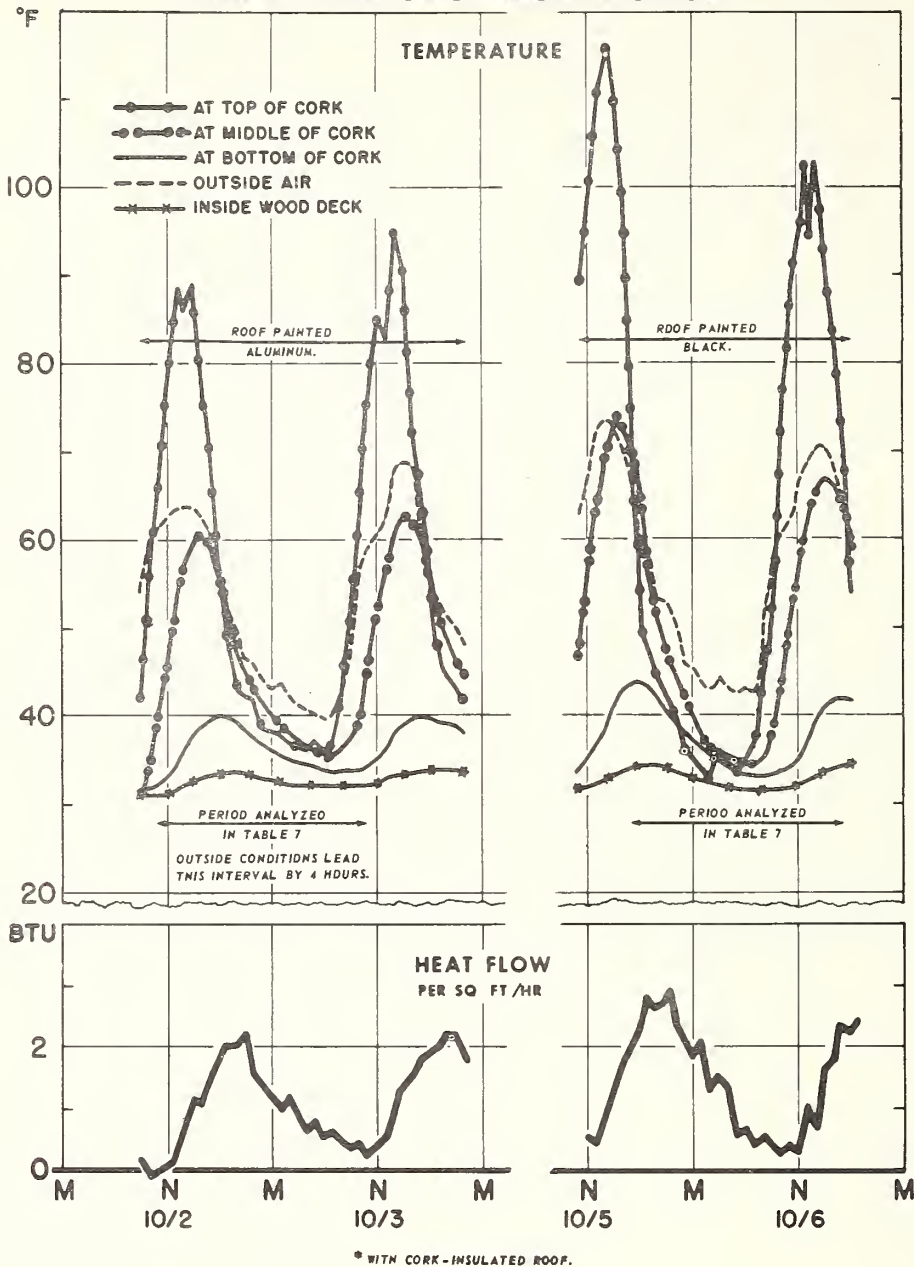
Through Roof, Location 3\*

## TEMPERATURES AND HEAT FLOW IN APPLE STORAGE HOUSE

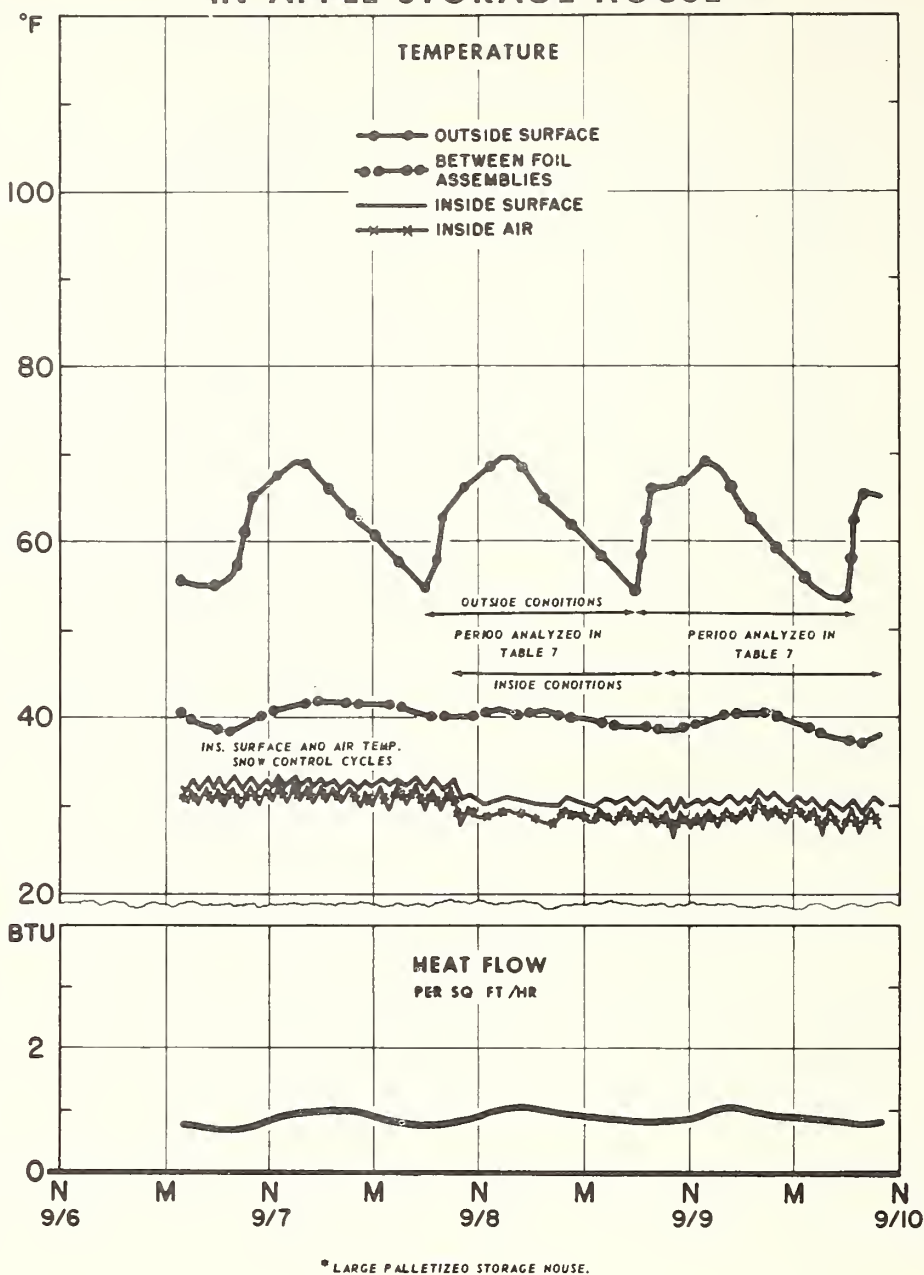
Through North Wall, Location 3\*

## TEMPERATURES AND HEAT FLOW IN APPLE STORAGE HOUSE

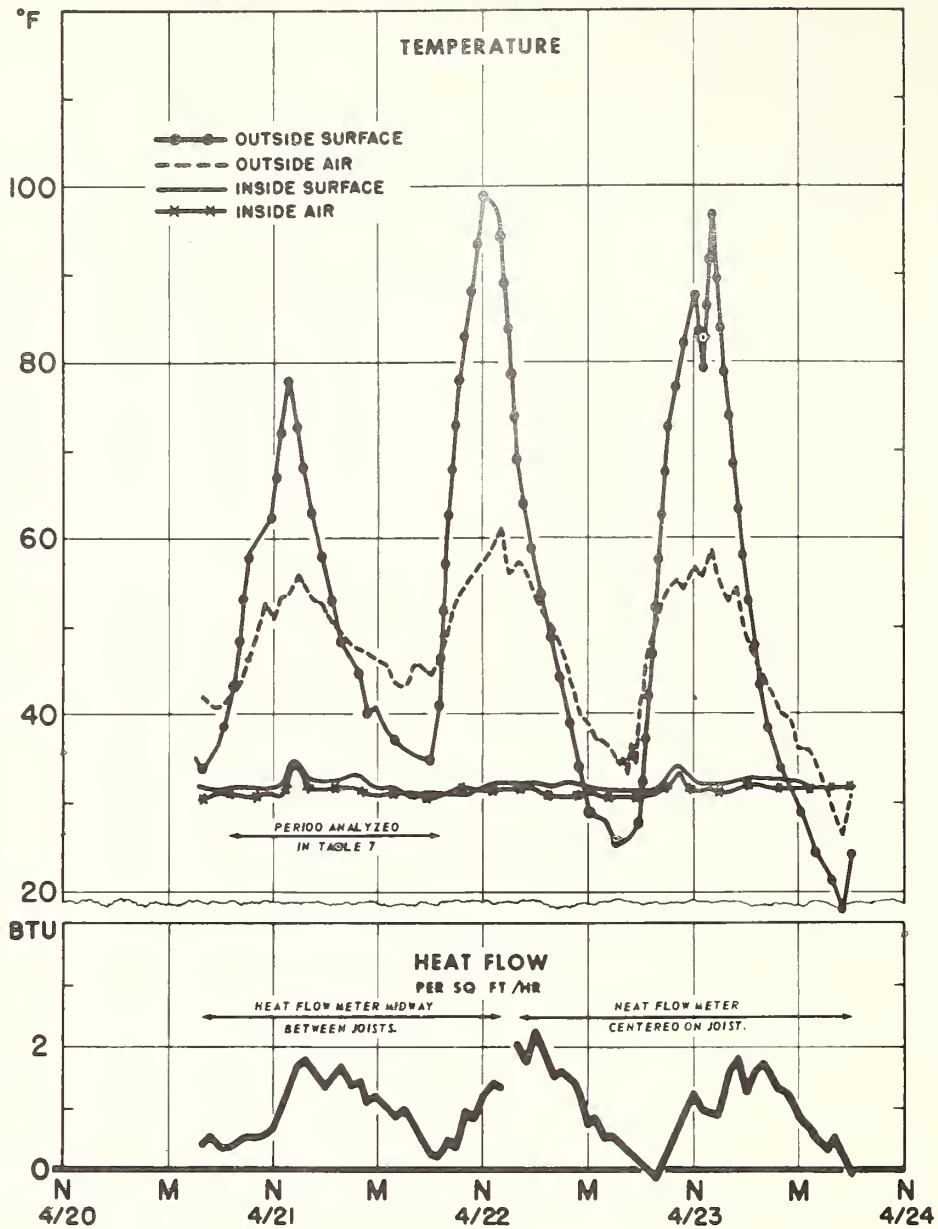
Through Roof, Location 4\*

## TEMPERATURES AND HEAT FLOW IN APPLE STORAGE HOUSE

\* WITH 2 COURSES OF 3-LAYER PREFABRICATED FOIL INSULATION BETWEEN PLYWOOD ROOF DECK AND PLYWOOD SHEATHING THAT FORMS INSIDE.

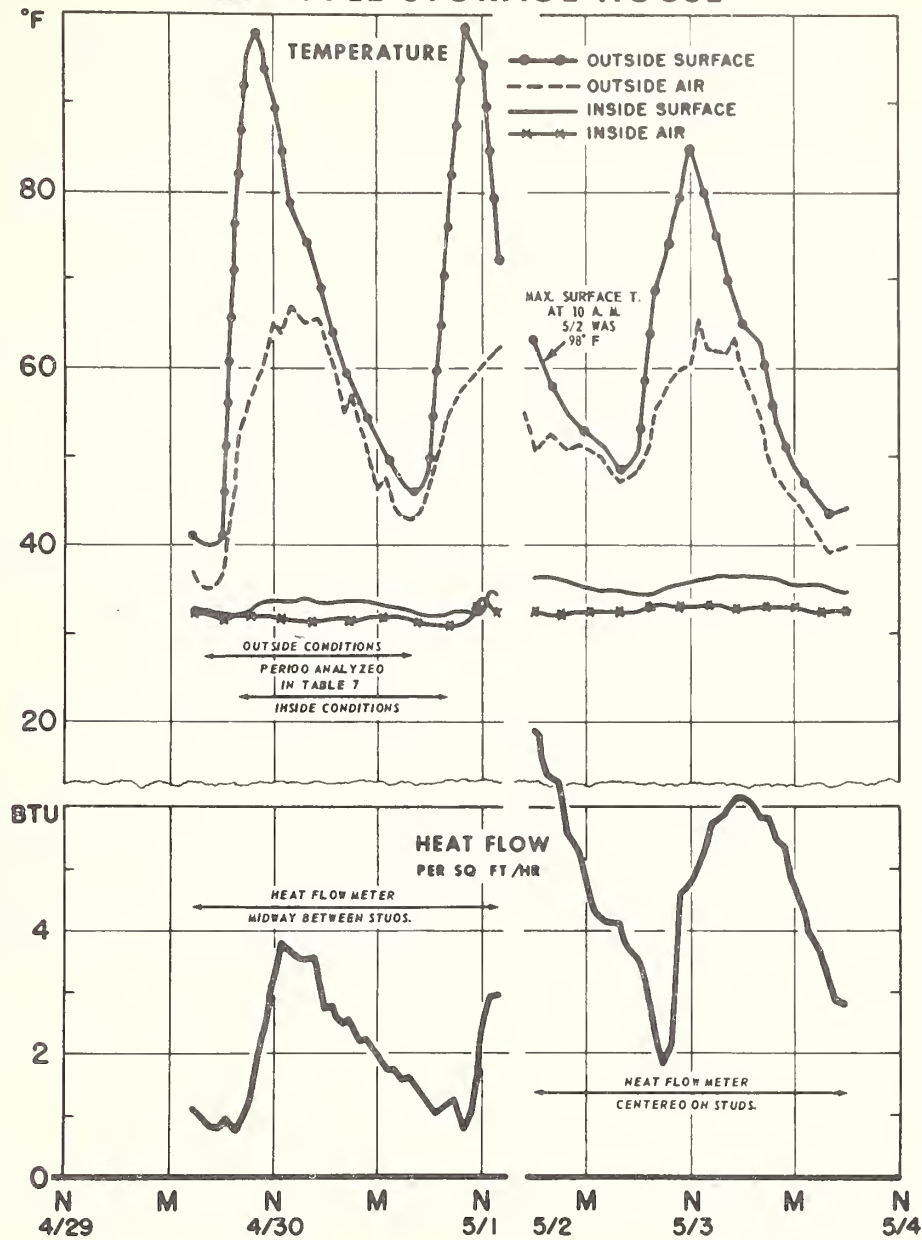
Through Wall, Location 4\*

# TEMPERATURES AND HEAT FLOW IN APPLE STORAGE HOUSE

\* WITH 8 INCH CONCRETE BLOCK WALLS AND REFLECTIVE INSULATION.

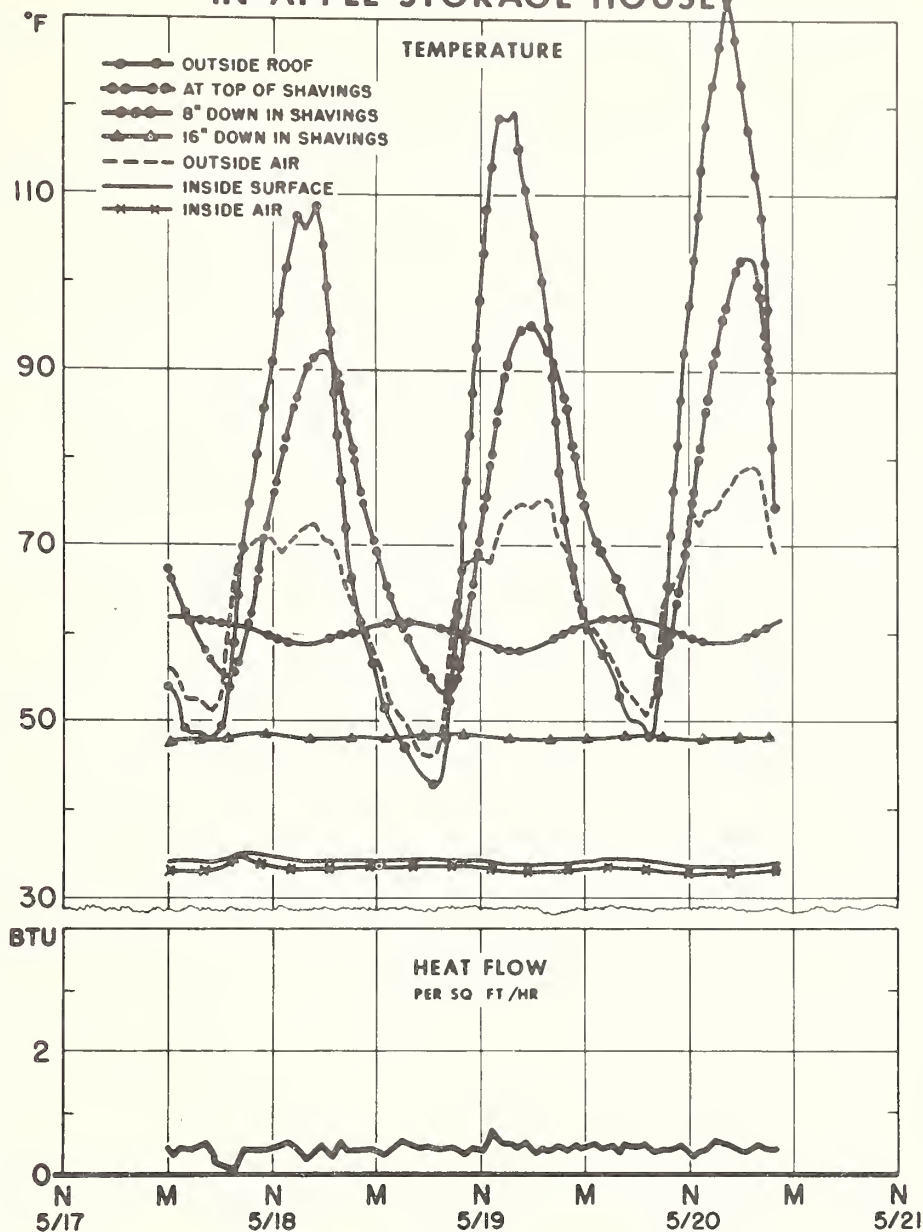
Through Ceiling, Location 5\*

## TEMPERATURES AND HEAT FLOW IN APPLE STORAGE HOUSE

\* LARGE MULTIFLOOR STORAGE WITH 24 INCHES OF SHAVINGS ABOVE CEILING OF UPPER ROOM, UNVENTILATED ATTIC, AND ROOF DECK COVERED WITH COMPOSITION ROOFING AND ALUMINUM PAINT
