# **HEAT LEAKAGE THROUGH FLOORS, WALLS, AND CEILINGS OF APPLE STORAGES**

Marketing Research Report No. 315

Agricultural Marketing Service—Marketing Research Division  
UNITED STATES DEPARTMENT OF AGRICULTURE

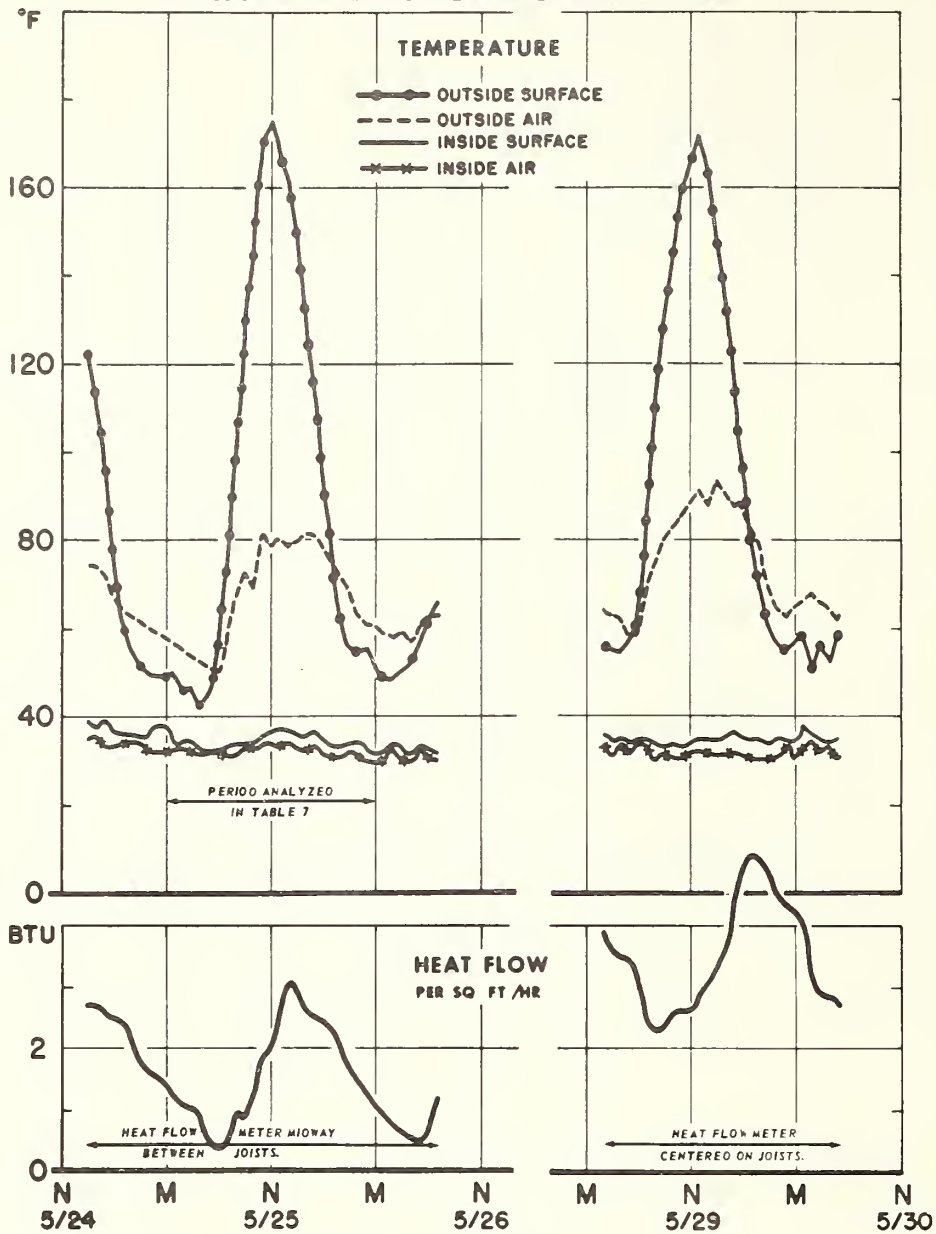
Through Roof, Location 6\*

## TEMPERATURES AND HEAT FLOW IN APPLE STORAGE HOUSE

\* LARGE PALLETIZED STORAGE WITH SLOPING, 3-PLY ROOF COATED WITH ALUMINUM PAINT AND MINERAL WOOL INSULATION.

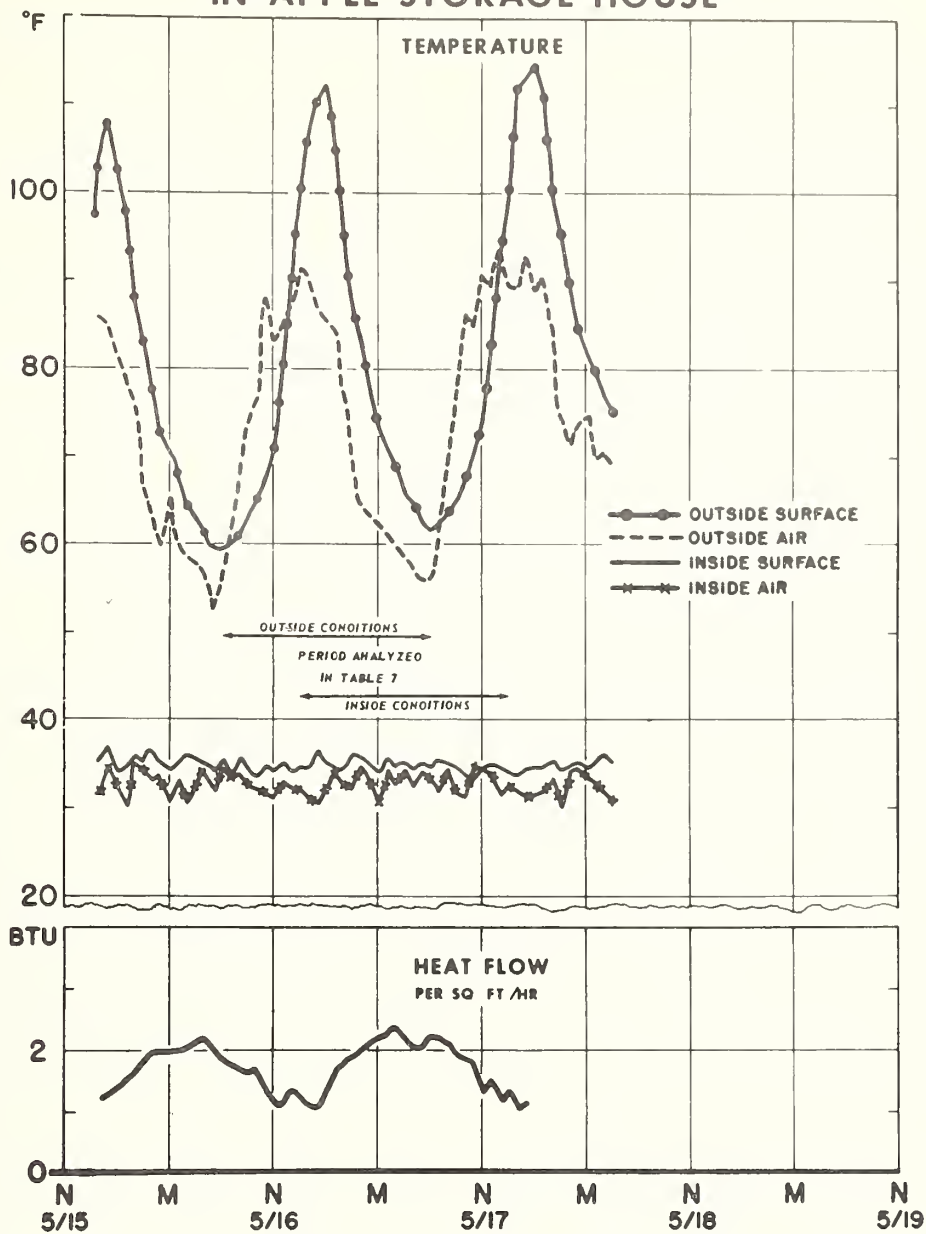
Through Wall, Location 6\*

## TEMPERATURES AND HEAT FLOW IN APPLE STORAGE HOUSE

\* LARGE PALLETIZED STORAGE HOUSE WITH 4-INCH CONCRETE WALLS,  $\frac{1}{8}$ " LAYER OF ALUMINUM FOIL, AND 4-INCH THICK FIBERGLASS INSULATION.

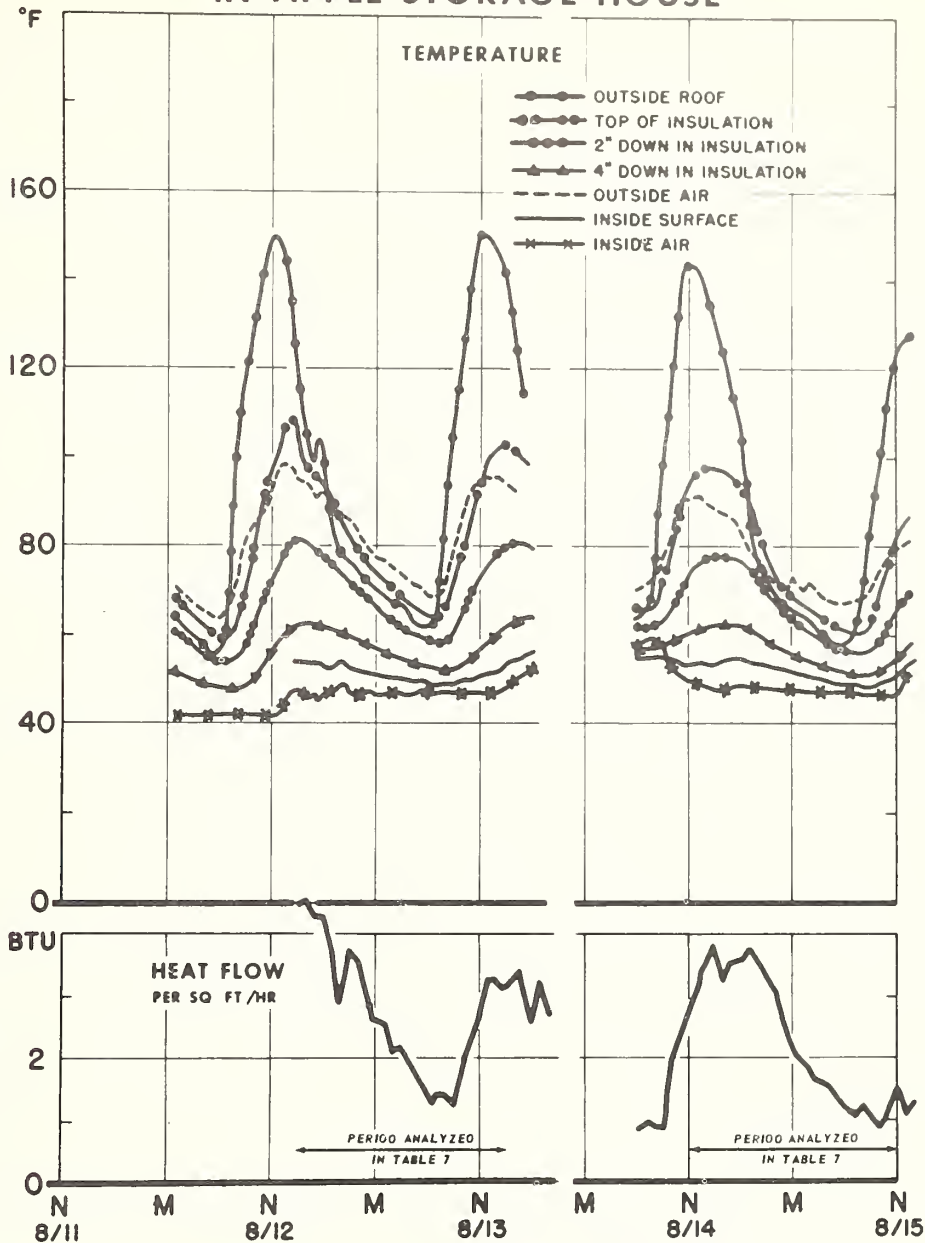
Through Ceiling, Location 7\*

## TEMPERATURES AND HEAT FLOW IN APPLE STORAGE HOUSE

\* WITH 4- TO 5-INCH VERMICULITE FILL SUPPORTED BY 1 INCH GYPSUM CEILING, ROOF 1 TO 10 FEET ABOVE CEILING; WELL VENTILATED ATTIC

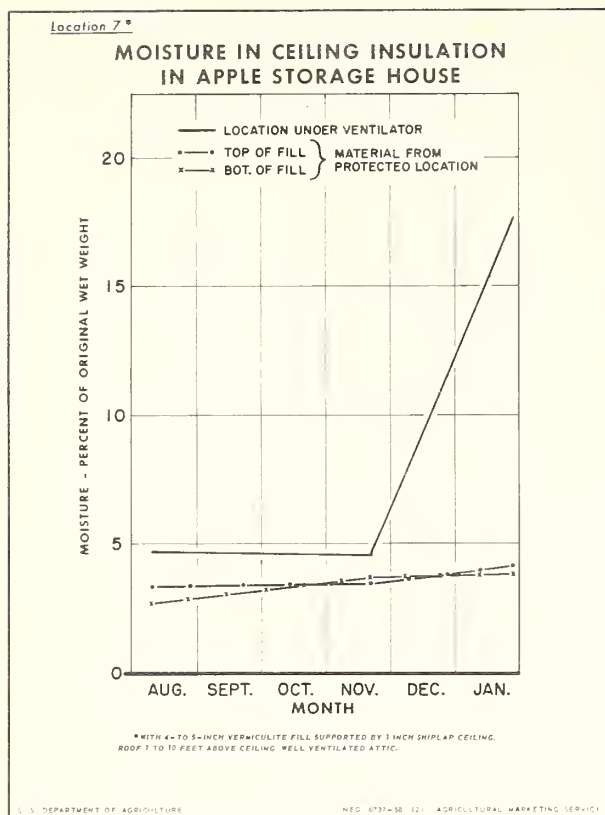
FIGURE 28

Figure 28 presents the data obtained. The change in moisture content in the protected location between August and January is not great, nor are there any remarkable differences

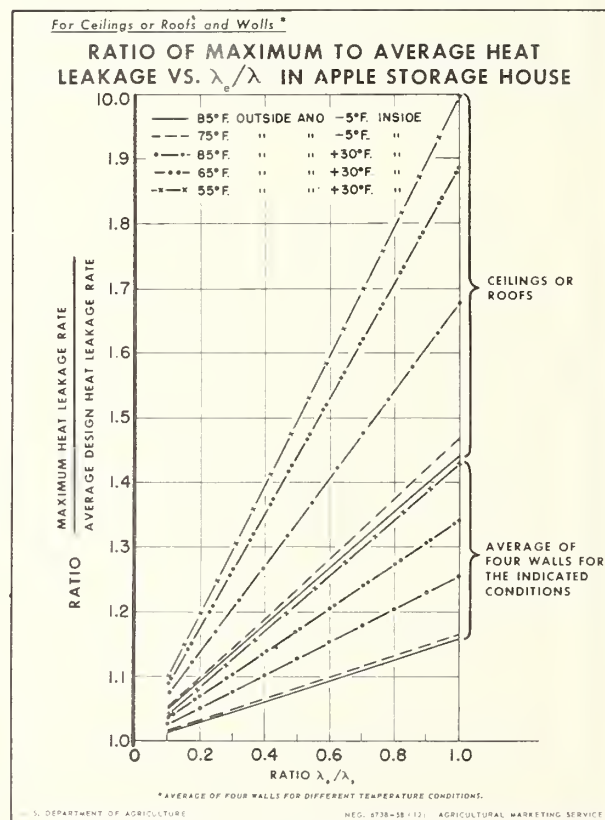
FIGURE 29

The effect of the second factor is best illustrated by figure 29. The ratio of maximum to average calculated heat flow rates is plotted against different  $\lambda_o/\lambda_s$  ratios through the range of 0.1 to 1.0 for different combinations of average outside design conditions and inside temperatures. Details of this calculation are given

in appendix B, but it may be stated briefly that the design conditions given on the figure determine the average temperature difference at which the various storages operate. The amplitude of variation between maximum and average sol-air temperature has been taken from the ASHAE Guide for the 85° outside design condition and has been arbitrarily decreased somewhat for the other outside design conditions. It can be seen that with freezer storage application, the average temperature difference is a greater factor than the sol-air temperature amplitude and that the ratio of maximum to average heat flow for a given  $\lambda_e/\lambda_s$  ratio is less than is experienced with a cooler operating at the same outside design condition. Coolers that do not operate in the warmest part of the year or that are located in mild climates show a considerably higher ratio of maximum to average flow rate, because in these instances the average design temperature difference is about as great as the amplitude of sol-air temperature. The steep slope of the lines for the 55° outside temperature design indicates that a storage that has been designed on an optimistic expectation of low outside temperatures may find the maximum heat flow rate at midday a very serious factor.

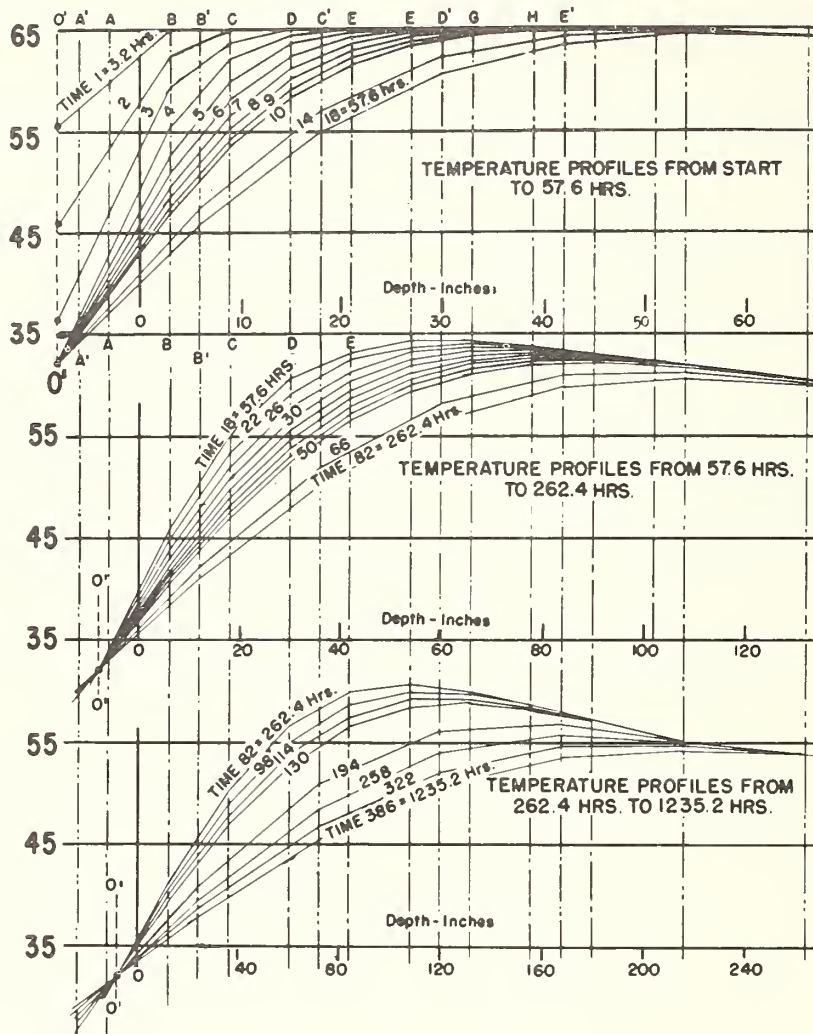
# ANALYTICAL DEVELOPMENT OF GROUND TEMPERATURE PROFILES AT LOCATION 2

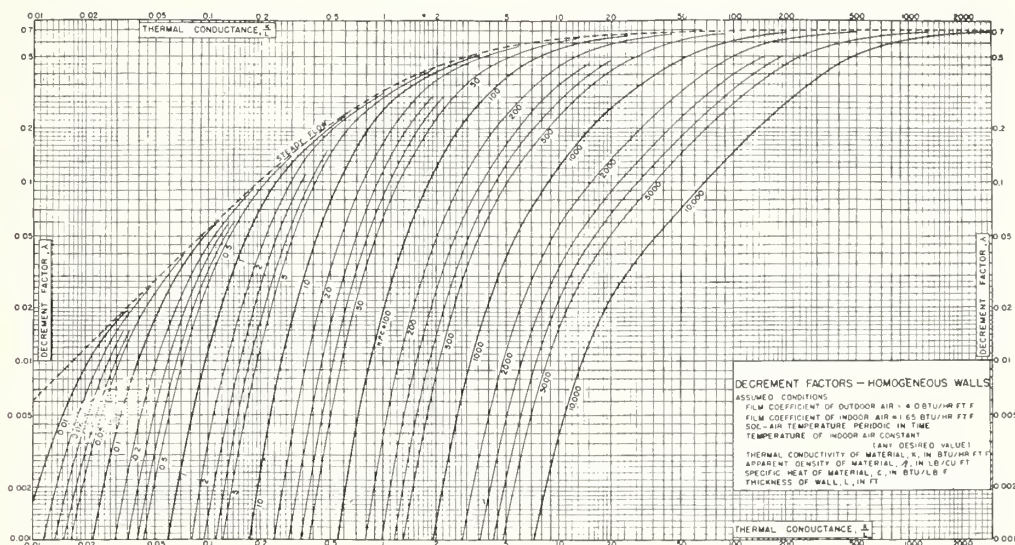
FIGURE 31.—Chart for determining decrement factors.

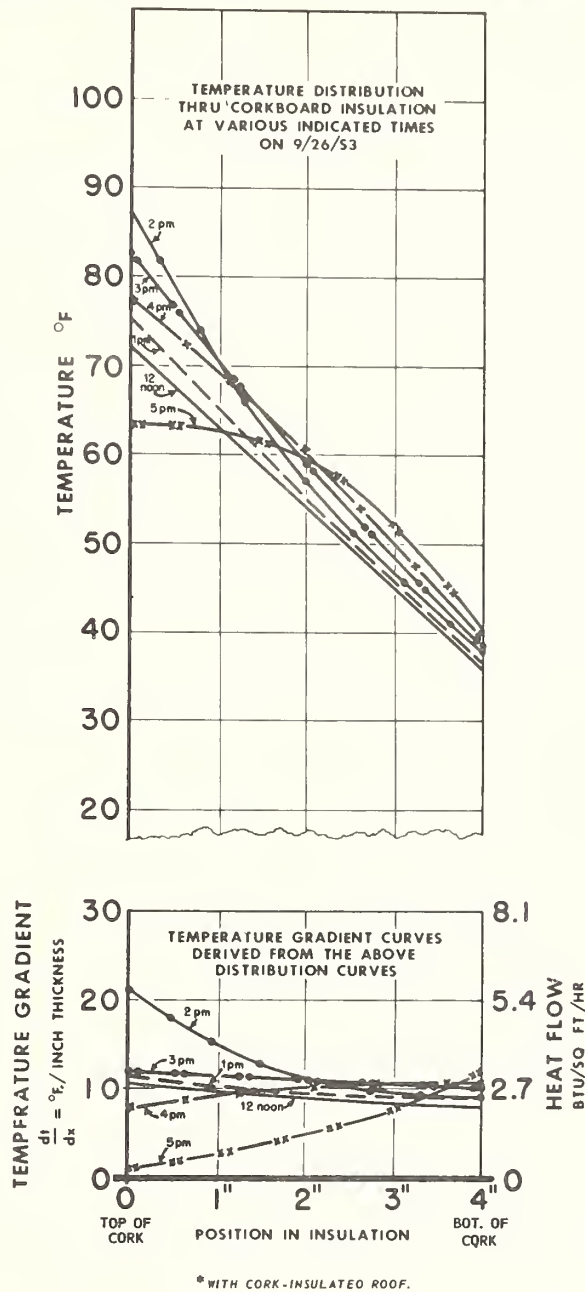
Through Aluminum-Painted Roof, Location 3\*

## TEMPERATURE DISTRIBUTION AND GRADIENT CURVES IN APPLE STORAGE HOUSE

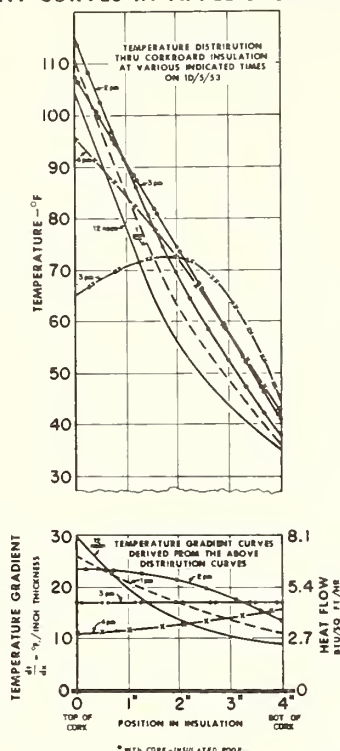
FIGURE 34

Through Block-Pointed Roof, Location 3\*

# TEMPERATURE DISTRIBUTION AND GRADIENT CURVES IN APPLE STORAGE HOUSE
