HANDLING TOMATOES in PALLET BOXES

Marketing Research Report No. 802

Agricultural Research Service
UNITED STATES DEPARTMENT OF AGRICULTURE
in cooperation with
MICHIGAN STATE UNIVERSITY AGRICULTURAL
EXPERIMENT STATION

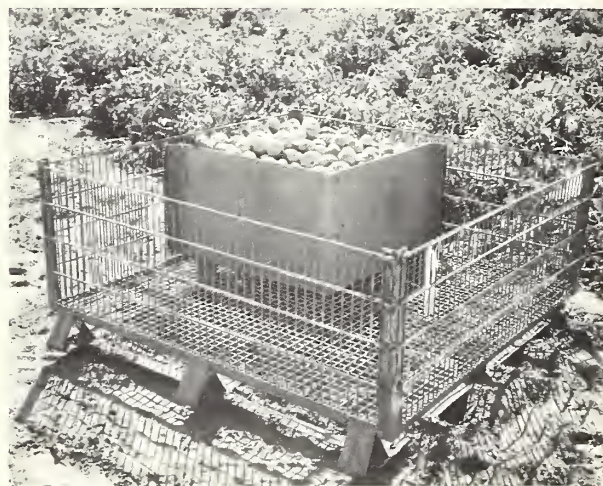
Wire mesh of 7-gage wires on $1\frac{1}{4}$ -inch centers was used for the vertical side members. The horizontal sides were 3-gage wires on 3-inch centers. The bottom wires were 7-gage spaced $1\frac{1}{4}$ inches on center supported by $\frac{3}{16}$ - by 1-inch-steel members. The corner posts were $1\frac{1}{2}$ - by $1\frac{1}{2}$ - by $\frac{1}{8}$ -inch angle iron. The legs were supported by corner brackets when the pallet boxes were stacked. All metal was galvanized or plastic-coated.

FIGURE 5.—Wire-mesh pallet box with one-quarter partition.

5. Wire-mesh box (fig. 5).

Both green and ripe fruits were used to fill the pallet boxes because sufficient ripe fruits had not matured at the time of harvest. The control treatments consisted of fruit hand-harvested into a quarter of a wire-mesh pallet box (fig. 5).

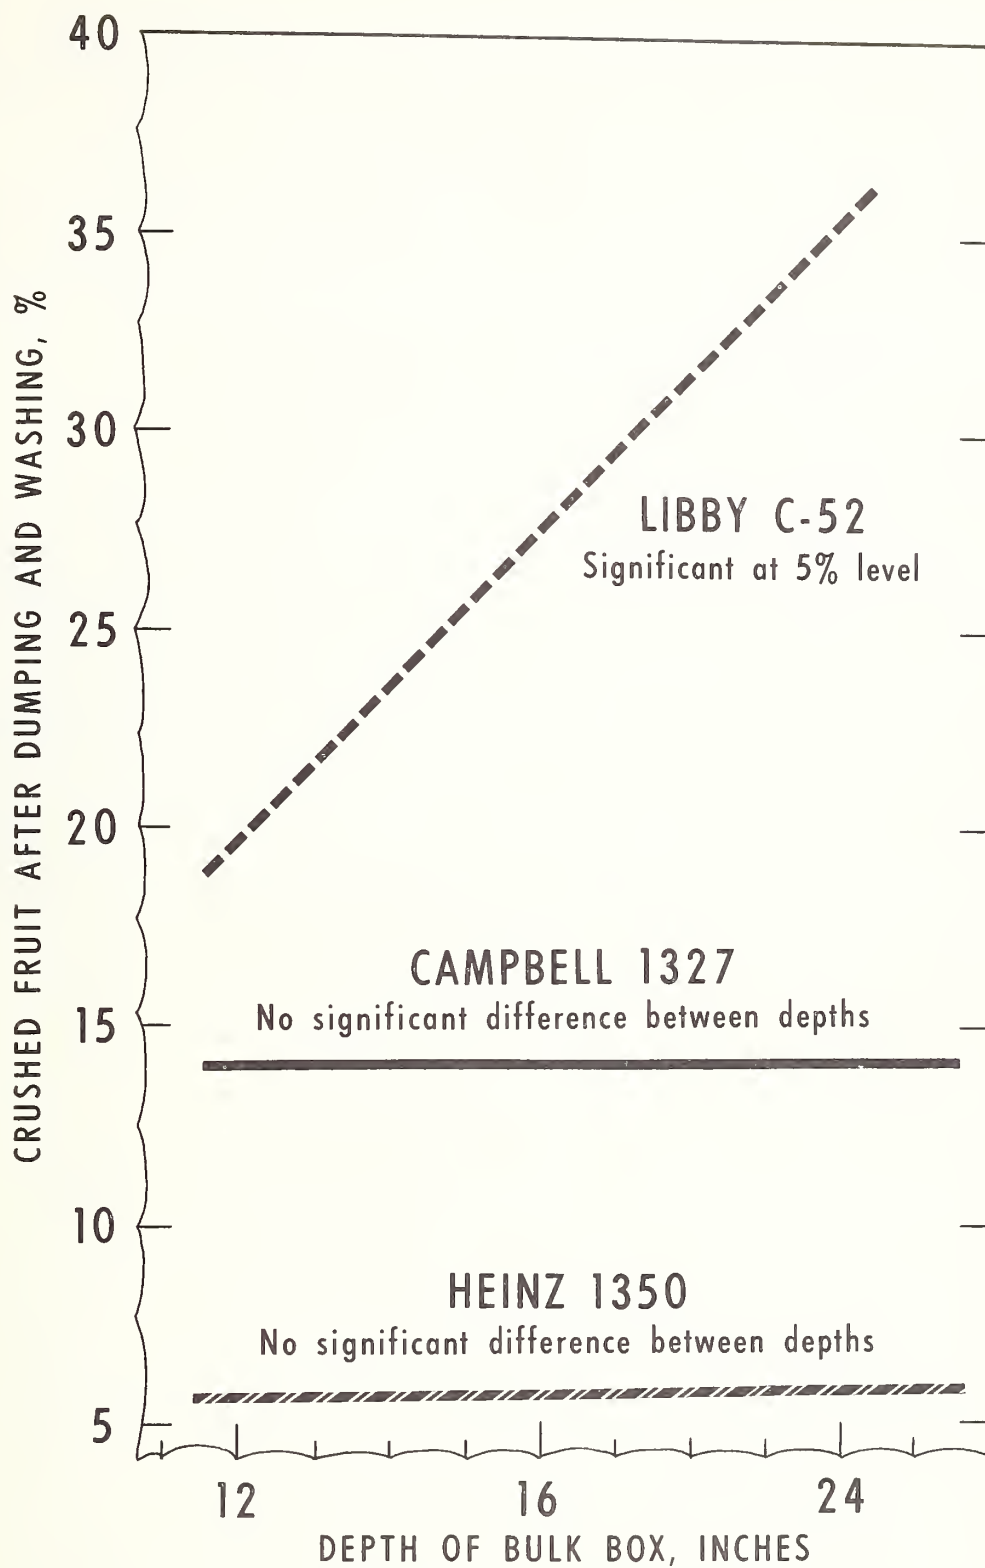
FIGURE 7.—The relationship between depth of bulk box and crushed ripe tomatoes after dumping and washing.

There were more cracked fruits in the bottom 4 inches of all boxes containing variety C-52 than in those containing either variety 1327 or variety 1350. Cracking was greater as the depth of box increased for the varieties C-52 and 1350, but not for variety 1327 (fig. 6). After the fruit was washed, there was no difference in the number of crushed fruit from the three depths of boxes studied for the varieties 1327 and 1350 (fig. 7). As the depth was increased from 12 to 24 inches, the number of crushed fruit increased for the variety C-52. The variety 1350 had fewer crushed fruit than variety 1327, and variety 1327 fewer than variety C-52.

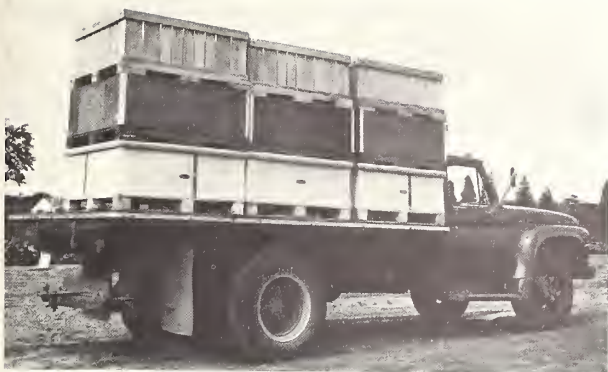
FIGURE 8.—Pallet boxes filled with tomatoes ready for hauling.

After harvest, the pallet boxes were transferred by forklift onto a truck (fig. 8) and hauled 20 miles to the dumping and washing apparatus.

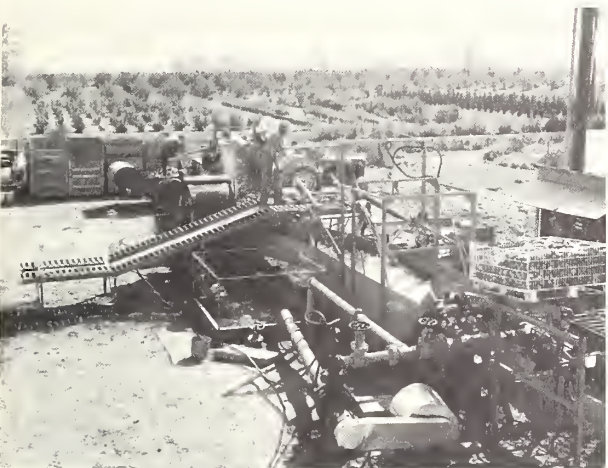
FIGURE 9.—Michigan State University (M.S.U.) pallet box dumper, flume, washing system as used in 1963.

Within 24 hours after harvest, the tomatoes were dumped with the M.S.U. experimental pallet box dumper and washed (fig. 9). Before dumping, samples of 50 ripe fruit each were taken from the top 4 inches and bottom 4 inches of each box and the number of fruit having cracks over 1 inch long was recorded. These samples were not returned to the boxes. After dumping and washing, the number of crushed fruit was determined by taking 100-fruit samples of each box from the sorting table.

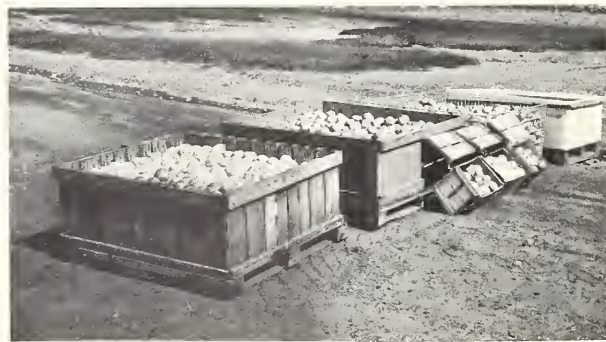
FIGURE 10.—Bulk boxes and 25-pound crates used in study of handling mature-green tomatoes.

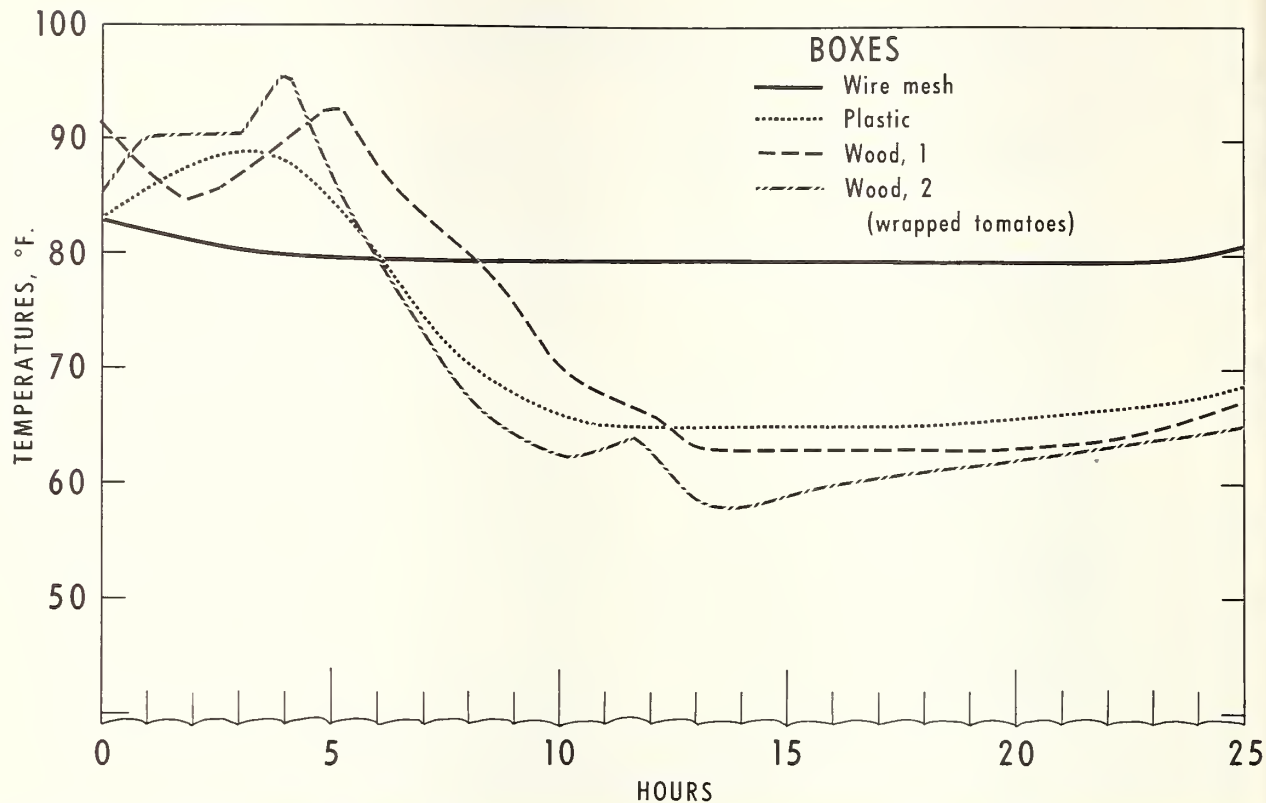
FIGURE 11.—Tomato temperature in wood, wire-mesh, and plastic pallet boxes from the time of loading until unloading.

During the trip, the temperature of the tomatoes was recorded on a thermograph imbedded in the center of each type of pallet box.
