**E-FLOWS FOR THE LIMPOPO RIVER BASIN:
PRESENT ECOLOGICAL STATE –
DRIVERS OF ECOSYSTEM CHANGE**

(Submitted in partial fulfilment of Milestone 6 : Wet Season Field Survey Report)

Report citation: O'Brien, G.; Dickens, C.; Stassen, R.; Erasmus, H.; Herselman, S.; van der Waal, B.; Wepener, V.; Pearson, H.; LeRoux, H.; Villholth, K.; Ebrahim, G.; Magombeyi, M.; Riddell, E.; Petersen, R. 2022. *E-flows for the Limpopo River Basin: present ecological state - drivers of ecosystem change*. Project report prepared by the International Water Management Institute (IWMI) for the United States Agency for International Development (USAID). Colombo, Sri Lanka: International Water Management Institute (IWMI); Washington, DC, USA: USAID. 296p. (E-flows for the Limpopo River Basin: Report 5). doi: <https://doi.org/10.5337/2022.220>

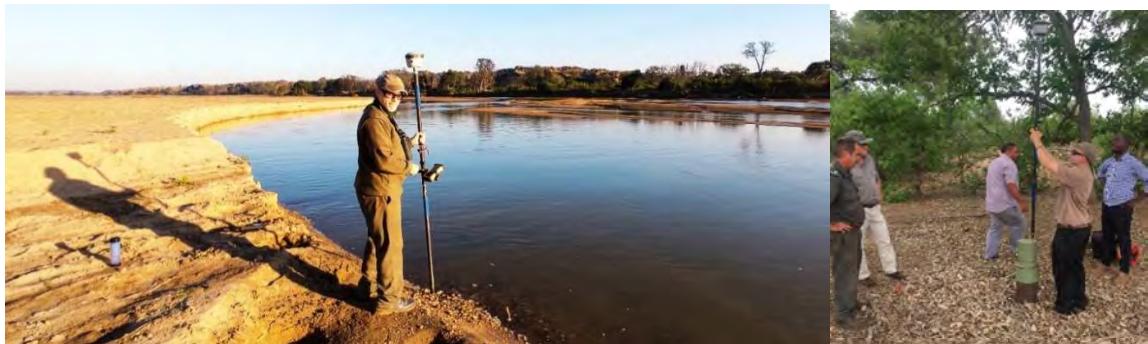
Taking riverbed and water level (left) and borehole casing (right) elevation in the Limpopo River downstream of Limpopo/Shashe confluence at the beginning of the low flow season

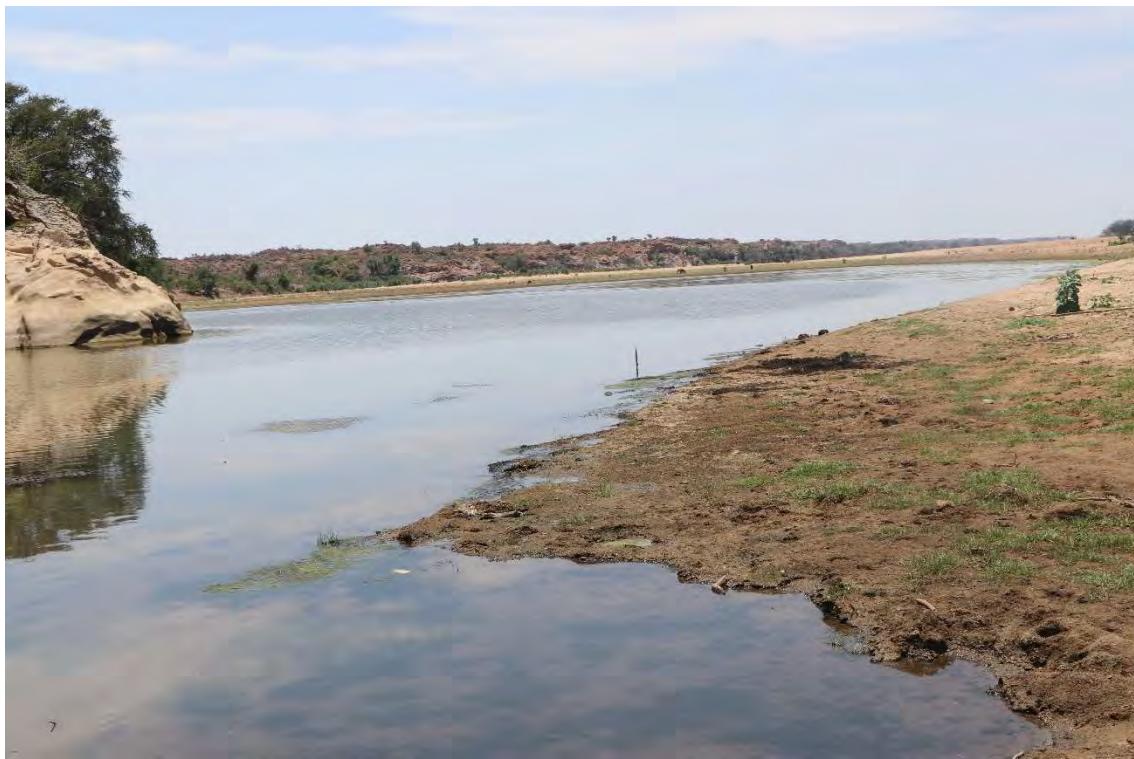
FIGURE 5 POOL NEAR LIMPOPO-SHASHE CONFLUENCE IN MAPUNGUBWE (19/11/2020)

Further work using remote sensed data to identify pools (Figure 2.5) in the ephemeral rivers was done to understand the occurrence and persistence of these pools and how they contributed to sustenance of E-flows and ecosystems during the dry season. The remote sensed data was sourced from the South Africa National Space Agency (SANSA) for the period of 2016-2021 for the whole Limpopo River Basin.

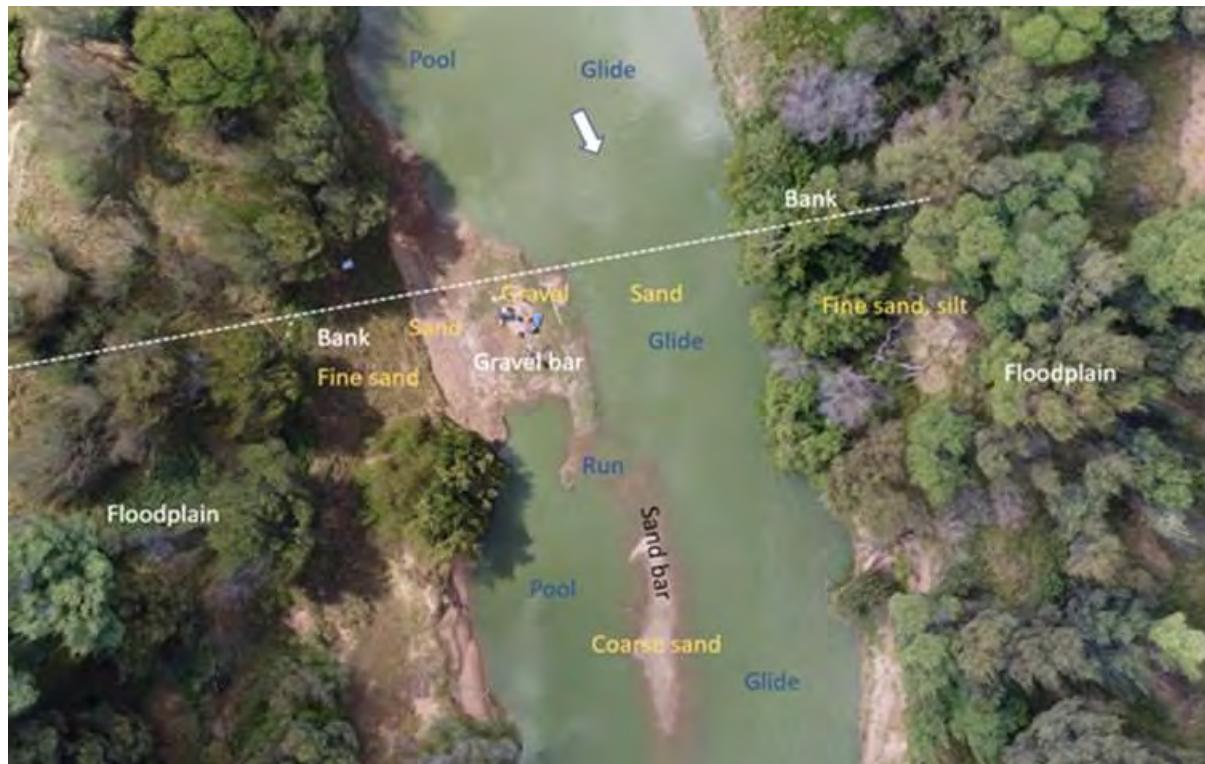
FIGURE 7: ORTHOPHOTO SHOWING HYDRAULIC BIOTYPES, MORPHOLOGICAL FEATURES AND SEDIMENT COMPOSITION

The Crocodile River site is located along a pool riffle/glide sequence with a wandering river plan form (FIGURE 7). The channel cross section can be seen in FIGURE 8 with some site images shown in FIGURE 9. Flood debris was visible at 7.2 m on the flood plain.

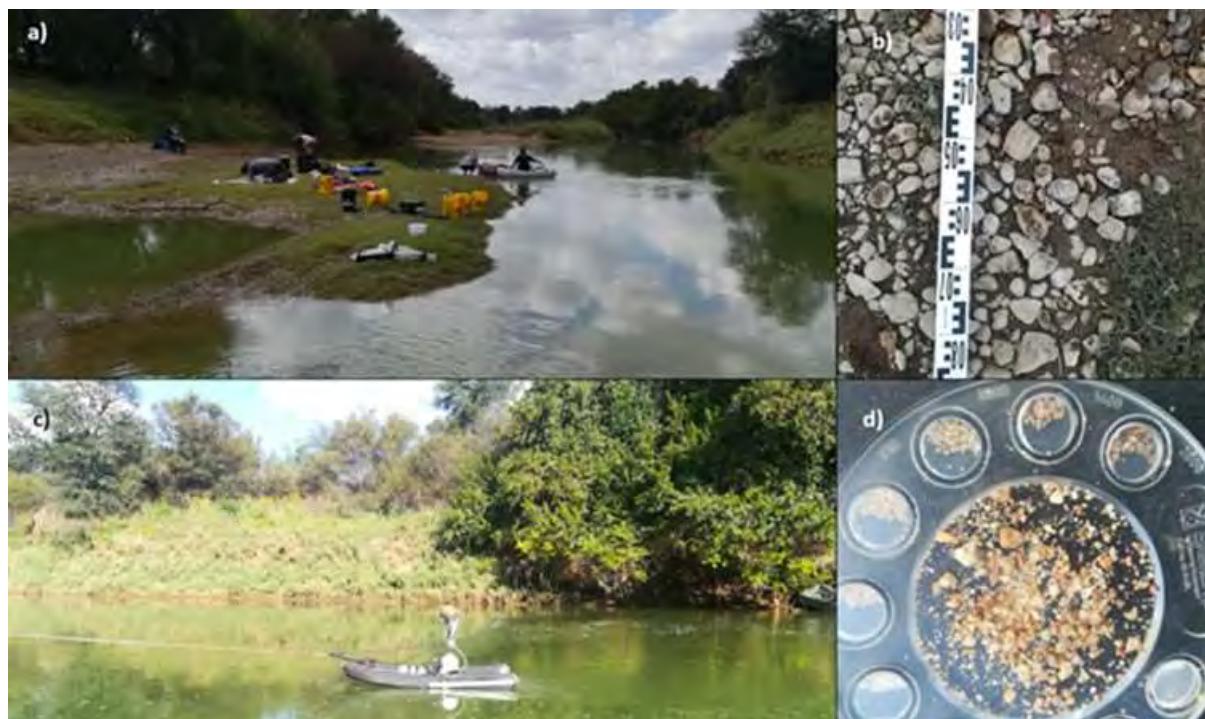
FIGURE 9: SITE IMAGES SHOWING A) GRAVEL BAR IN THE FOREGROUND AND SAND BAR IN THE DISTANCE; B) PARTLY EMBEDDED GRAVELS; C) WELL VEGETATED BANKS; AND D) COARSE SAND AND FINE GRAVEL FROM SAND BARS.

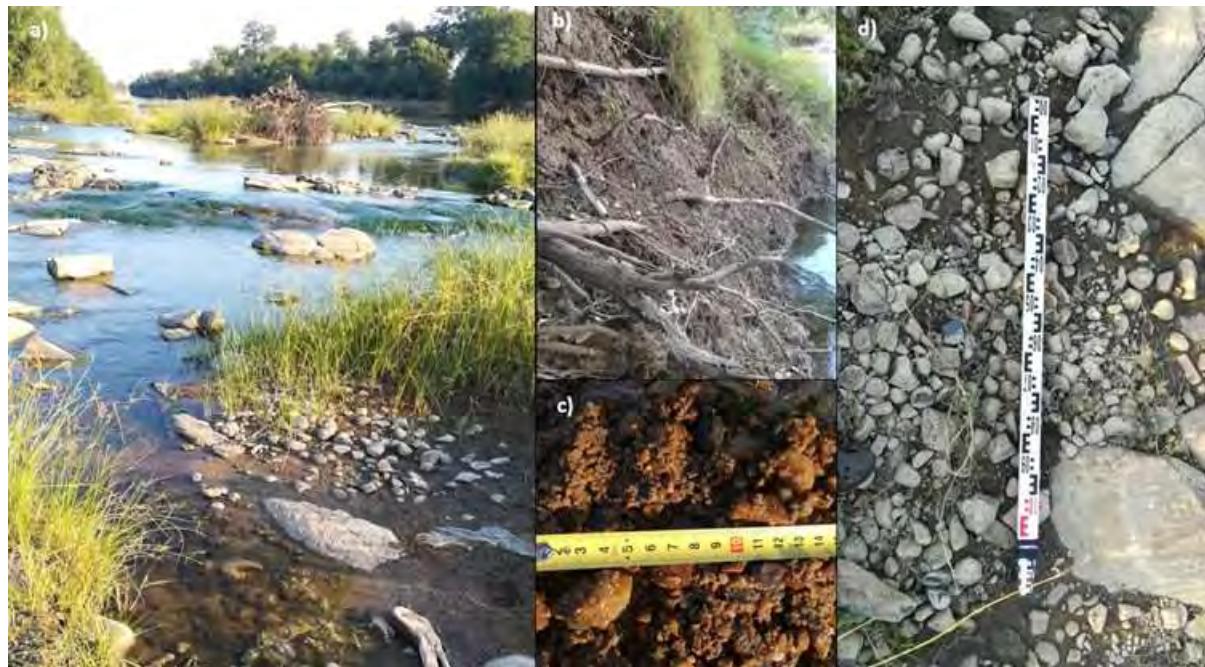
FIGURE 14: SITE IMAGES SHOWING A) EMBEDDED GRAVEL BAR IN THE FOREGROUND AND BEDROCK AND BOULDER SUBSTRATES; B) COHESIVE BANKS SHOWING EROSION; C) FINE GRAVEL AND COARSE SAND DEPOSITED IN THE RIFFLES; AND D) PARTLY EMBEDDED GRAVEL SUBSTRATES

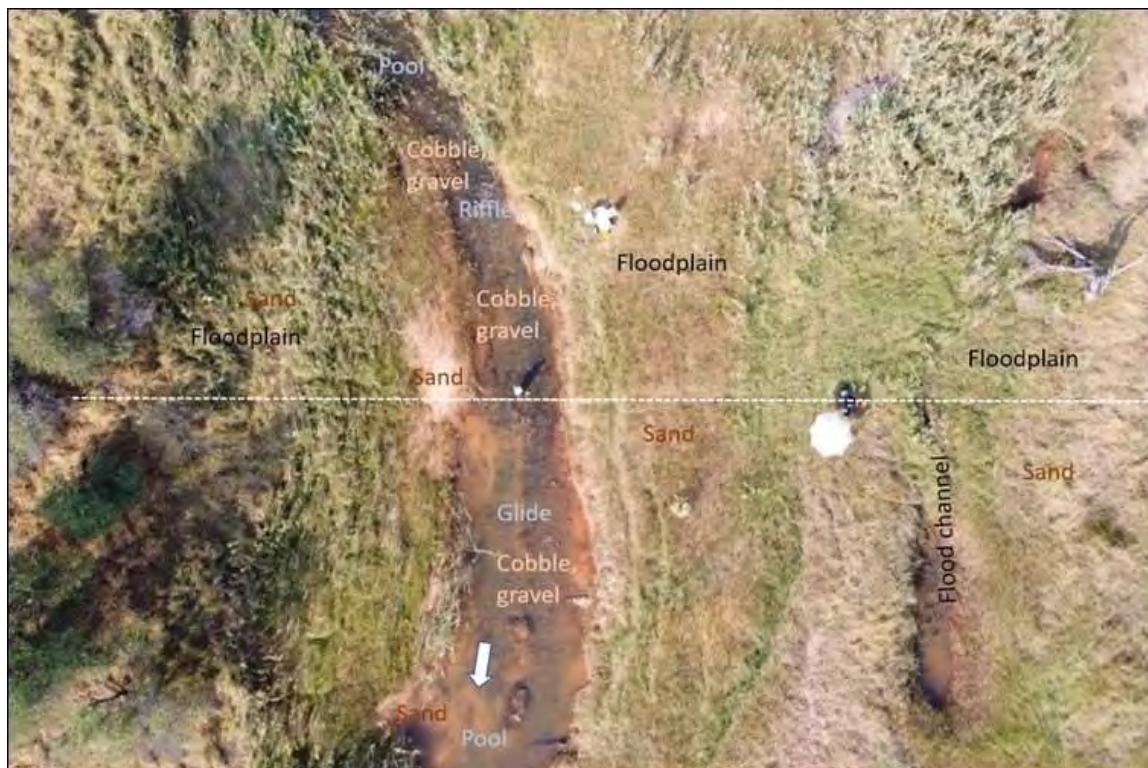
FIGURE 17: ORTHOPHOTO SHOWING MORPHOLOGICAL FEATURES AND SEDIMENT COMPOSITION OF THE MATLABAS RIVER.

This relatively small river is in a good condition. The single channel follows a pool riffle section with some localised bedrock (FIGURE 17). Small cobble and gravel form the riffle areas, with sandy sections where flow velocities are lower (wider shallow sections or pool areas) (FIGURE 18). The cobbles are moderately embedded with sand and gravel, resulting in partly fixed substrates. Sandy habitats dominate upstream and downstream of the site with multiple channels, mainly high flow channels, between sandy islands (FIGURE 19). The vegetation cover is good with low evidence of trampling at the site. No flood level recorded.

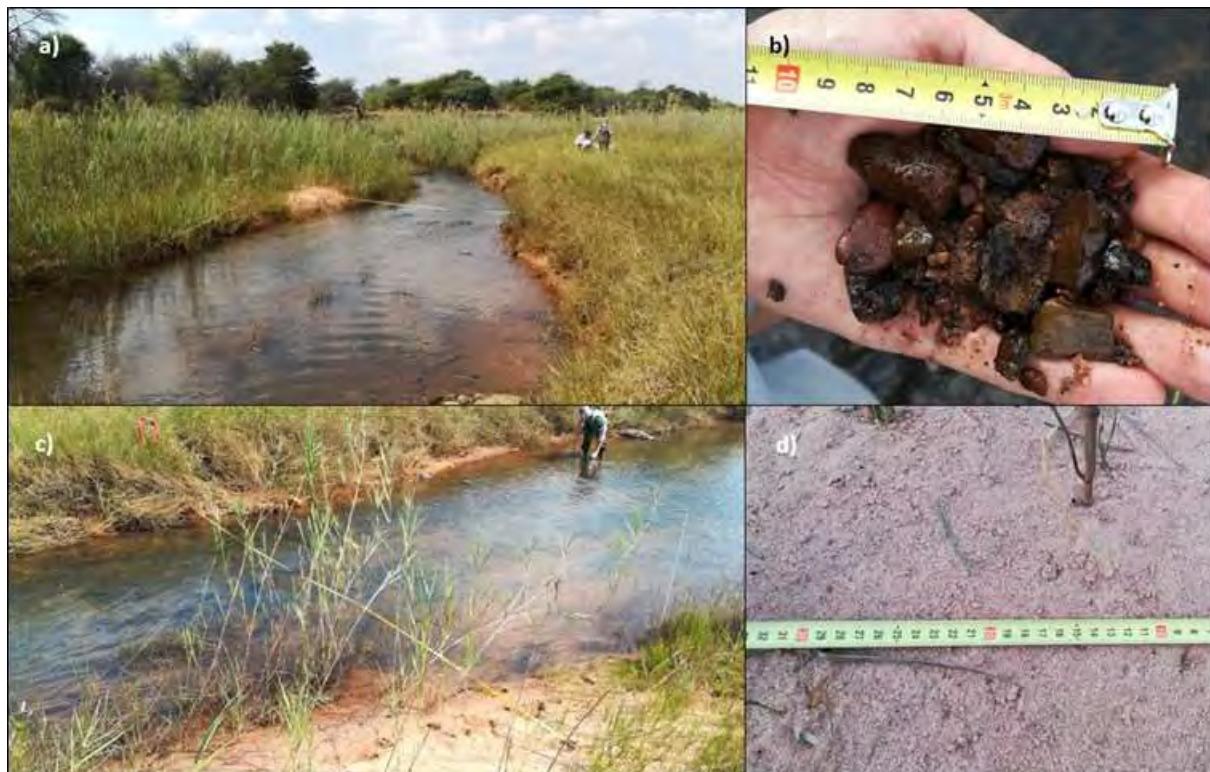
FIGURE 19: SITE IMAGES SHOWING A) AN UPSTREAM VIEW OF THE WELL VEGETATED CHANNEL; B) FINE GRAVEL FROM THE RIFFLE SECTION; C) SAND INSET BENCH ALONG RIGHT BANK; D) RECENT SAND DEPOSIT ALONG THE CHANNEL MARGIN

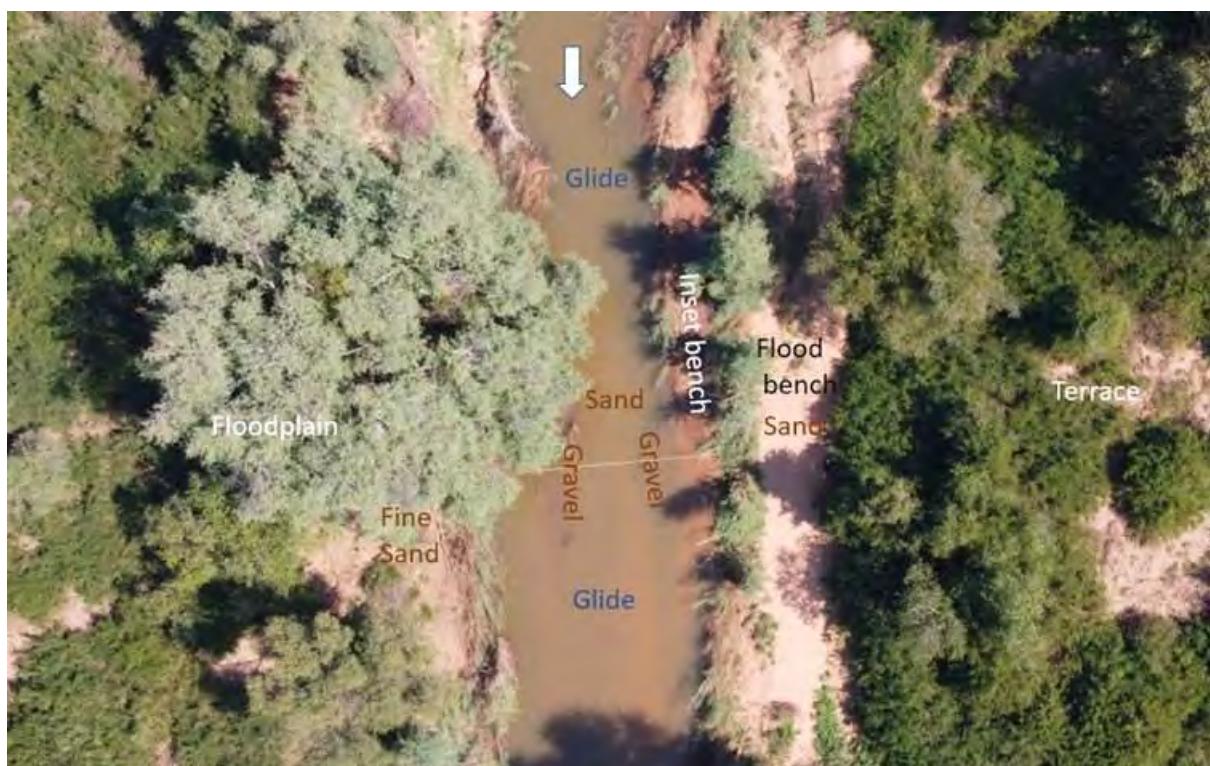
FIGURE 22: ORTHOPHOTO SHOWING MORPHOLOGICAL FEATURES AND SEDIMENT COMPOSITION OF THE LEPHALALA RIVER.

The site is situated along a sandy reach immediately downstream of a steep bedrock section with a weir and bridge. It has a single channel with inset benches, flood benches and a high floodplain/terrace (FIGURE 22, FIGURE 23). The bed consists mostly of fine gravel and coarse sand (FIGURE 24). Narrow elongated medium gravel bars form in the channel and provide anchor to reeds. The Banks are composed of fine sand and silt, with recent medium grained sand deposits on the flood benches. There is evidence of recent high flows with extensive sand deposits and flood debris on flood prone areas. Shallow sandy pools are likely at low flow, with deeper pools associated with bedrock sections. The observed flow was mostly a glide type due to the largely uniform bed structure. Flood debris surveyed at 6.8m.

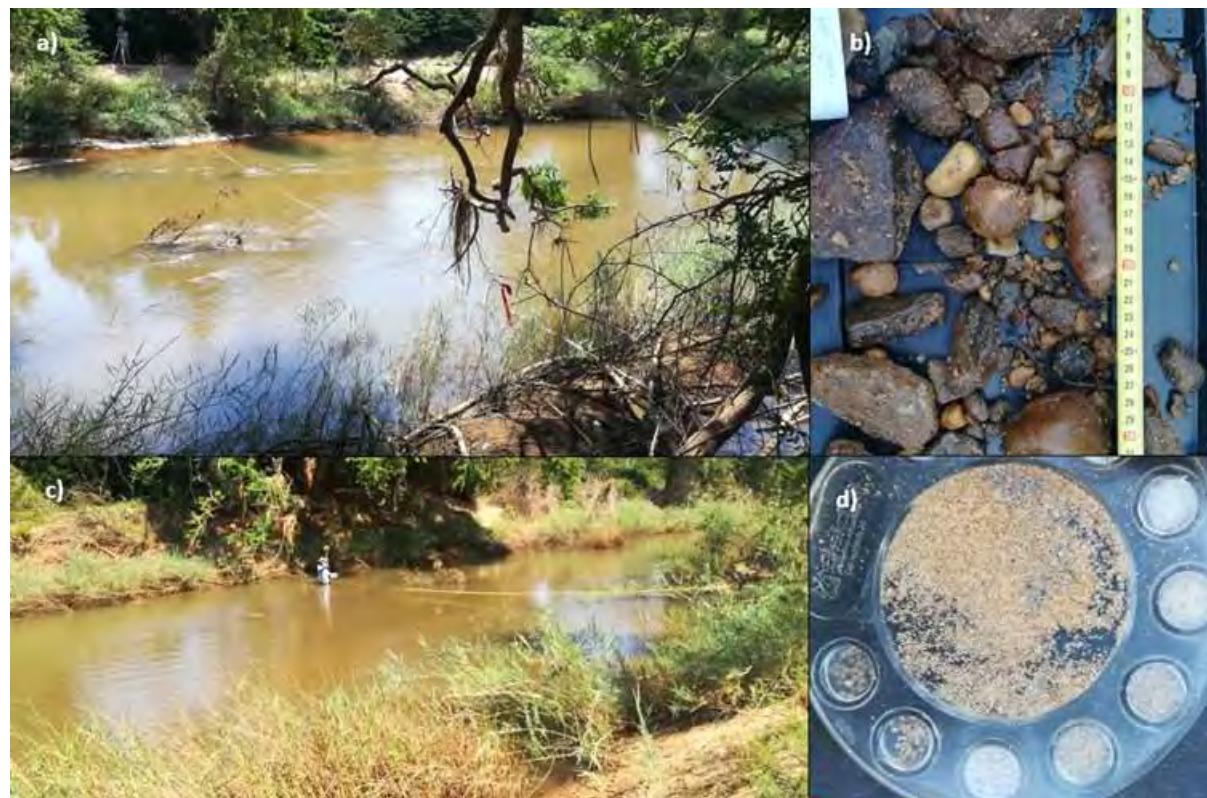
FIGURE 24: SITE IMAGES SHOWING A) VIEW OF THE CHANNEL FROM THE RIGHT BANK; B) GRAVEL FROM ELONGATED GRAVEL BARS; C) CHANNEL VIEW FROM LEFT BANK; D) RECENTLY DEPOSITED SAND FROM FLOOD BENCH

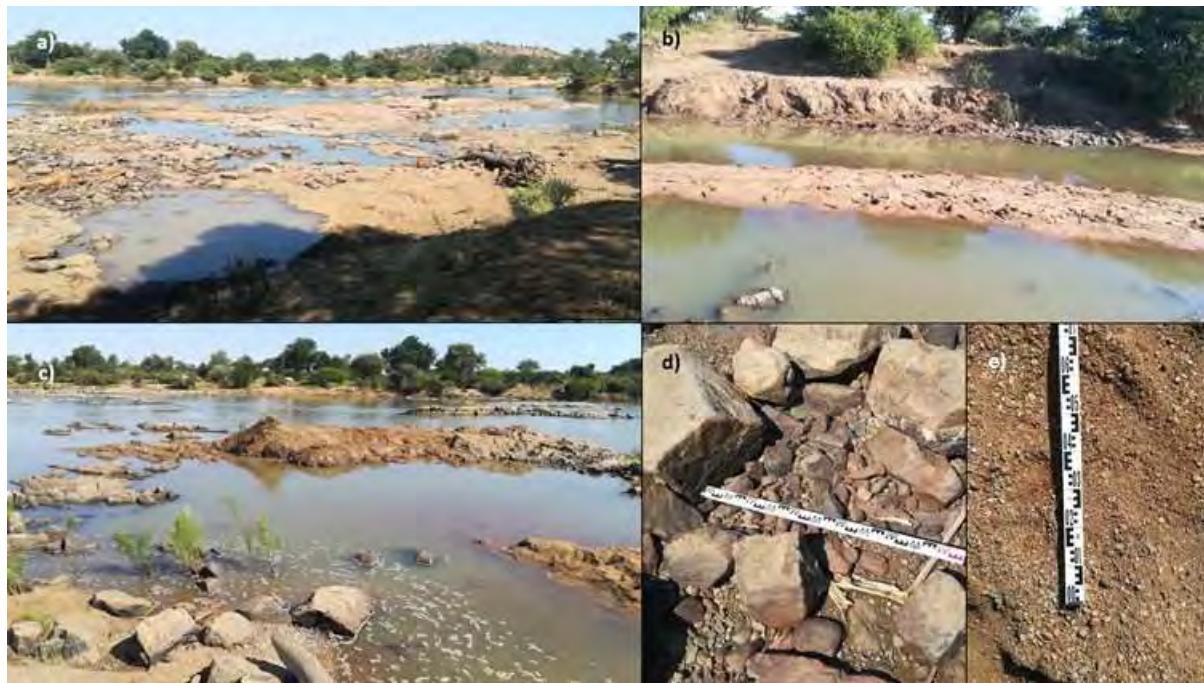
FIGURE 29: SITE IMAGES SHOWING A) SCATTERED BOULDERS OVER BEDROCK ALONG THE LEFT BANK; B) SAND AND FINE GRAVEL BAR IN A HIGH FLOW CHANNEL ALONG THE RIGHT BANK; C) FINE GRAVEL DEPOSITS AND BEDROCK CORE BAR; D) COBBLE AND BOULDER SUBSTRATES; E) AND GRAVEL SUBSTRATES

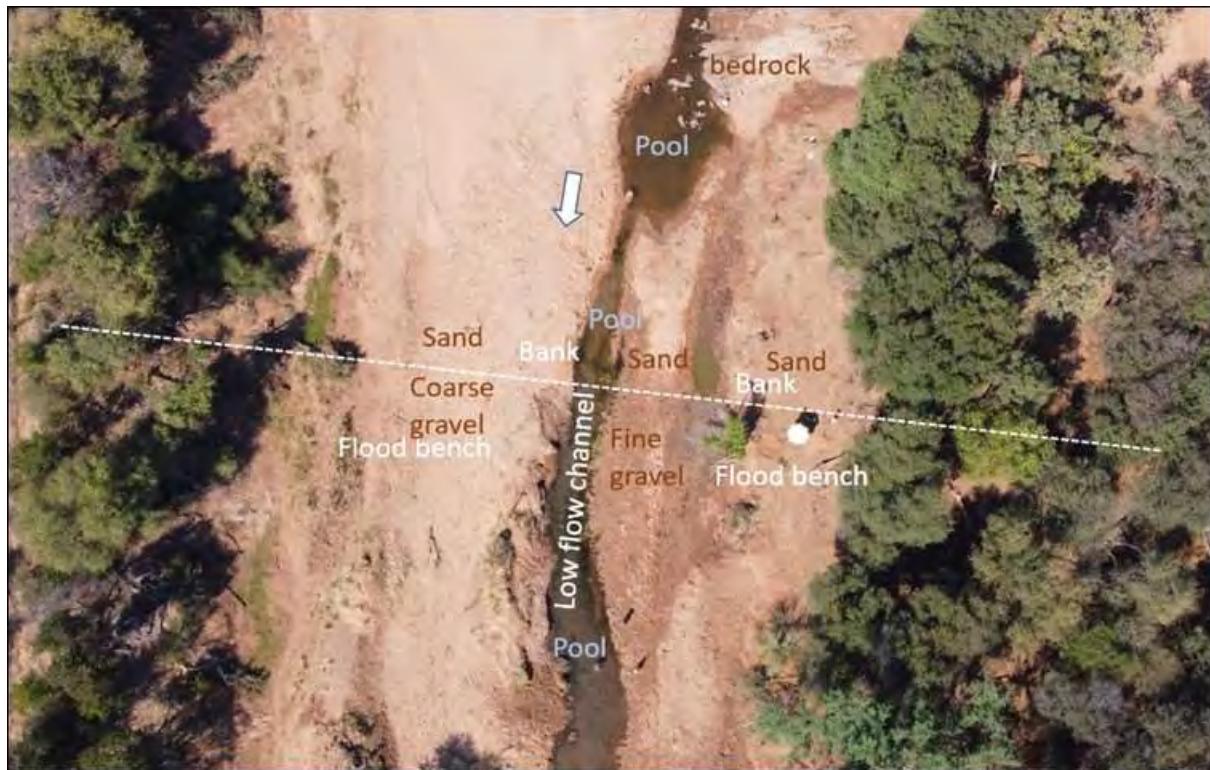
FIGURE 33: ORTHOPHOTO SHOWING MORPHOLOGICAL FEATURES AND SEDIMENT COMPOSITION OF THE MOGALAKWENA RIVER.

The Mogalakwena is a mixed bed single channel with a wandering planform (FIGURE 33, FIGURE 34). The site is located downstream of a steep bedrock section with a weir on it. The river follows a pool riffle sequence when there is flow (no perceptible flow during field visit; FIGURE 35). Coarse sand and gravels dominate the relatively flat bed. Banks consist of fine sand and silt, with medium sand deposits on the left flood bench. The right flood bench has a gravel cover. Low signs of siltation in the pools. The banks are poorly vegetated and eroding, with short sections of bank that is undercut. The banks are trampled by game.

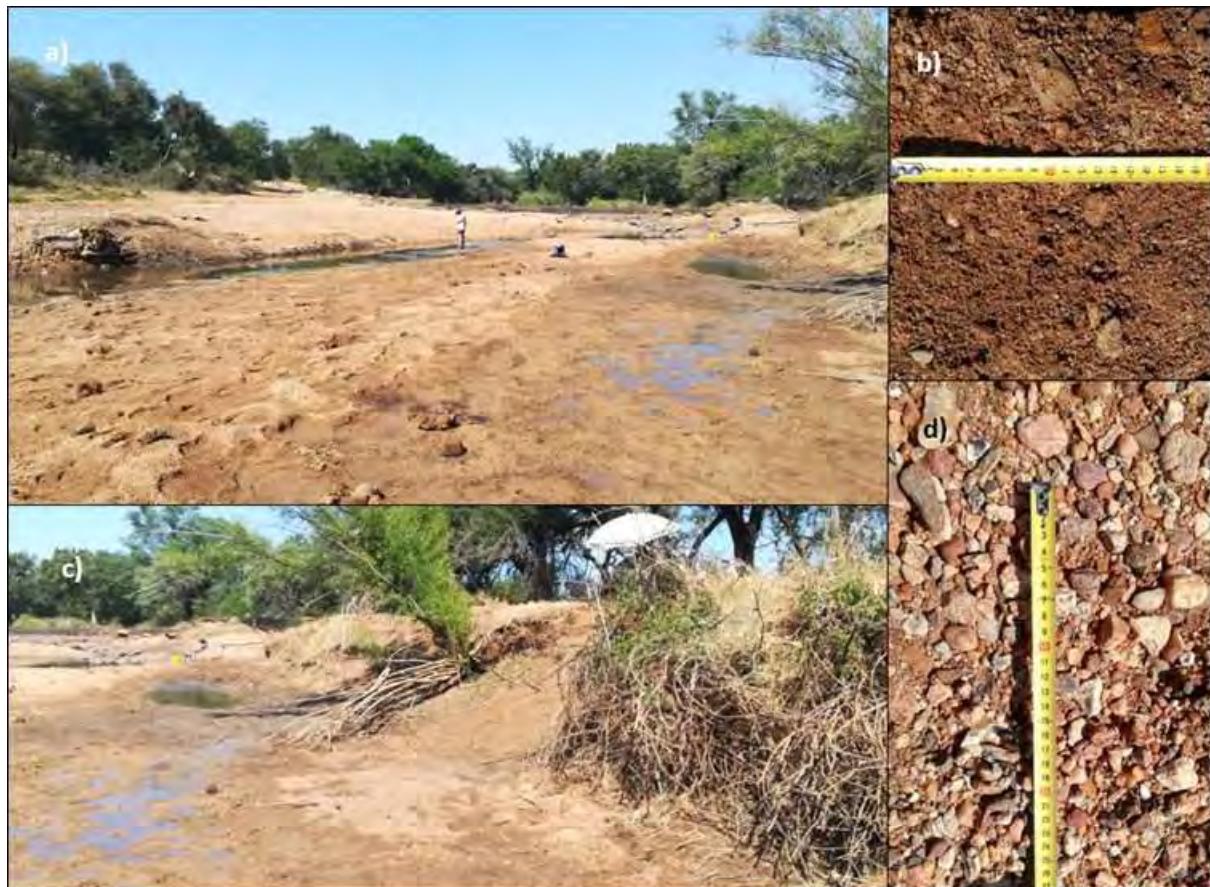
FIGURE 35: SITE IMAGES SHOWING A) AN UPSTREAM VIEW OF THE SANDY CHANNEL; B) COARSE SAND ON THE CHANNEL BED; C) ERODING LEFT BANK; D) GRAVEL DEPOSIT ON RIGHT FLOOD BENCH

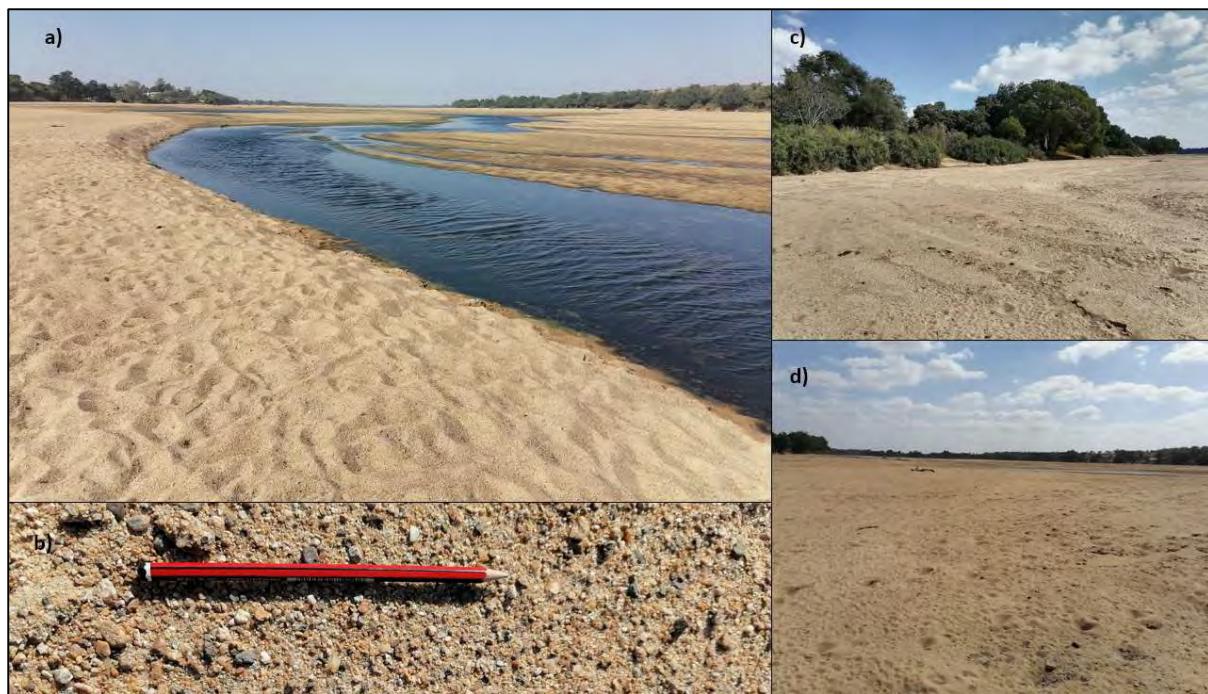
FIGURE 40: SITE IMAGES SHOWING A) AN UPSTREAM VIEW OF THE WELL VEGETATED CHANNEL; B) FINE GRAVEL FROM THE RIFFLE SECTION; C) SAND BENCH ALONG RIGHT BANK; D) RECENT SAND DEPOSIT ALONG THE CHANNEL MARGIN

The Shashe River is a wide alluvial river with a coarse sand bed. At the site it falls in the lower foothills zone and is over 500 m wide. It has a narrow floodplain and is set in a gently undulating landscape. The low flow channel has a braided flow pattern and becomes straight to wandering pattern at higher flows ([Error! Reference source not found.](#)). The banks are composed of fine sand and silt and lined with trees and shrubs. The sandy bed has some gentle undulations with an inset bench along the right bank and sand bars along the left bank (Figure 39). The bed of the channel was mostly composed of coarse sand and fine gravel (Figure 40).

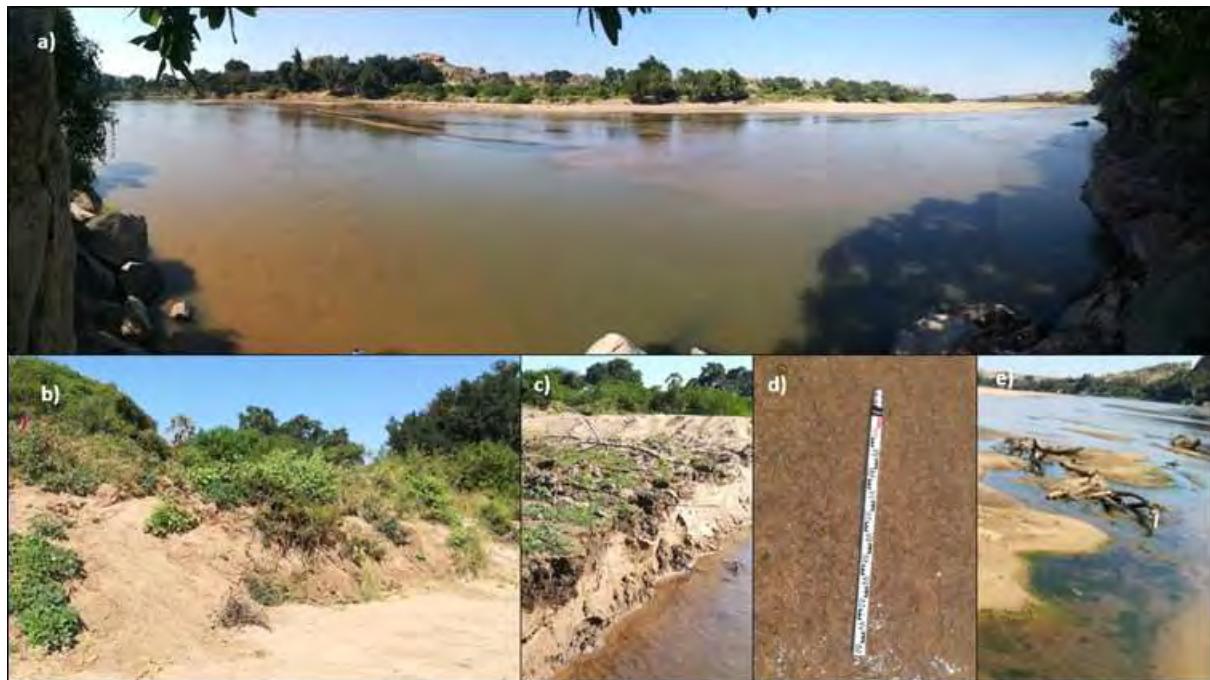
FIGURE 45: SITE IMAGES SHOWING A) A PANORAMIC VIEW OF THE CHANNEL FROM THE ROCKY LEFT BANK; B) STEEP FINE SAND AND SILT FLOOD BENCH ALONG THE RIGHT BANK; C) ORGANIC RICH SILT DEPOSIT DOWNSTREAM OF SAND BAR; D) FINE GRAVEL SUBSTRATE IN SHALLOW WATER; AND E) WOODY DEBRIS CREATING LOCAL COVER FOR BIOTA

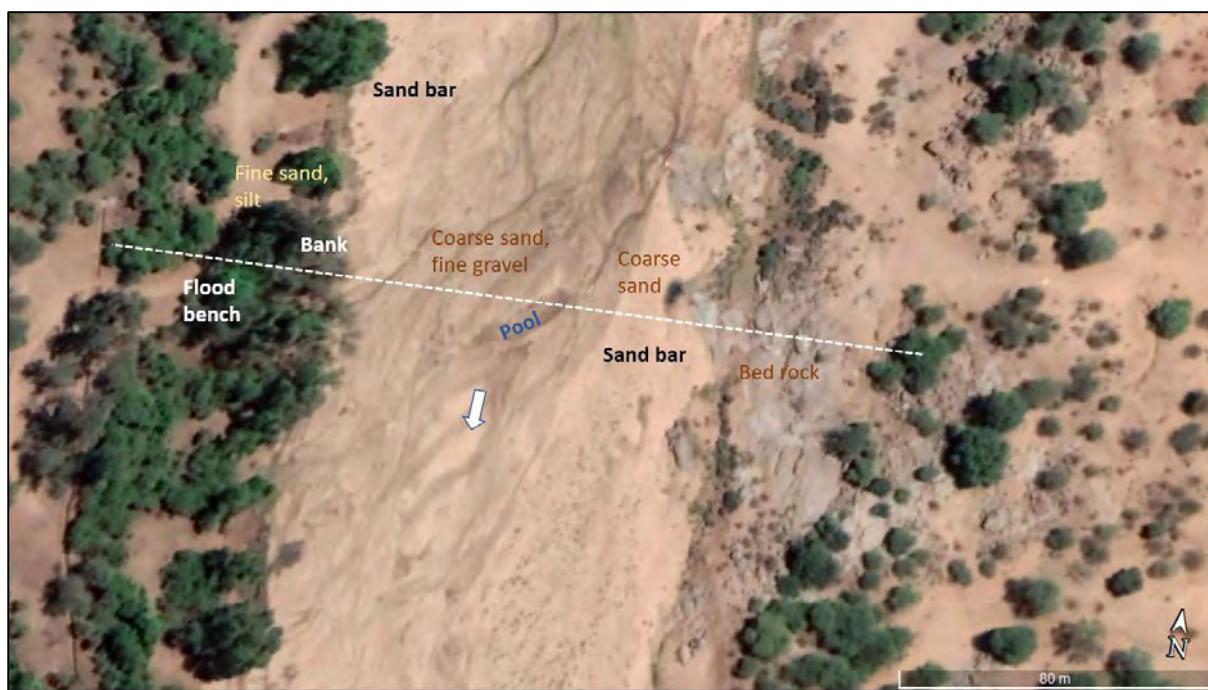
FIGURE 50: ORTHOPHOTO SHOWING MORPHOLOGICAL FEATURES AND SEDIMENT COMPOSITION OF UMZI-Y20C-BEITB (UMZINGWANI RIVER; GOOGLE EARTH IMAGE DECEMBER 2020).

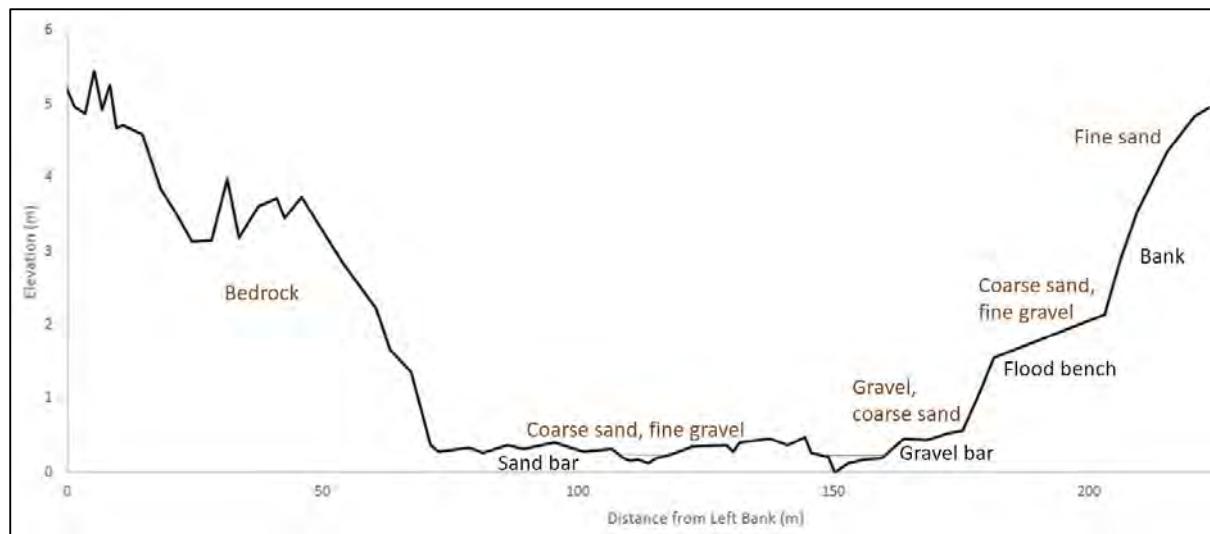
FIGURE 51: CROSS SECTION OF UMZI-Y20C-BEITB (UMZINGWANI RIVER) SHOWING MORPHOLOGICAL FEATURES AND SEDIMENT COMPOSITION.

The Umzingwani River is a mixed bed sand river set in a gently undulating landscape. The site falls in the lower foothill geomorphic zone and has a very narrow floodplain and wide sandy bed approximately 100m wide (Figure 50, Figure 51). Bedrock forms the left bank and fine sand and silt the right bank. Trees and shrubs grow along both banks with low grass cover due to overgrazing (Figure 52). The plane sand bed has low topographic variation longitudinally, resulting in very shallow pools. The bed and bar substrate are dominated by coarse sand and fine gravels. Some larger gravels were forming an armour layer over the coarse sand along the right channel margin (Figure 52).

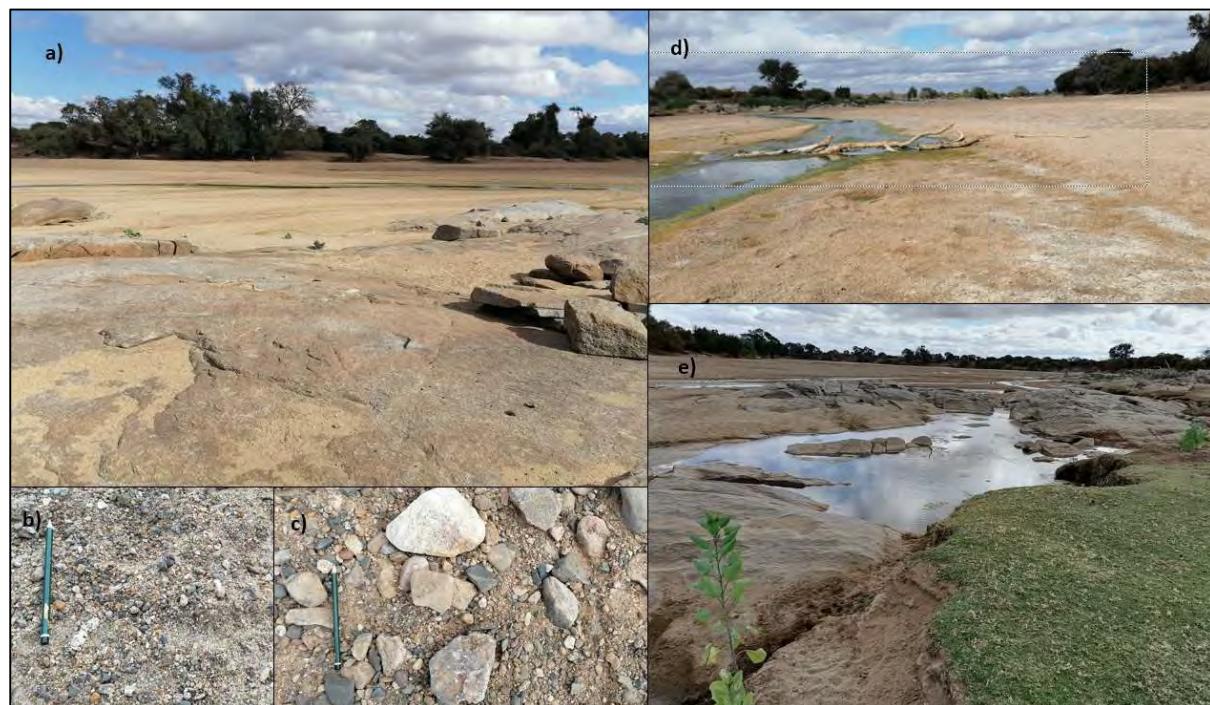
FIGURE 52: SITE IMAGES SHOWING A) THE SANDY CHANNEL FROM THE ROCKY LEFT BANK; B) COARSE SAND AND FINE GRAVEL IN THE CHANNEL; C) MEDIUM GRAVEL ARMOURING COARSE SAND ALONG THE RIGHT CHANNEL MARGIN D) SHALLOW POOL HABITAT WITH WOODY DEBRIS; AND E) BEDROCK POOL HABITAT ALONG THE LEFT BANK

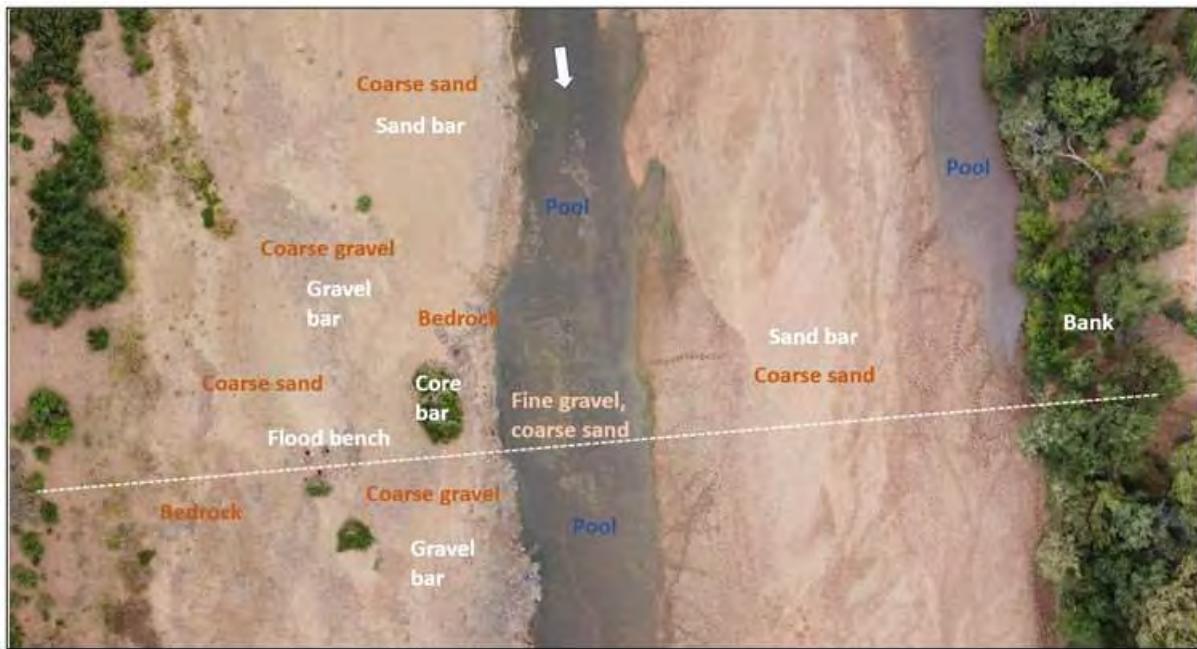
FIGURE 66: ORTHOPHOTO SHOWING MORPHOLOGICAL FEATURES AND SEDIMENT COMPOSITION OF THE SHINGWEDZI RIVER.

The Shingwedzi River is incised into the surrounding landscape with a very narrow floodplain (

FIGURE 66). Pools form along the gentler gradients with wide shallow slow flowing water. Coarse sand and fine gravel dominate the bed material. The left bank is steep with good tree cover and composed of fine sand and silt. The right bank is composed of various levels of sand and gravel bars forming various flood levels.

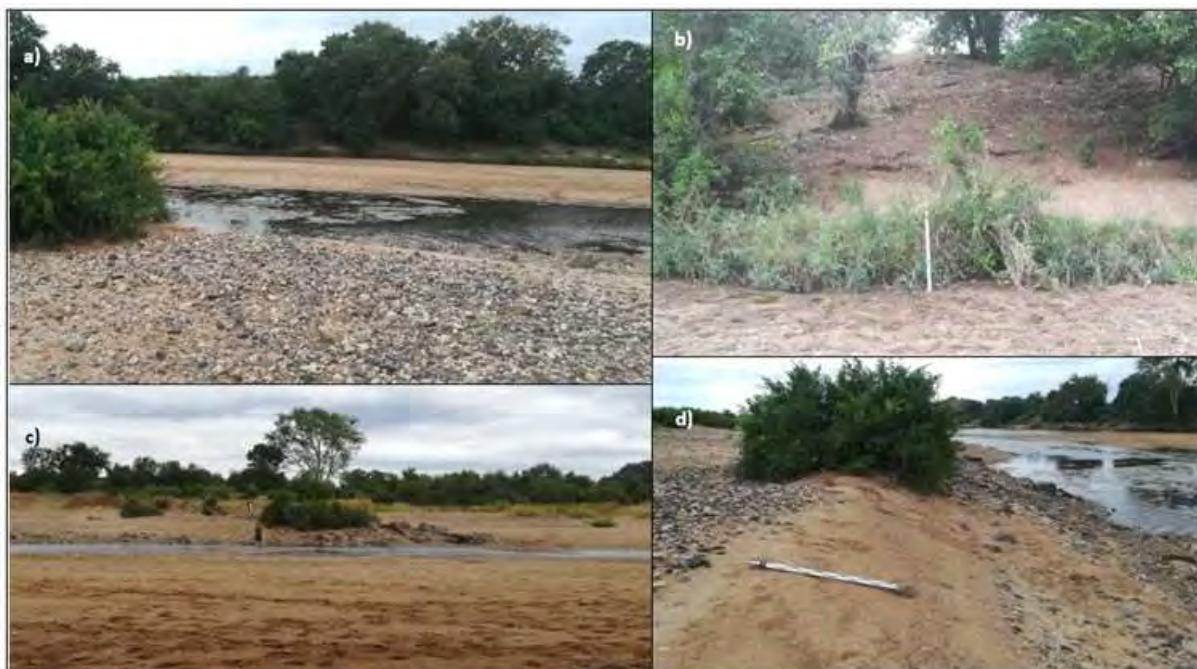
FIGURE 68: SITE IMAGES SHOWING A) A VIEW FROM THE RIGHT BANK (GRAVEL ON THE FLOOD BENCH IN FOREGROUND); B) WELL VEGETATED BANKS AND SANDY CHANNEL; C) FIEW OF THE SANDY CHANNEL FROM THE LEFT BANK; D) SANDY LEE DEPOSIT BEHIND BEDROCK CORE ISLAND

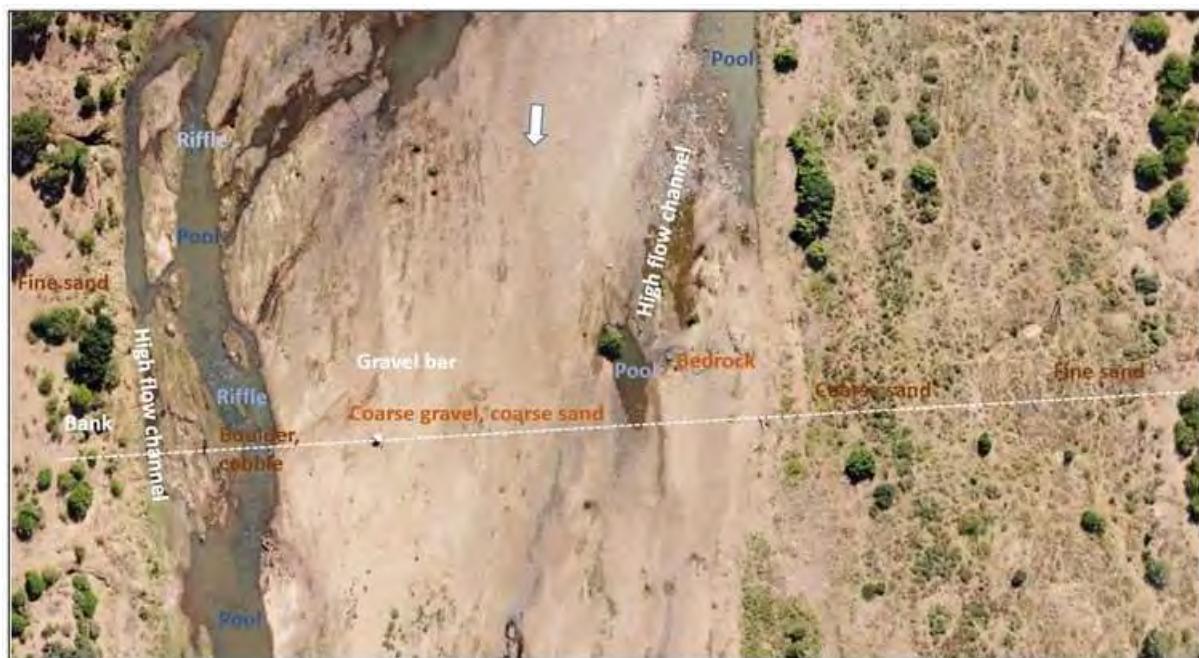
FIGURE 71: ORTHOPHOTO SHOWING MORPHOLOGICAL FEATURES AND SEDIMENT COMPOSITION OF THE LETABA RIVER.

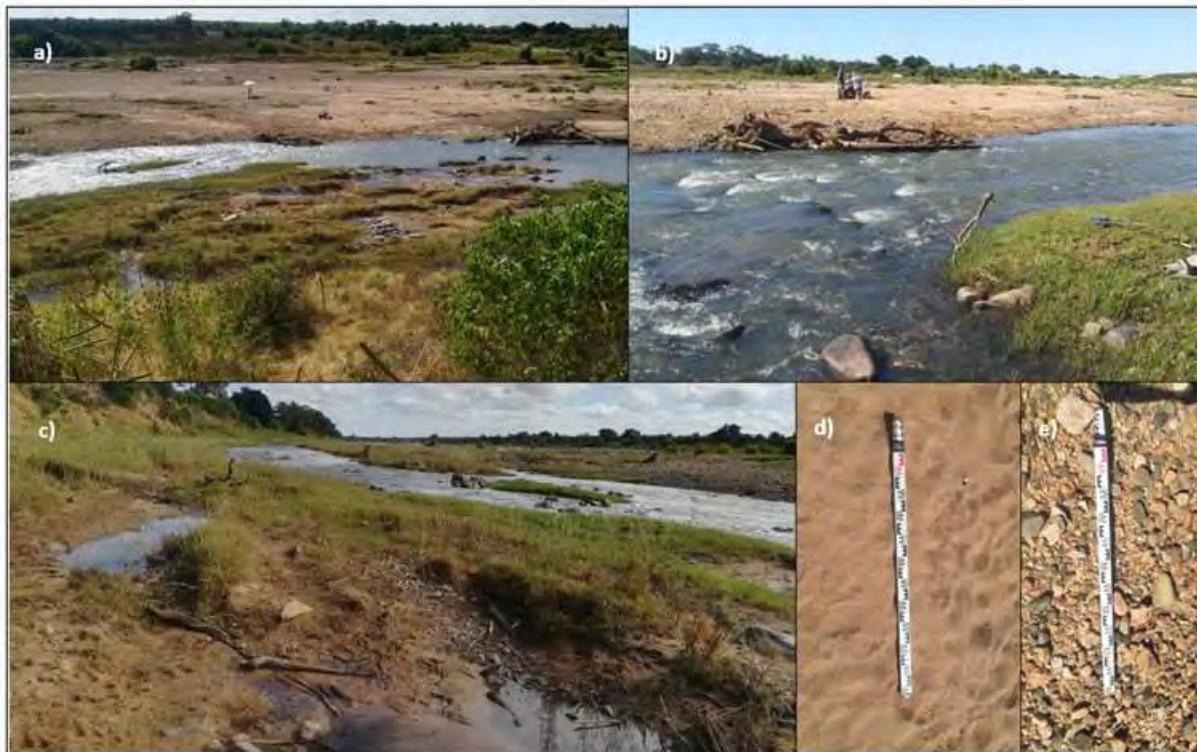
FIGURE 73: SITE IMAGES SHOWING A) A VIEW OF THE CHANNEL FROM THE RIGHT BANK; B) BOULDERS AND COBBLE IN THE RIFFLE; C) VEGETATED INSET BENCHES ALONG THE RIGHT BANK; D) SAND BAR MATERIAL; AND E) GRAVEL BAR MATERIAL

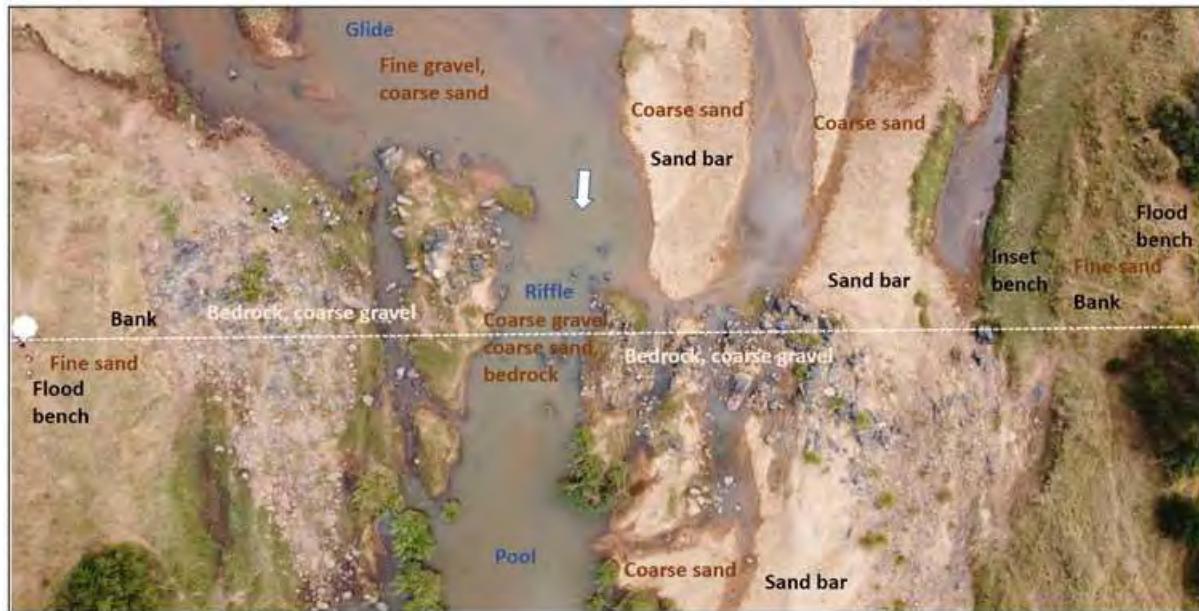
FIGURE 76: ORTHOPHOTO SHOWING MORPHOLOGICAL FEATURES AND SEDIMENT COMPOSITION OF THE GROOT LETABA RIVER.

FIGURE 76, FIGURE 77). The bedrock sections are steeper, providing riffle type habitats. It follows a pool riffle sequence, except for steeper bedrock sections where rapids form. Glides and runs were observed. In between the bedrock sections the channel is wider and less steep, resulting in the

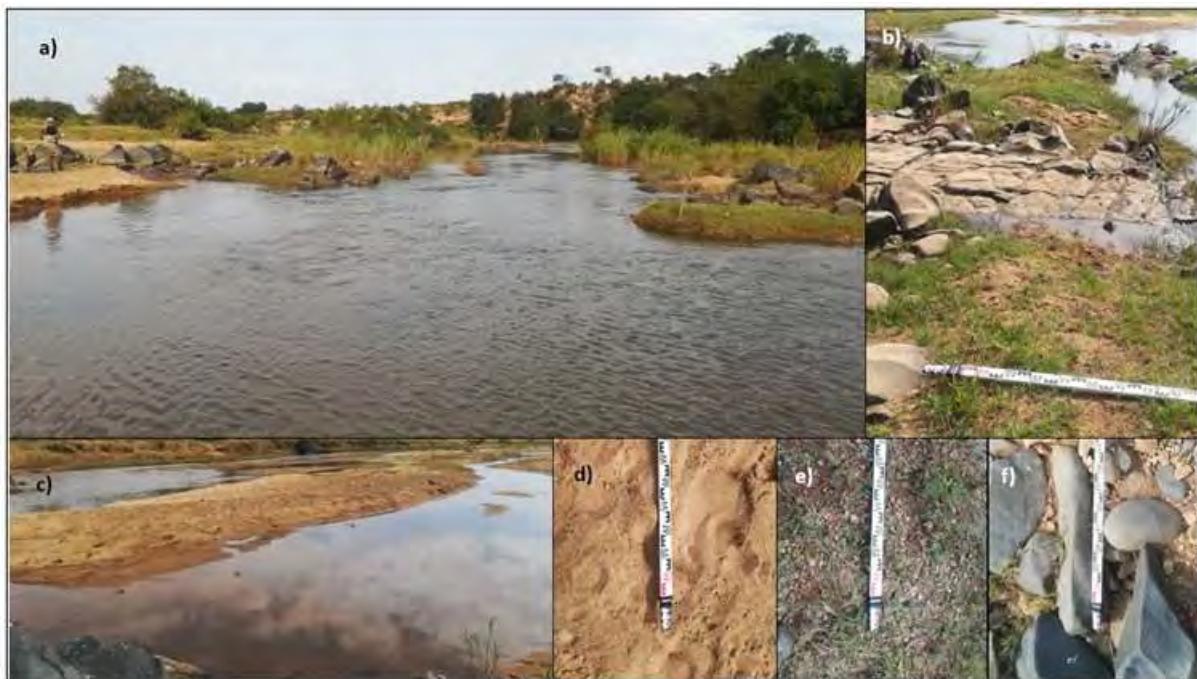
FIGURE 78: SITE IMAGES SHOWING A) A DOWNSTREAM VIEW OF THE CHANNEL; B) SANDY LEE DEPOSITS BEHIND BEDROCK; C) SAND BARS IN THE CHANNEL; D) COARSE SAND DEPOSIT; E) SPARSELY VEGETATED GRAVEL BAR; AND F) EMBEDDED COBBLES AND BEDROCK

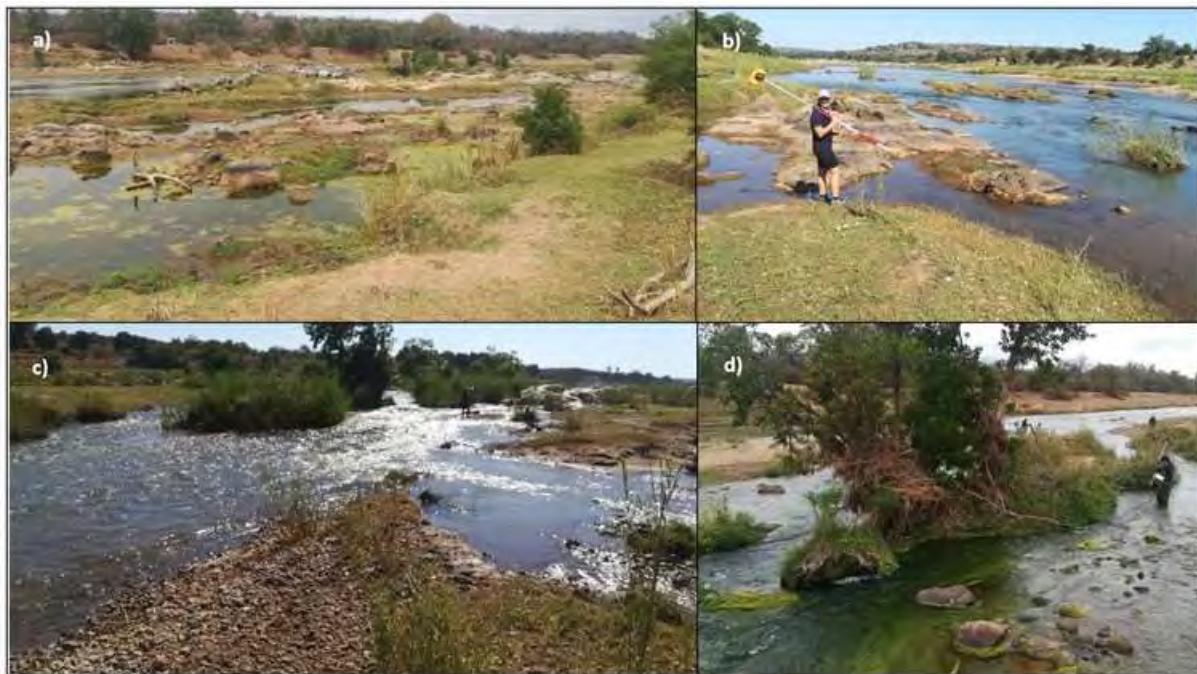
FIGURE 83: SITE IMAGES SHOWING A) A DOWNSTREAM VIEW OF THE ANASTOMOSING CHANNEL; B) VIEW DOWNSTREAM OF THE ANASTOMOSING SECTION; C) GRAVEL RIFFLE IMMEDIATELY DOWNSTREAM OF BEDROCK SECTION; D) CORE BAR WITH REED AND TREE COVER
