**E-FLOWS FOR THE LIMPOPO RIVER BASIN:
PRESENT ECOLOGICAL STATE –
DRIVERS OF ECOSYSTEM CHANGE**

(Submitted in partial fulfilment of Milestone 6 : Wet Season Field Survey Report)

Report citation: O'Brien, G.; Dickens, C.; Stassen, R.; Erasmus, H.; Herselman, S.; van der Waal, B.; Wepener, V.; Pearson, H.; LeRoux, H.; Villholth, K.; Ebrahim, G.; Magombeyi, M.; Riddell, E.; Petersen, R. 2022. *E-flows for the Limpopo River Basin: present ecological state - drivers of ecosystem change*. Project report prepared by the International Water Management Institute (IWMI) for the United States Agency for International Development (USAID). Colombo, Sri Lanka: International Water Management Institute (IWMI); Washington, DC, USA: USAID. 296p. (E-flows for the Limpopo River Basin: Report 5). doi: <https://doi.org/10.5337/2022.220>

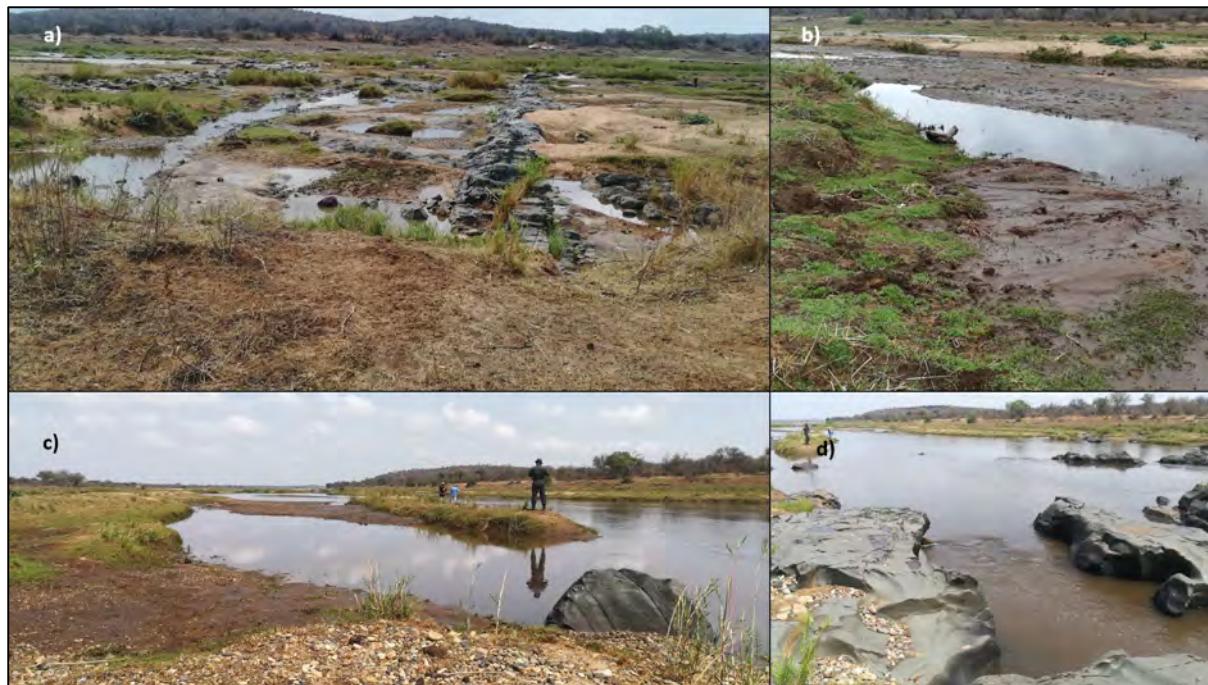
FIGURE 88: SITE IMAGES SHOWING A) A VIEW FROM THE RIGHT BANK OF THE ANASTOMOSING BEDROCK CHANNELS; B) SILT DRAPE OVER SANDY BED MATERIAL; C) VEGETATED BARS AND STAGNANT HIGH FLOW CHANNELS; D) GRAVEL DEPOSITS IN AND AROUND BEDROCK CHUTES

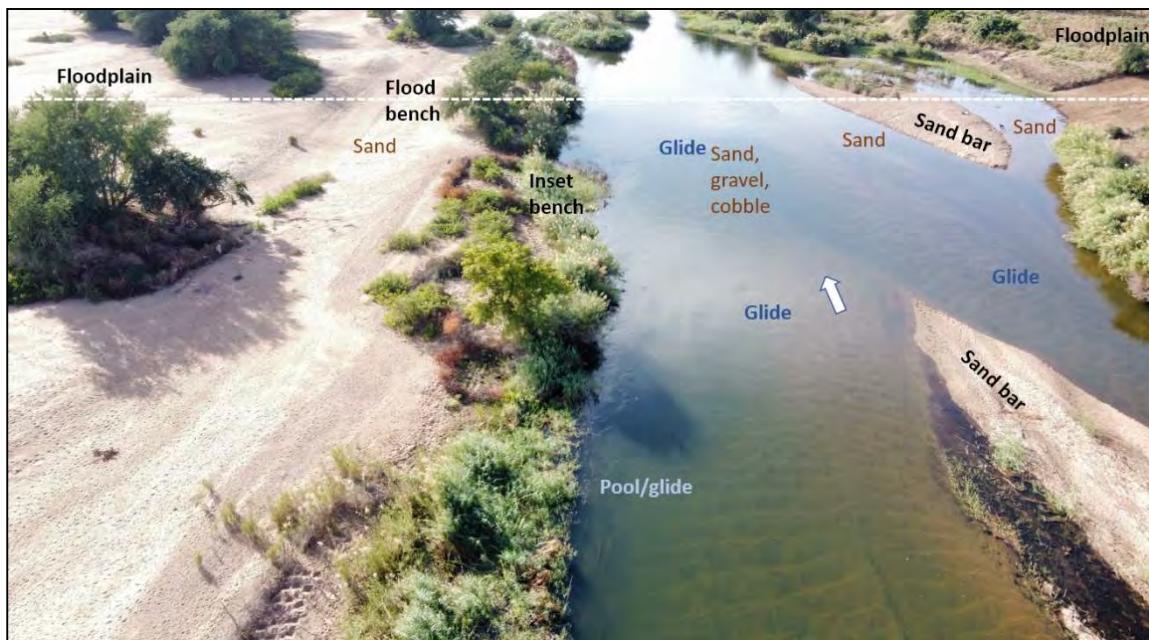
FIGURE 91: OBLIQUE PHOTO SHOWING MORPHOLOGICAL FEATURES AND SEDIMENT COMPOSITION OF ELEP-Y30C-SINGU (ELEPHANTES RIVER). THE DASHED LINE INDICATE THE LOCATION OF THE TRANSECT.

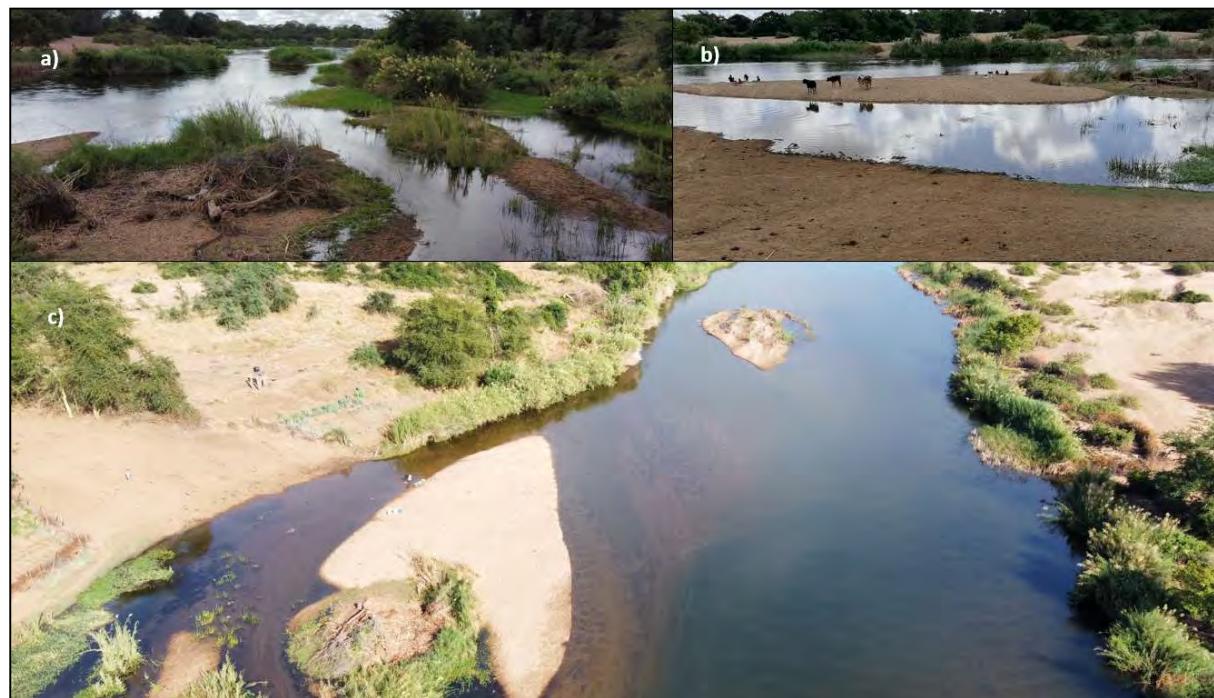
FIGURE 93: SITE IMAGES SHOWING A) AN UPSTREAM VIEW OF THE WELL VEGETATED CHANNEL MARGIN; B) UNVEGETATED BANK AND SAND BAR WHERE LIVESTOCK ACCESS THE RIVER; C) OBLIQUE UPSTREAM VIEW OF THE SITE SHOWING SAND BARS AND CULTIVATION ALONG THE RIGHT BANK

The Elephantes River is an alluvial channel with sand dominating the bed, morphological features and finer sand the floodplain (Figure 91). It is located 8km downstream of the Masingir Dam (constructed before 1984 based on LandSat images), with associated sediment and flow regulation. There are no signs of sediment starvation of channel incision or widening at the site yet (Figure 92). The floodplain is 3km wide at the site, with a gentle fall in elevation away from the channel banks and levees. The low-flow channel has a braided pattern, becoming a wandering channel pattern during higher flows (Figure 93). The active channel has various bars and benches that are transient as they are composed of non-cohesive sandy material and non-vegetated. The majority of the bars along the fringes are well vegetated and stable, effectively forming islands. Small dunes can be seen on the river bed, indicating slow ongoing sand movement during the observed flows.

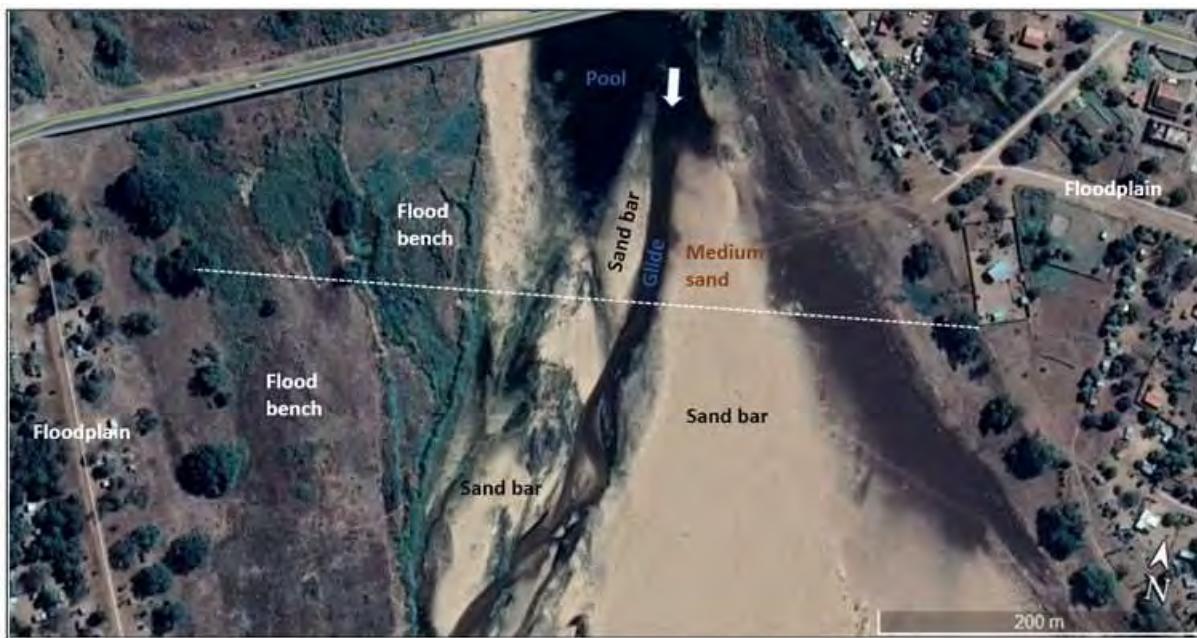
FIGURE 97: SATELLITE IMAGE SHOWING MORPHOLOGICAL FEATURES AND SEDIMENT COMPOSITION OF THE LIMPOPO RIVER AT CHOKWE.

The floodplain at Chockwe is used for housing and agriculture (

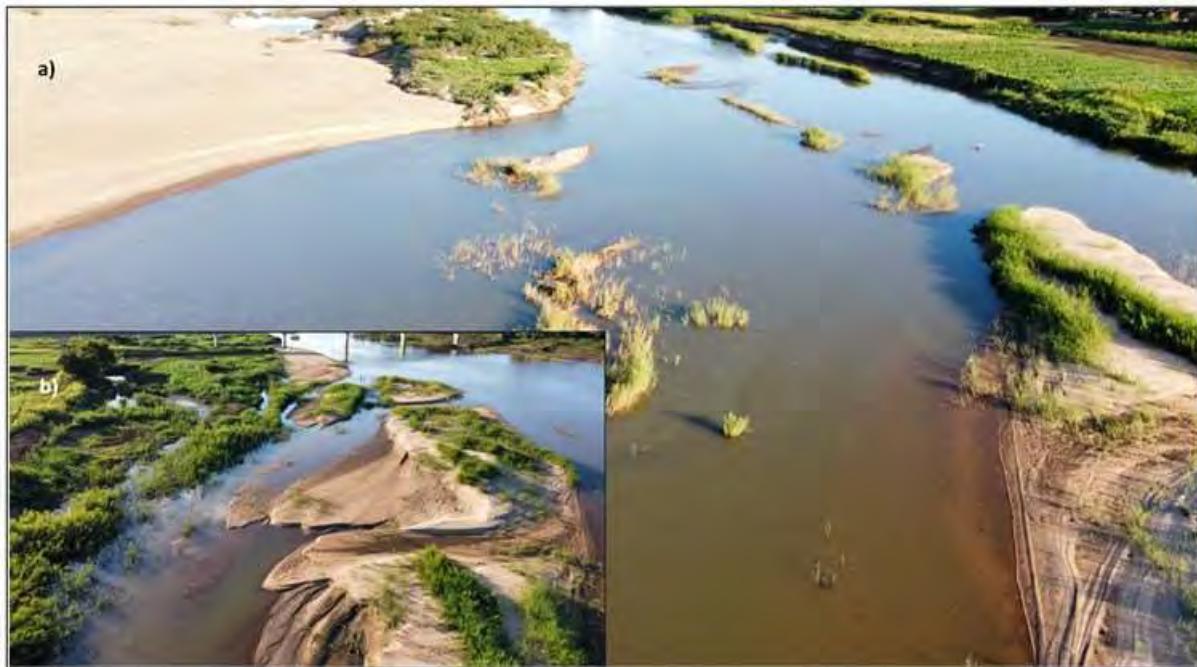
FIGURE 99: SITE IMAGES SHOWING A) A DOWNSTREAM VIEW OF THE CHANNEL WITH EXTENSIVE SAND BARS AONG THE LEFT BANK AND CULTIVATION ON THE FLOOD BENCH ALONG THE RIGHT BANK; B) BRAID CHANNELS BETWEEN SAND BARS

Figure 97). The low-flow channel has a braided pattern that becomes a wandering channel pattern during higher flows (FIGURE 98;

FIGURE 99). Within the macro channel, the sandy flood benches along the right bank are used for agriculture. The sand bars are reworked frequently, thus not well vegetated unless protected during higher flows (out of the main current). The deeper part of the active channel is composed mainly of coarse sand, with patches of gravel.

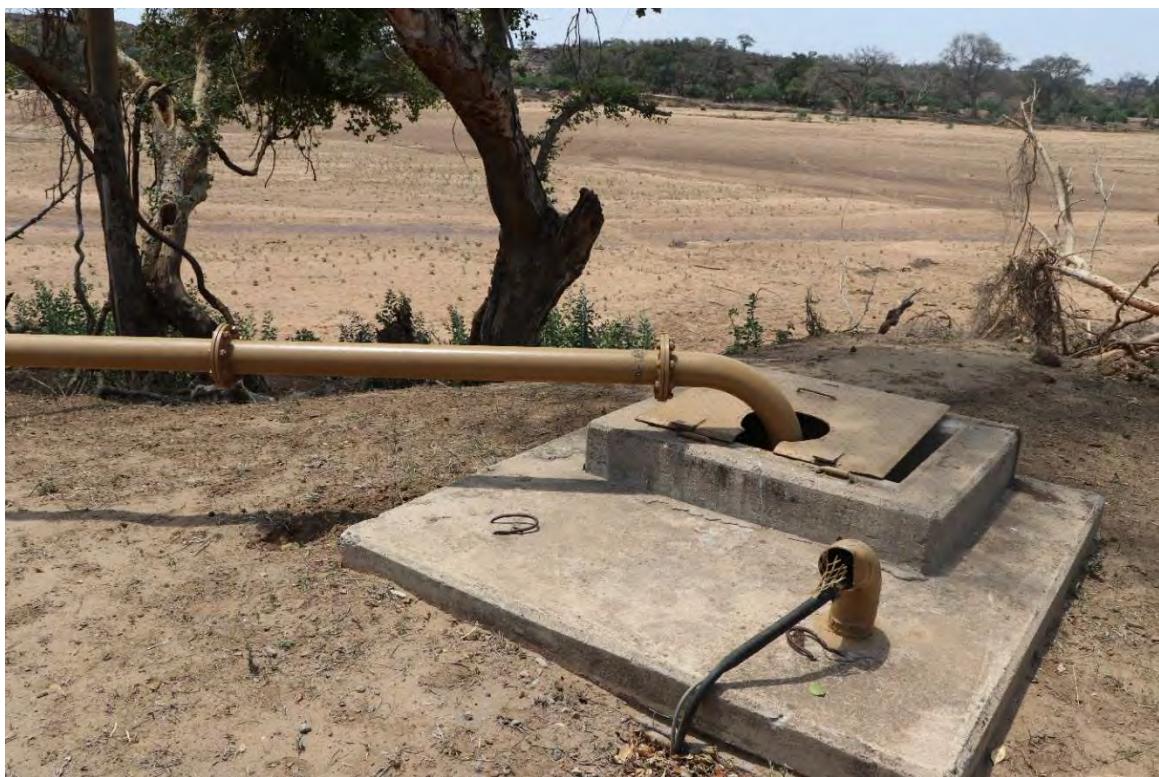
FIGURE 124: BOREHOLE IN MAPUNGUBWE CLOSE TO LIMPOPO RIVER, PUMPING WATER TO A NEARBY MINE

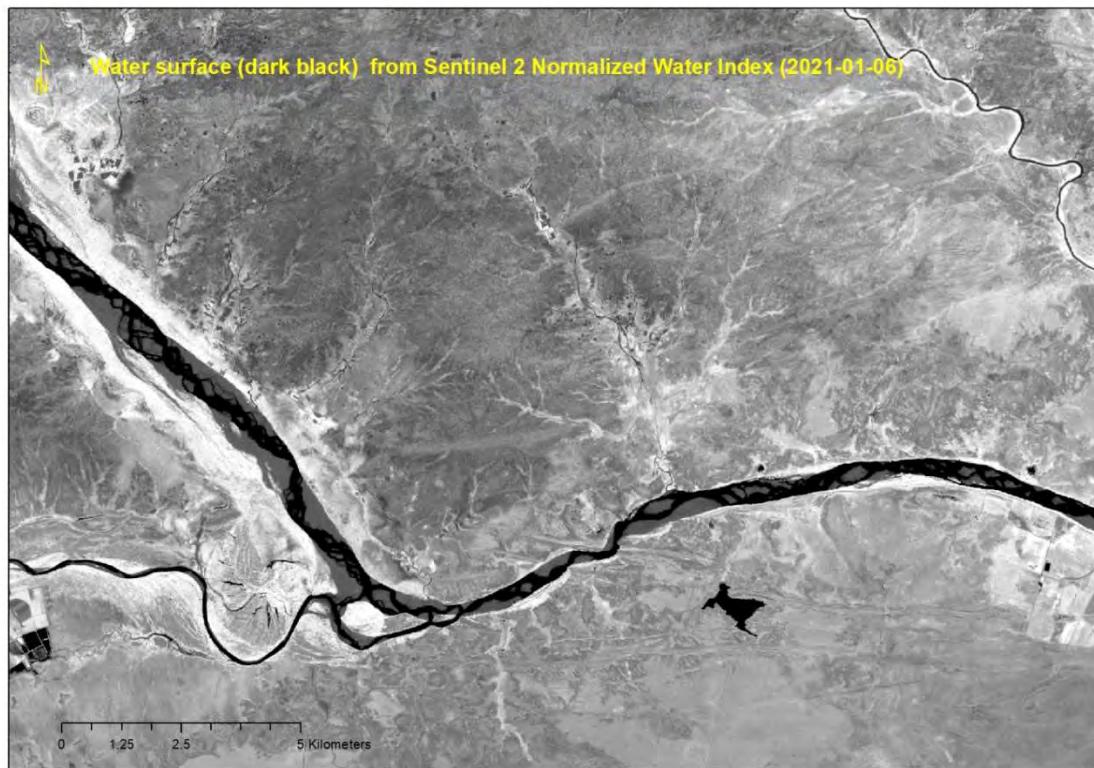
FIGURE 125: WATER SURFACE FEATURE MAPPING USING SENTINEL 2 (JANUARY –WET SEASON)
