ASSESSMENT OF THE RATE OF SEDIMENTATION AT THE ENTRANCE CHANNEL OF THE DAR ES SALAAM HARBOUR

¹Edna William Machumu, ²Melchior Vitalis Shukuru

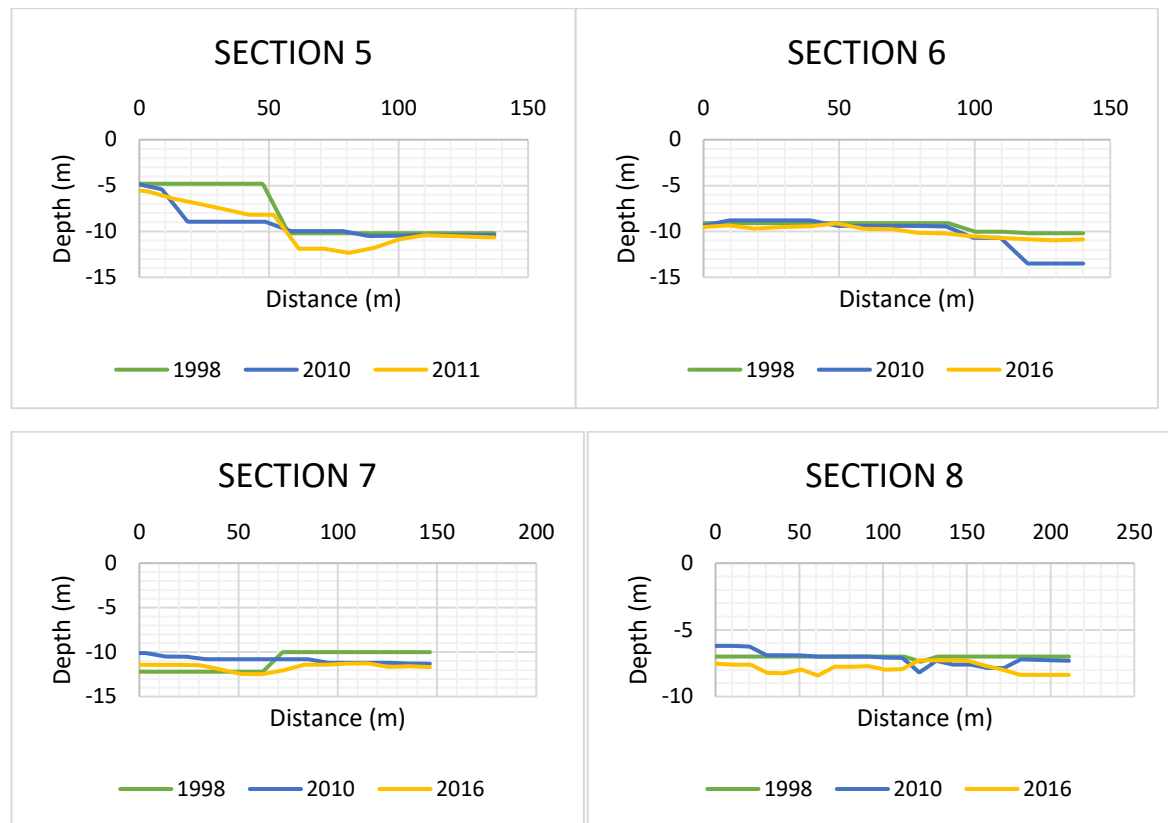
Figure 3: cross-section of the entrance channel of the Dar es Salaam harbour, comparing depths after dredging in 1998, 2010 and 2016.

From the cross-sections below, it can be seen that after dredging in 1998, the entrance channel has experienced both scouring and deposition of sediments. Bathymetry along the berth basins in section 3 which is Q in figure 4.4 and 4.5, indicates that sediment deposition in some areas has reached up to 4.8m and 10m in thickness for the year 2016 and 2010 respectively. Sediment deposition is also seen in section 5, 6, 7 and 8 which is R, Z, M and N as respectively indicated in figure 2. The trend of sediment deposition shows that there is scouring in the entrance channel where the magnitude differs from section to section and in the harbour basin, sedimentation is seen closer to the quays. The sections S1 to S46 from Figure 2, also shows both deposition and scouring in which scouring has manifested. The pattern from the cross sections drawn is not regular that is it does not occur at regular interval. This type of pattern is called a cyclical pattern in which it is difficult to predict if deposition or erosion will occur at that particular place and at a particular time.

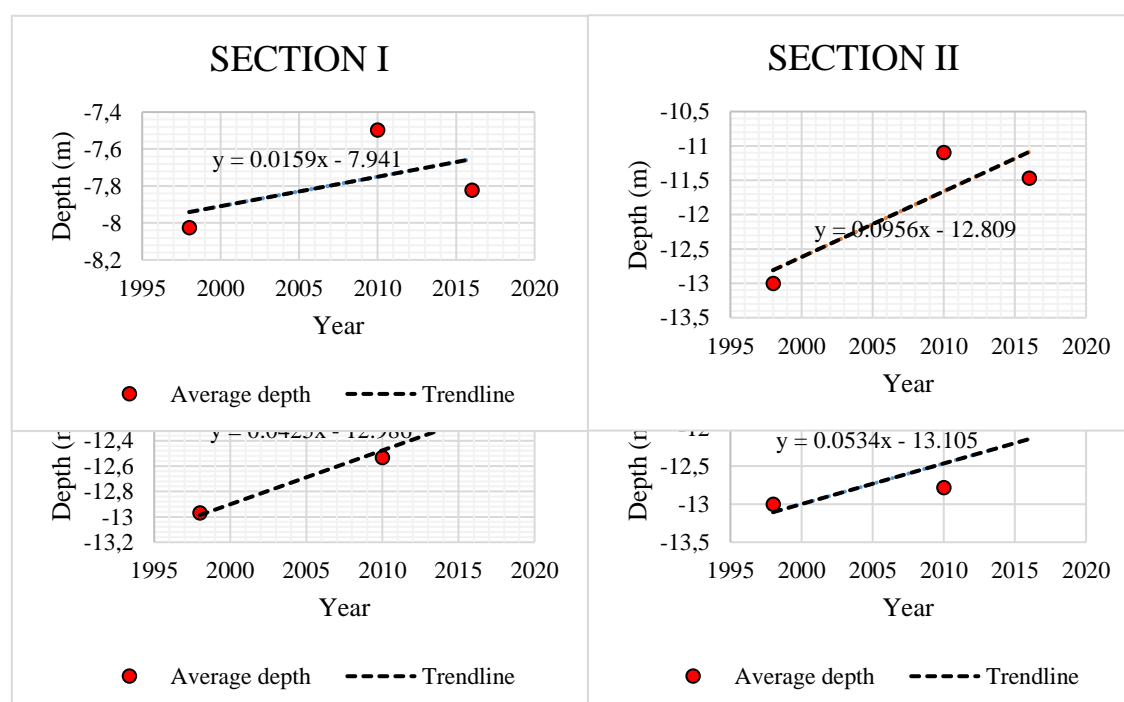
Figure 5(a): Time series maps indicating how the rate has changed at different sections at the main quay

Time series maps were drawn for each section at varying depth to show the rate of sedimentation and how it differs between the sections. From the time series maps drawn, it shows that the rate has been changing significantly from the time of dredging to 2010 and 2016. The rates are calculated from the main quay in which at each section average depth is taken in each year and the rate is determined from the best fitting line equation where the slope indicates the rate of sediment deposit at that year. The rate ranges from 1.59 to 12.25cm/yr. Most of the part has experienced scouring with exception for sections between S21 and S23 where the rate is between 10.18 and 10.15 cm/year.

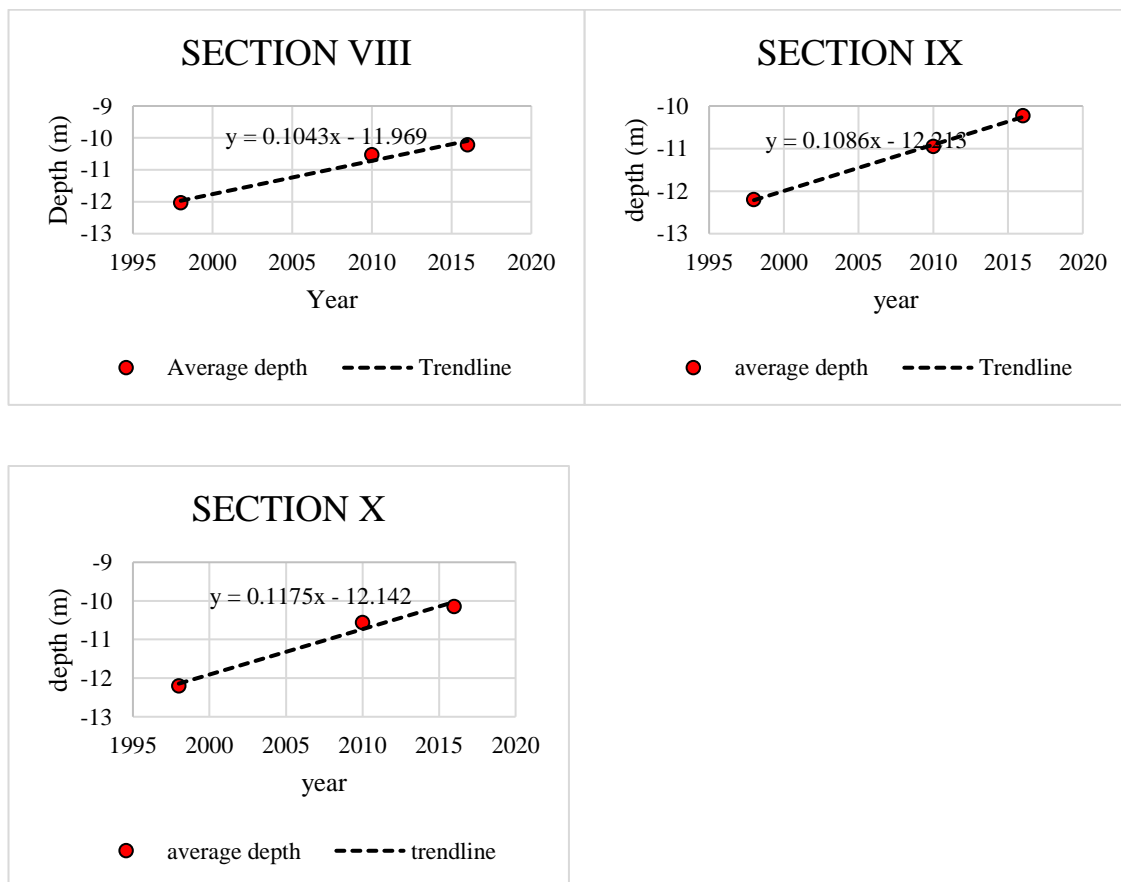
Figure 5(b): Time series maps indicating how the rate has changed at different sections at the main quay
