**AN ANALYSIS OF SUITABILITY OF GROUNDWATER FOR
AGRICULTURAL PRACTICES IN AMBALA CITY AND AMBALA
CANTONMENT AREA, HARYANA, INDIA**

Ritu Sarsoha

DOI: <https://doi.org/10.51193/IJAER.2024.10508>

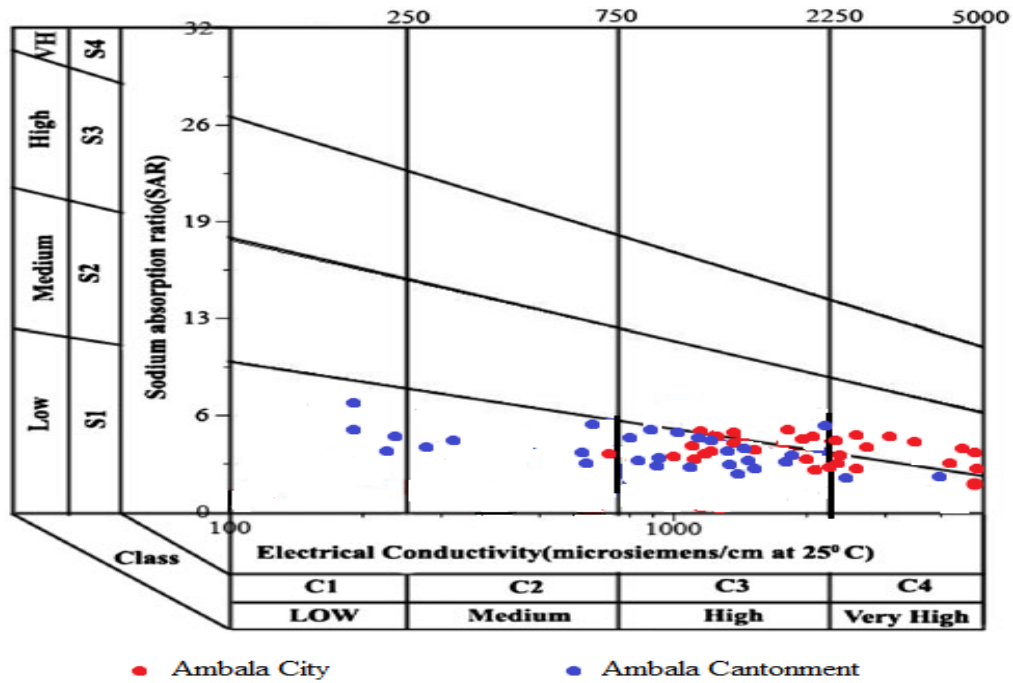
Fig. 3: USSL diagram showing classification of water in Ambala City and Ambala Cantonment (Pre- monsoon)

The analytical data plotted on US salinity diagrams shows that during pre-monsoon (Fig. 3), the groundwater in Ambala City and Ambala Cantonment for irrigation purposes are of C₃S₁, C₄S₁ and C₁S₁ type indicating that water in Ambala City and Ambala Cantonment exhibits high salinity and low sodium and very high salinity and low sodium hazard. This indicates that high salinity and low sodium water which can be used for irrigation for almost all types of soils.

A diagram has been proposed for the classification of irrigation water by US salinity staff (1954). This diagram is being used widely to classify the irrigation water with reference to salinity and sodium hazard. On a semi-logarithmic paper, the Electrical Conductivity (EC) and Sodium Absorption Ratio (SAR) values of water are plotted against each other. The high concentration of sodium in water makes the soil impermeable to water by blocking its pores due to adsorption of sodium on the cation exchange process.

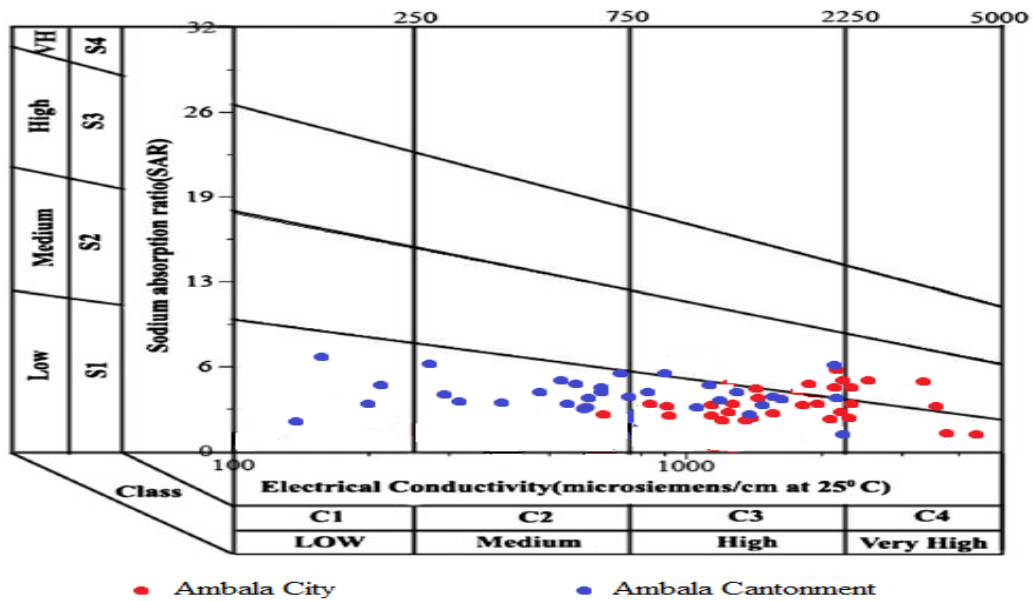
Fig. 4: USSL diagram showing classification of water in Ambala City and Ambala Cantonment (Post- monsoon)

The analytical data plotted on US salinity diagrams shows that during post monsoon (Fig. 3), the groundwater in Ambala City and Ambala Cantonment for irrigation purposes is mainly of C₂S₁, C₃S₁ and C₄S₁. 4 samples of Ambala City fall in C₄S₁, and C₄S₂ type (high hazard) It indicates that water in Ambala City and Ambala Cantonment is mainly of high salinity and low sodium and very high salinity and medium sodium hazard This indicates that high salinity and low sodium water which can be used for irrigation for almost all types of soils (Fig. 4).

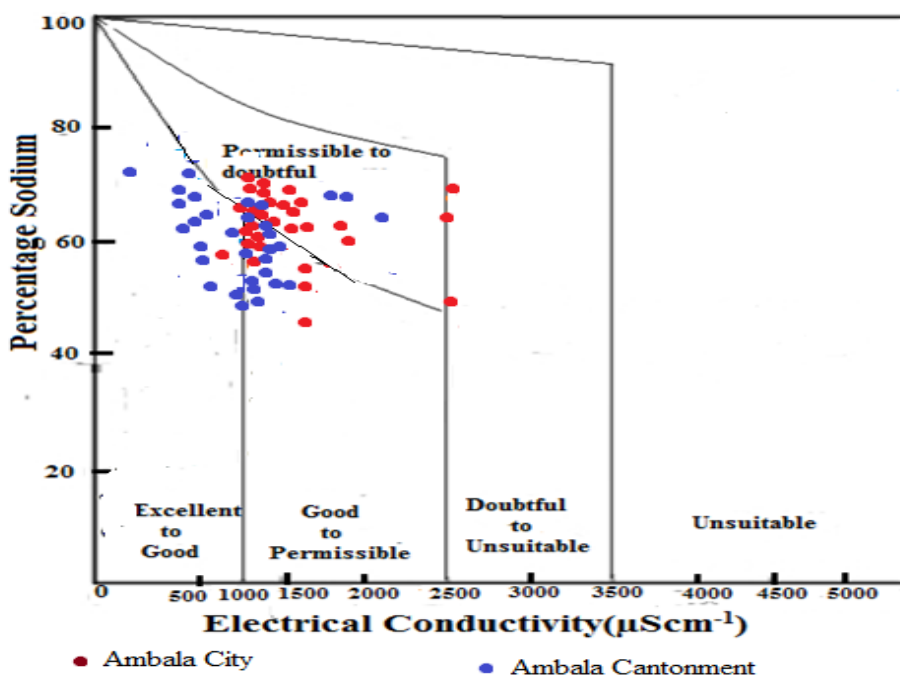
Fig. 5: Wilcox Classification for suitability of groundwater (Pre- monsoon)

Wilcox (1955) diagram is adopted for classification of irrigation, wherein the EC is plotted against the percentage of Na. During pre-monsoon, based on Wilcox classification, (Table 3.7), in Ambala City, 10% of the samples were under unsuitable category, 46.6% of the samples were under permissible to doubtful category, 60% of the samples belonged to good to permissible category, 3.3% of the samples belong to the excellent to good category, whereas in Ambala Cantonment, 16.1% of the samples were under permissible to doubtful category, 38.7% of the samples belonged to good to permissible category and 45.1% of the samples were under excellent to good category (Fig. 5 and Fig. 6). During post monsoon, none of the sample fell in unsuitable category. Only 3 samples from Ambala City were at border line. Figure 5 and Figure 6 reveals that the quality of water samples from Ambala Cantonment was better than Ambala City.
